# Hume Lake Dam Preservation and Rehabilitation Project

Designed by John Eastwood and constructed in 1908 Hume Lake Dam is the first multi-arch reinforced concrete dam in the world. The dam is located in the Sierra Mountains east of Fresno, California. Its original purpose was as a log pond and water source for a 17 mile flume used to transport timber downstream.

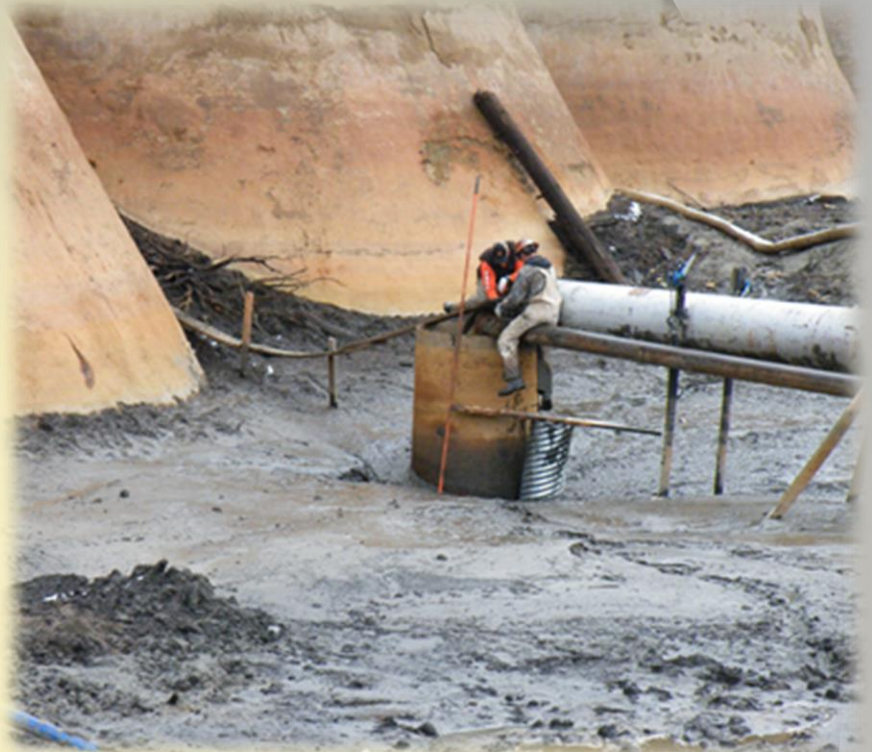
Prime Contractor – MCS Construction prepping the inflow bypass. Approximately 7 feet of sediments were deposited since the last major project in 1984. Total depth of sediments is approximately 15 feet which included material from a coffer dam failure in 1984.

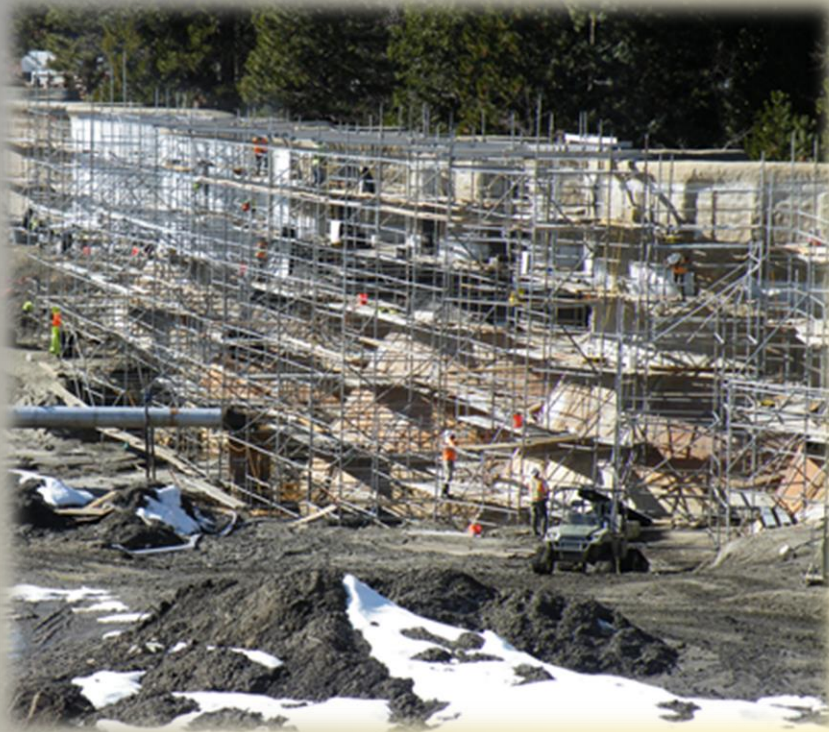
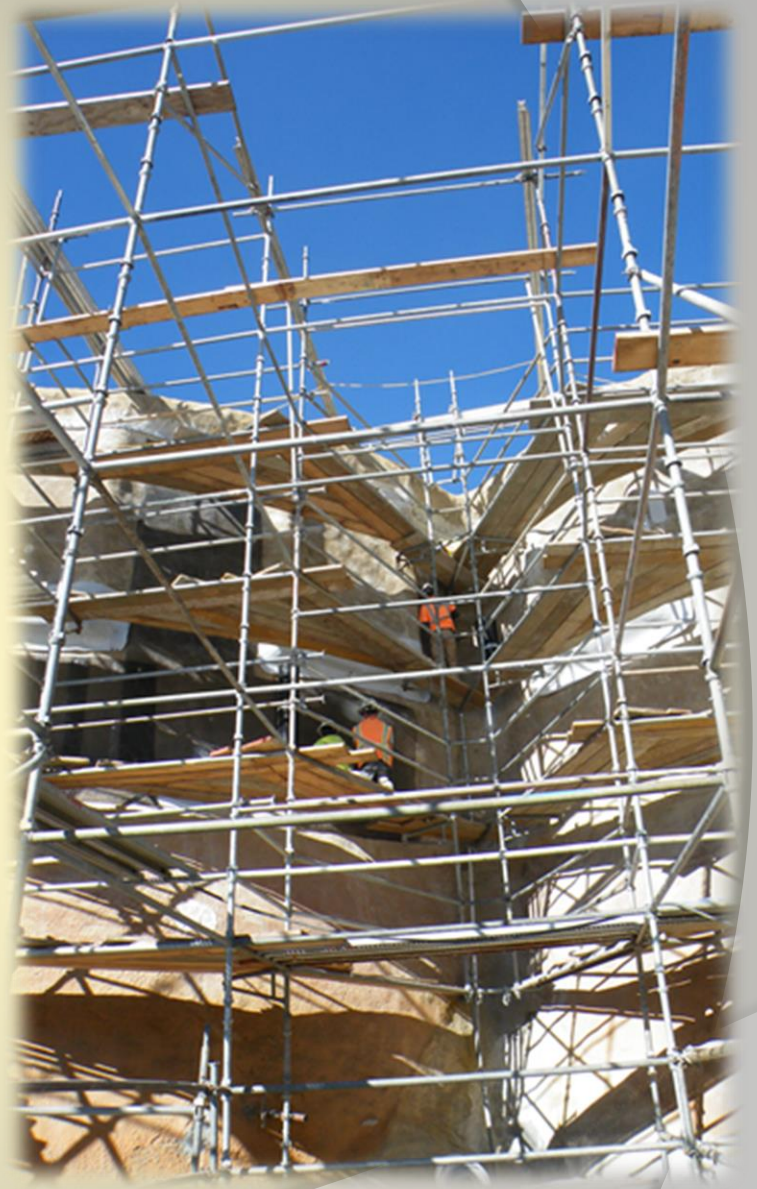
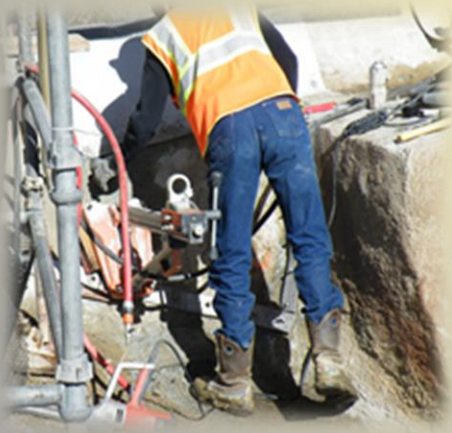
Construction of the liner on the upstream face – January 2016. The liner consist of a 100 mil PVC membrane over a geonet drain. Four holes were cored through the dam to drain the geonet.

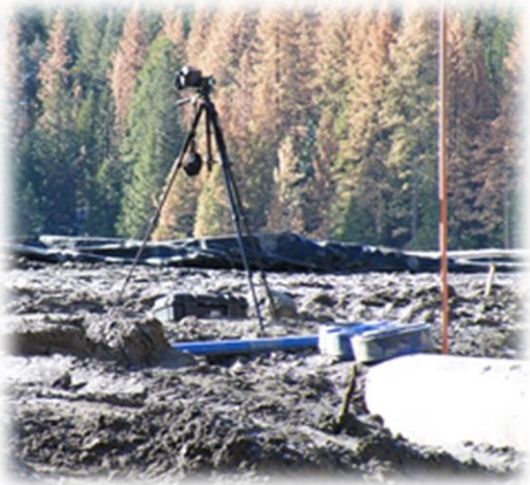
Infrared imaging to detect areas of shotcrete delamination for liner installation.

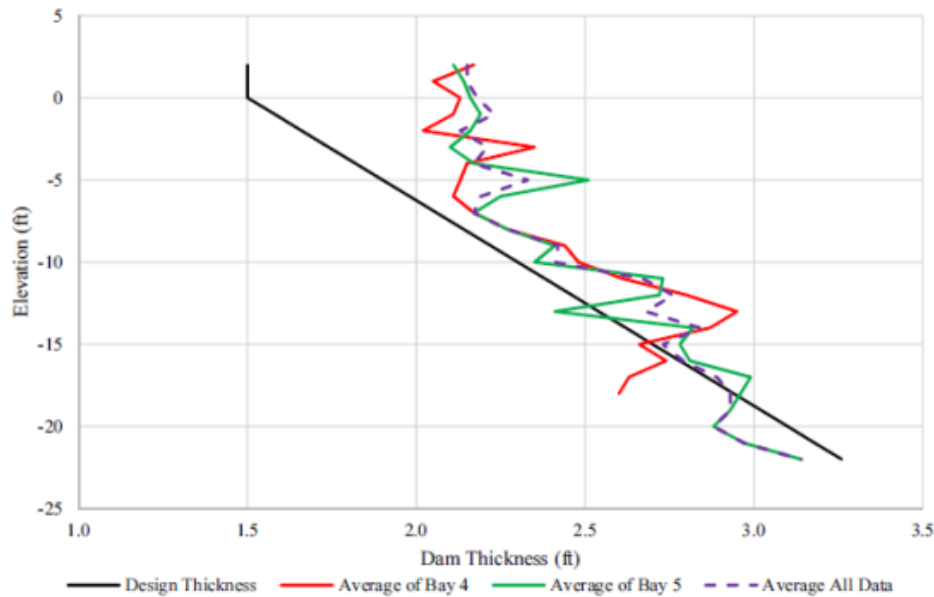
Echo impact/pulse velocity results Bay 4 and 5. The loading response and coring suggest results were skewed by shotcrete overlay. However, future investigations and/or treatments could use results as a guide. Targeted structural grouting may benefit from such non-destructive techniques.

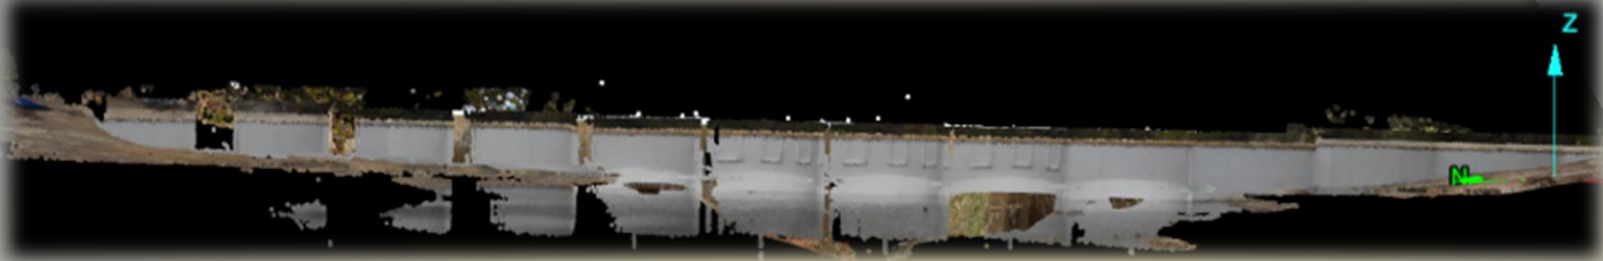
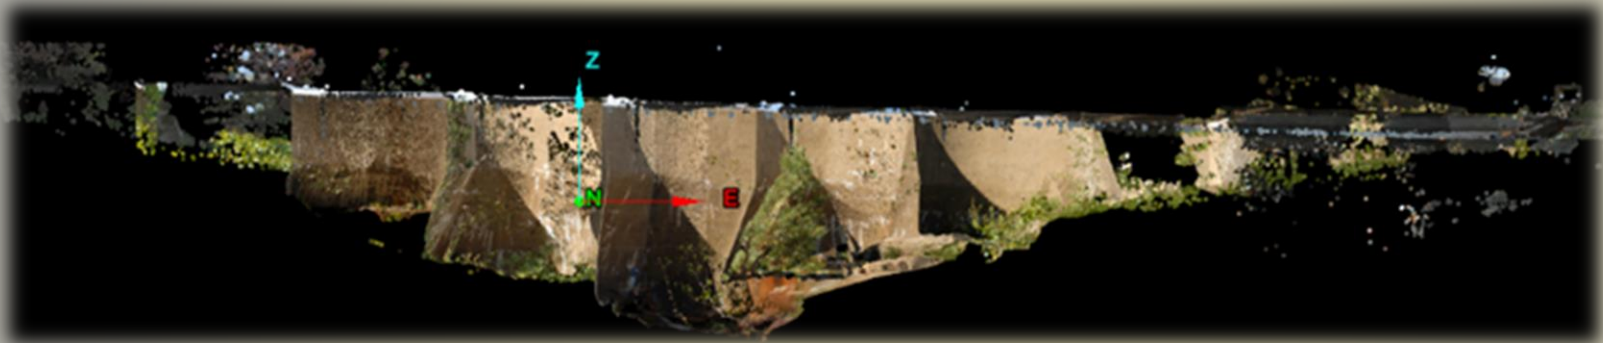
Terrestrial Lidar and Survey – point cloud sample of upstream and downstream dam face. Preliminary result appears to indicate the dam crest rotates in an upstream direction during loading – counter to the assumed direction. Also, movement in buttress 8 was two to three times greater than the rest of the buttresses surveyed.

Finite element modeling is underway to determine conditions that would produce the result.

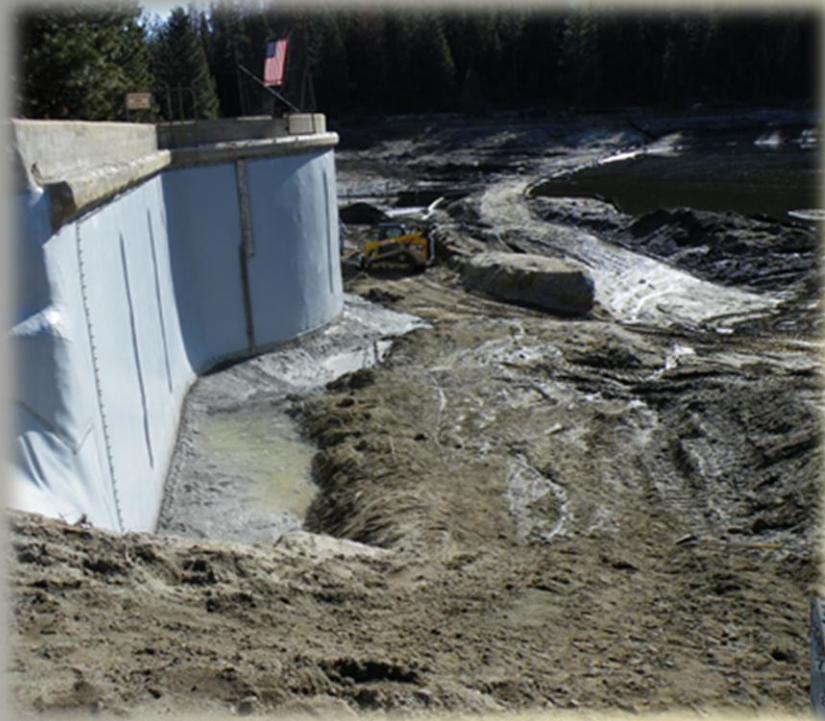
Low permeability control density fill on upstream toe – March 2016.

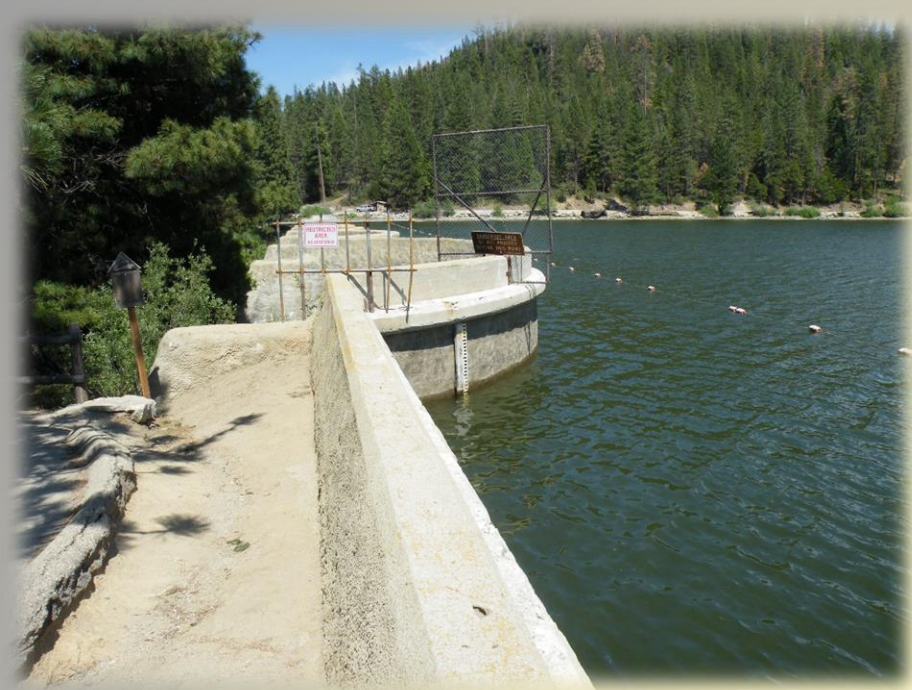
Upstream side of Hume Lake Dam 2015.  
Reservoir at 4.5 feet below sill with .25 to .5  
cfs seepage in Bay 4

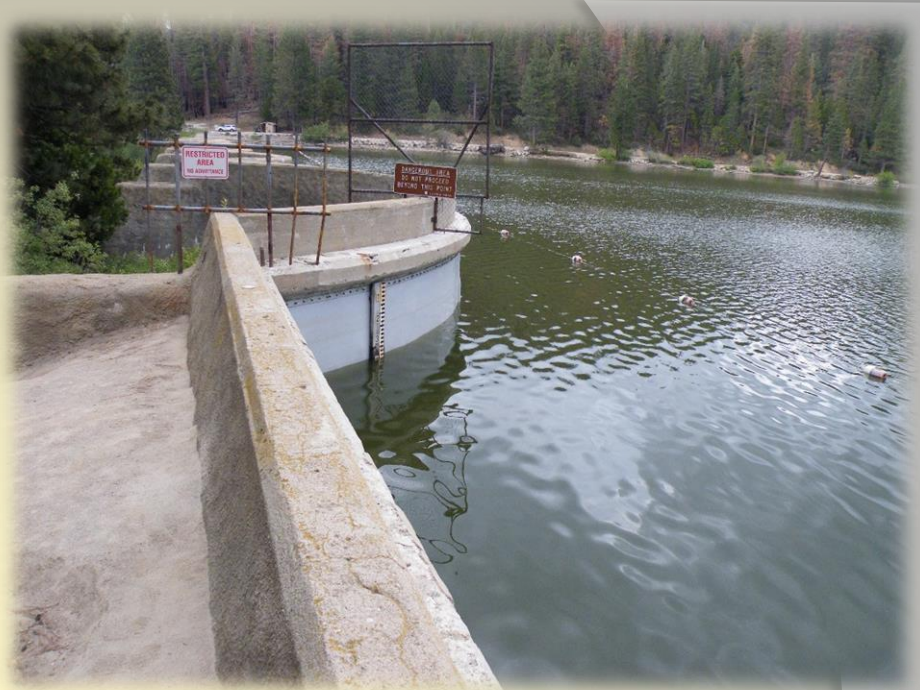
Upstream side of Hume Lake Dam 2016.  
Reservoir at 4 feet below sill with 0 cfs  
seepage in Bay 4.

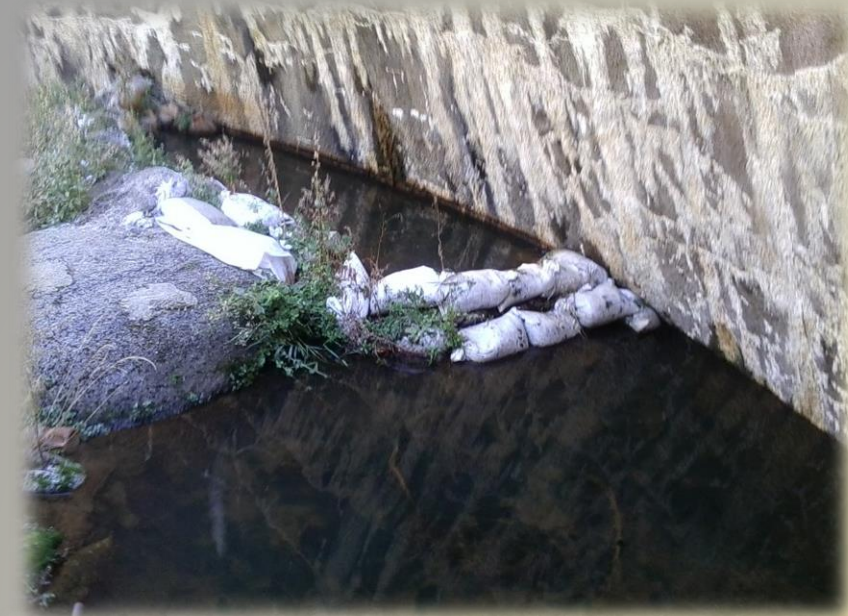
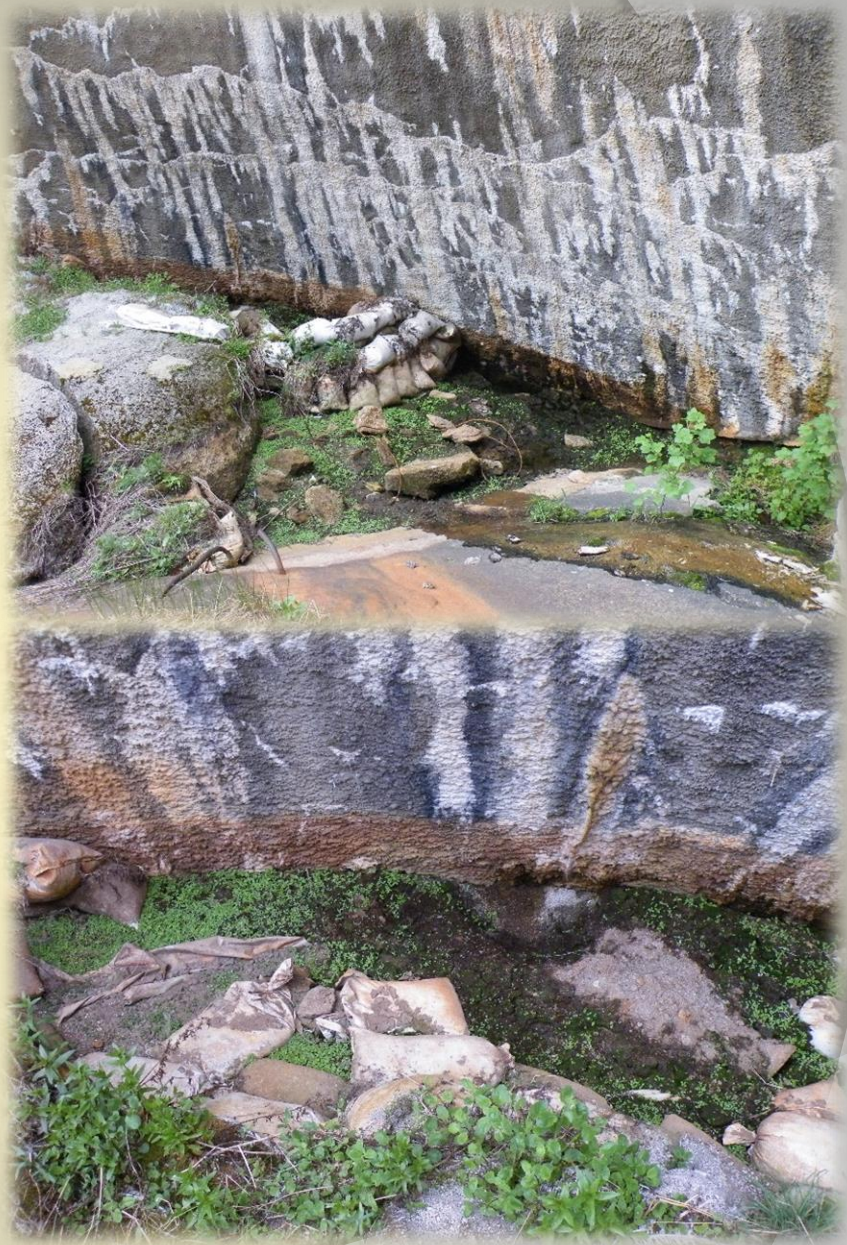
Bay 4 foundation seepage has essentially been eliminated. Seepage through the dam structure has been eliminated. Preconstruction pictures are on the left.

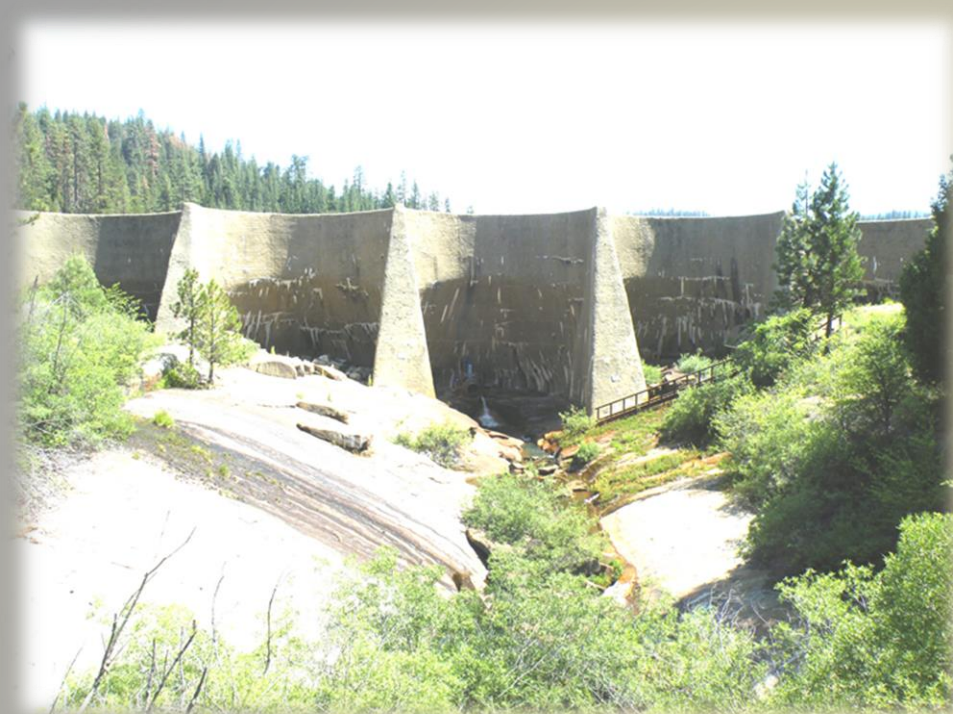
Downstream face 2015. Significantly increased seepage on the West side (right side of picture) has encouraged plant growth.

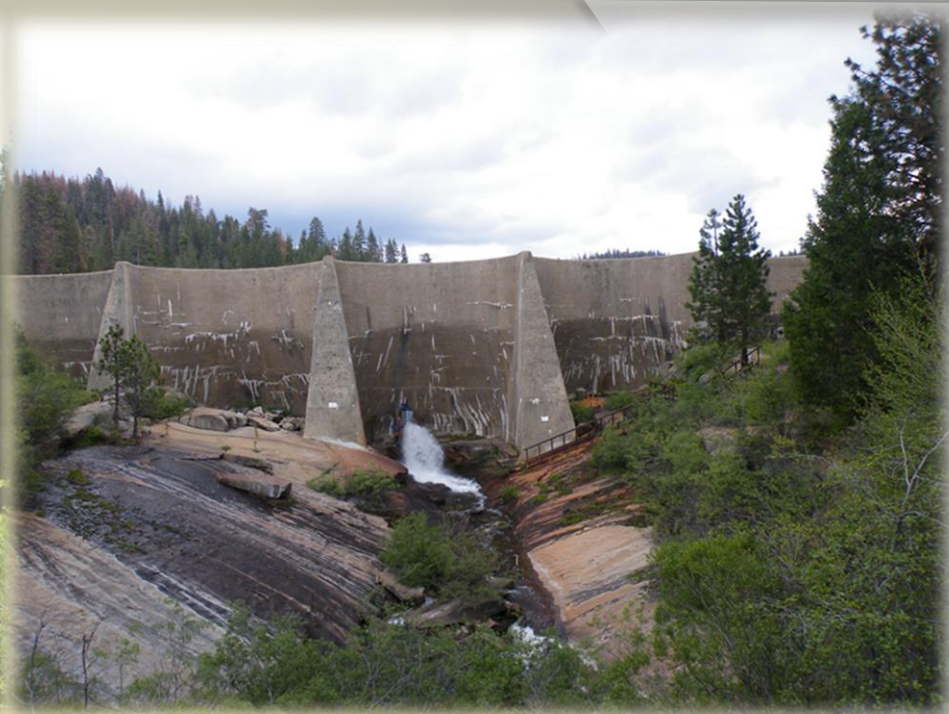
Post Construction 2016 - seepage through the entire dam has been in effect eliminated. Seepage in the West side dam foundation has been significantly reduced or eliminated.

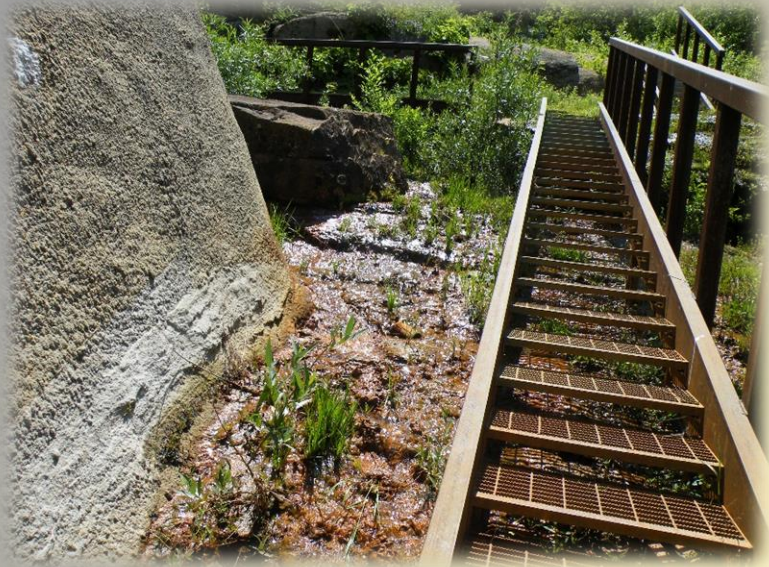
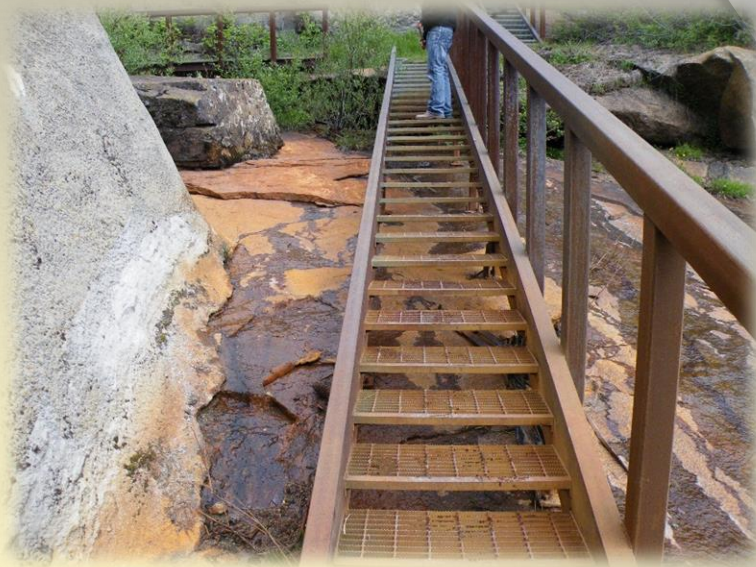
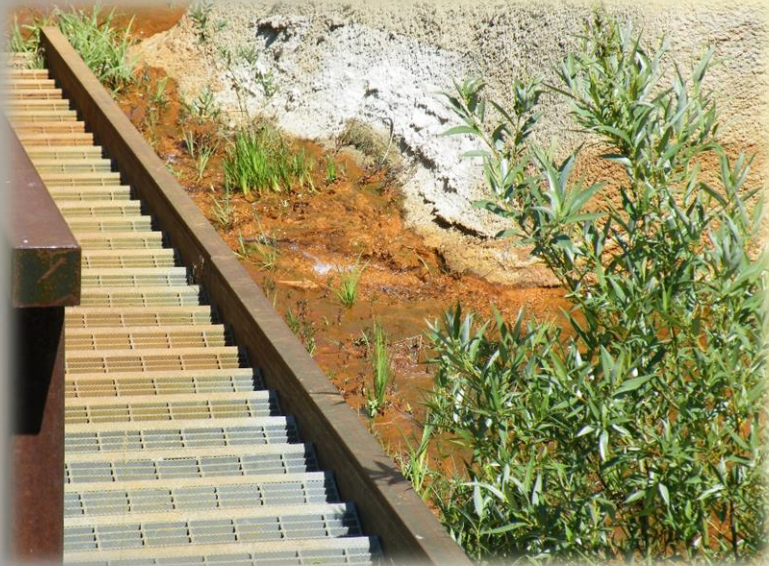
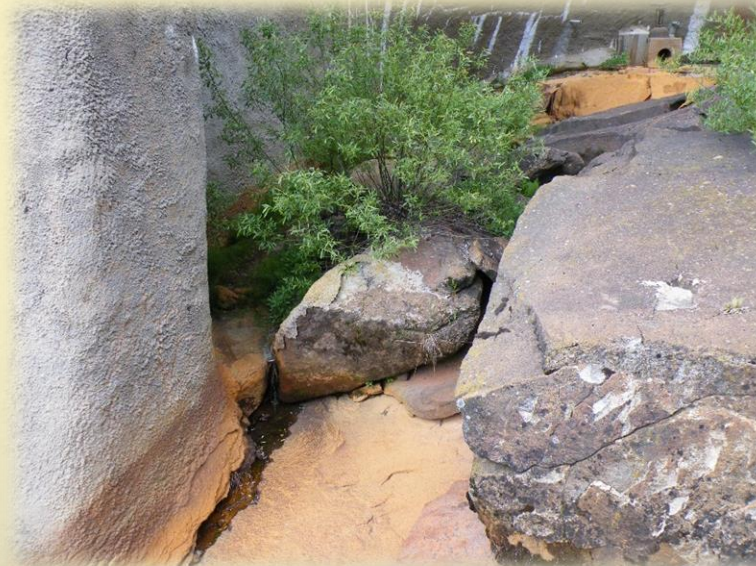
Seepage in Bay 5 has been reduced from 5 to 10 cfs to level that is difficult to measure. Stained rocks are the previous seepage path. Preconstruction are pictures on left. Post construction on right.

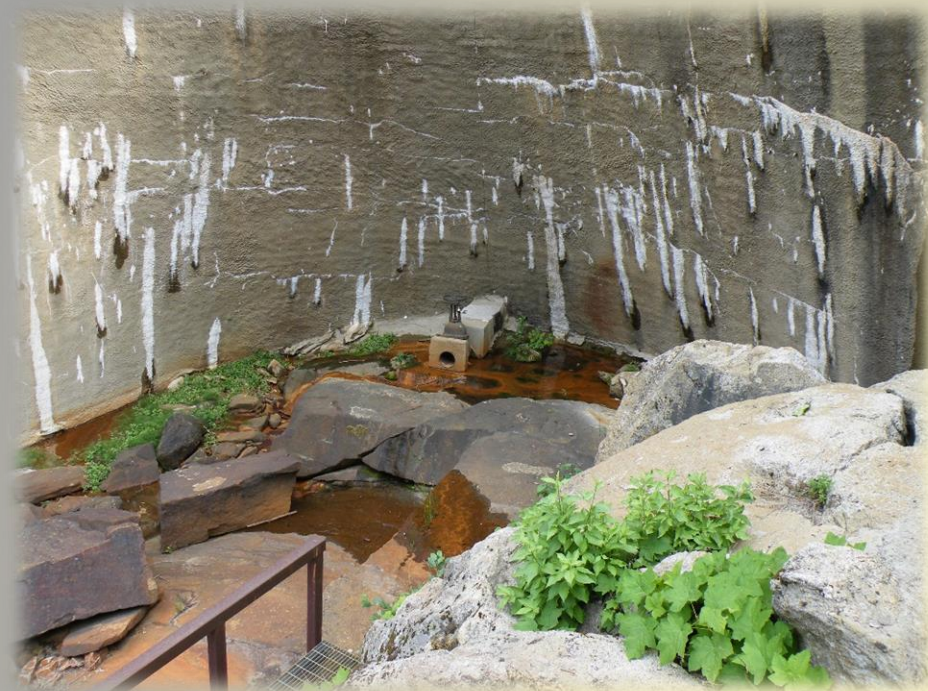
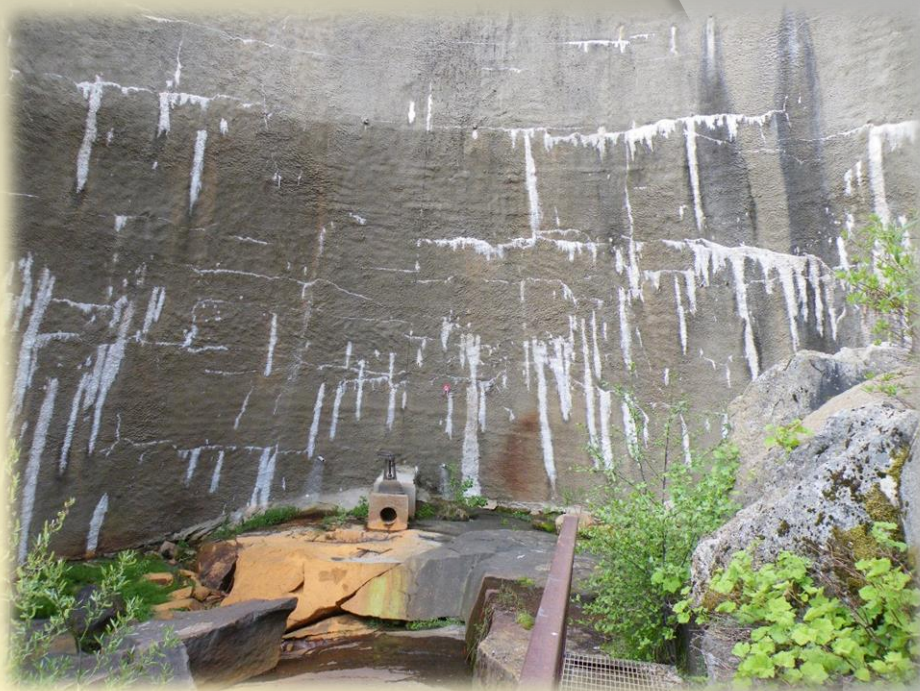
Note ponds and majority of foundation seepage have been eliminated. Preconstruction is on the left. Note also that wet spots on face no longer exist indicating seepage through the dam has been eliminated.

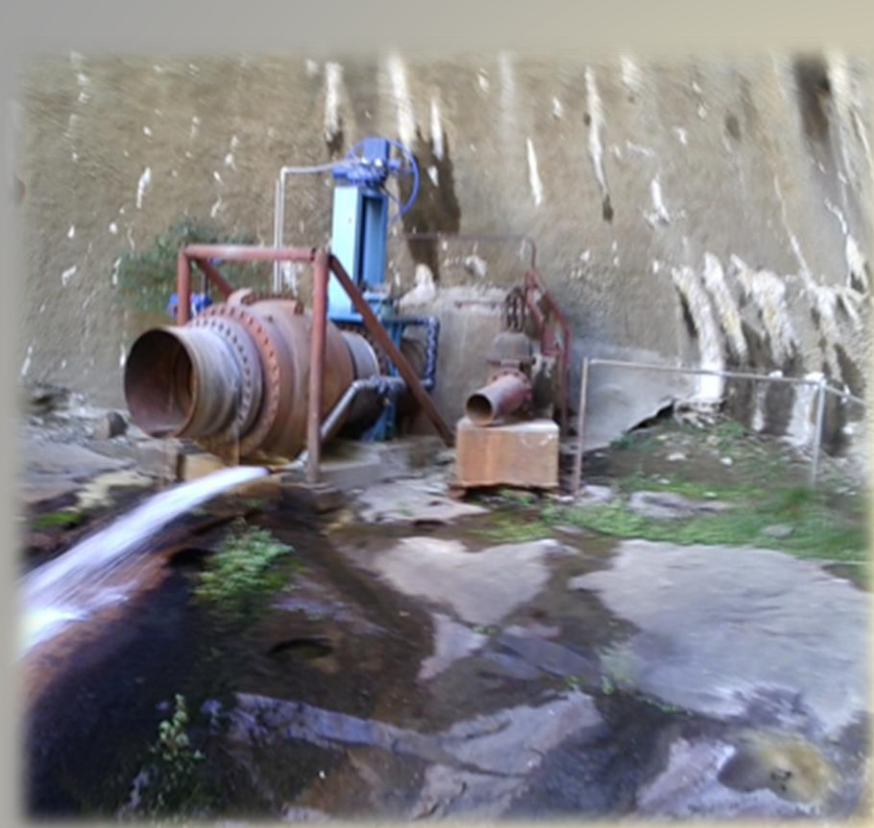
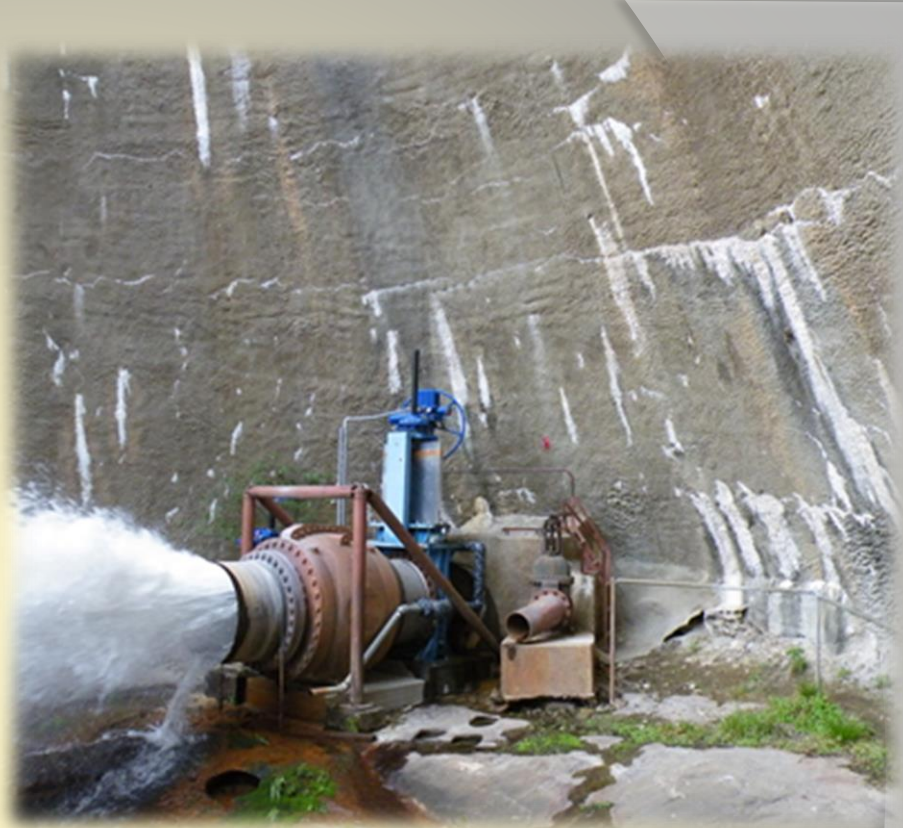
Seepage through dam face in Bay 6 has been eliminated. Preconstruction is on the left.

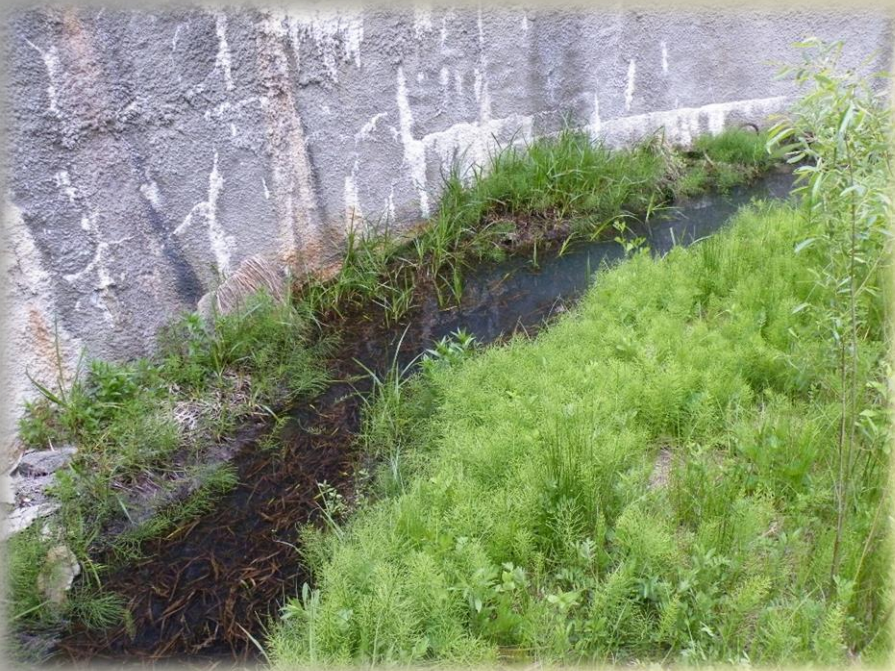
Bay 2 is still impacted by a spring discovered during construction activities. No welling or other indications of head driven seepage from the reservoir are evident.

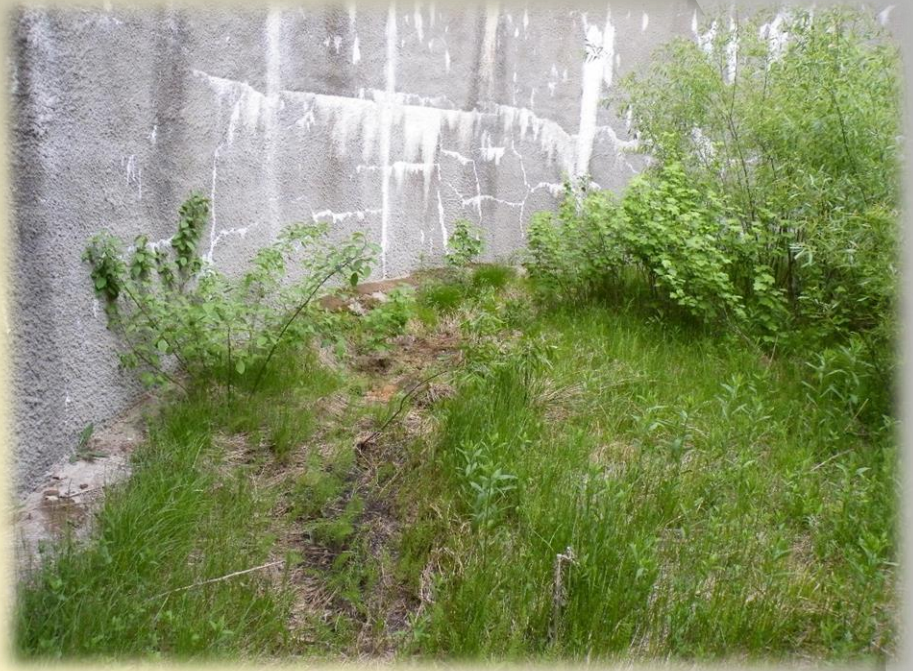
Foundation seepage in Bay 3 has been eliminated – picture on right.
