Stabilization of an Infinite Slope Failure Utilizing Hollow Bar Soil Nails with Long-Term Monitoring Plan September 2013

Presented By: Christopher "Chud" Lundgreen, EIT
Regional Geotechnical/Pavements Engineer
Northern Region, USDA Forest Service

Hyalite Canyon Slide, Gallatin NF

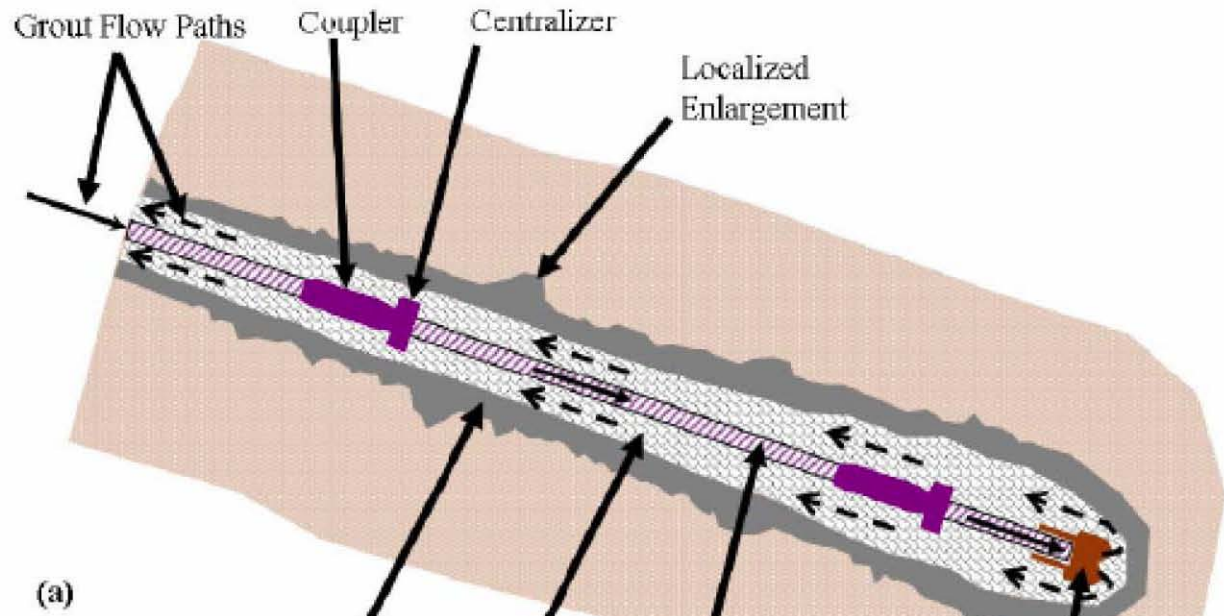
(a)

Soil Nail Wall Details

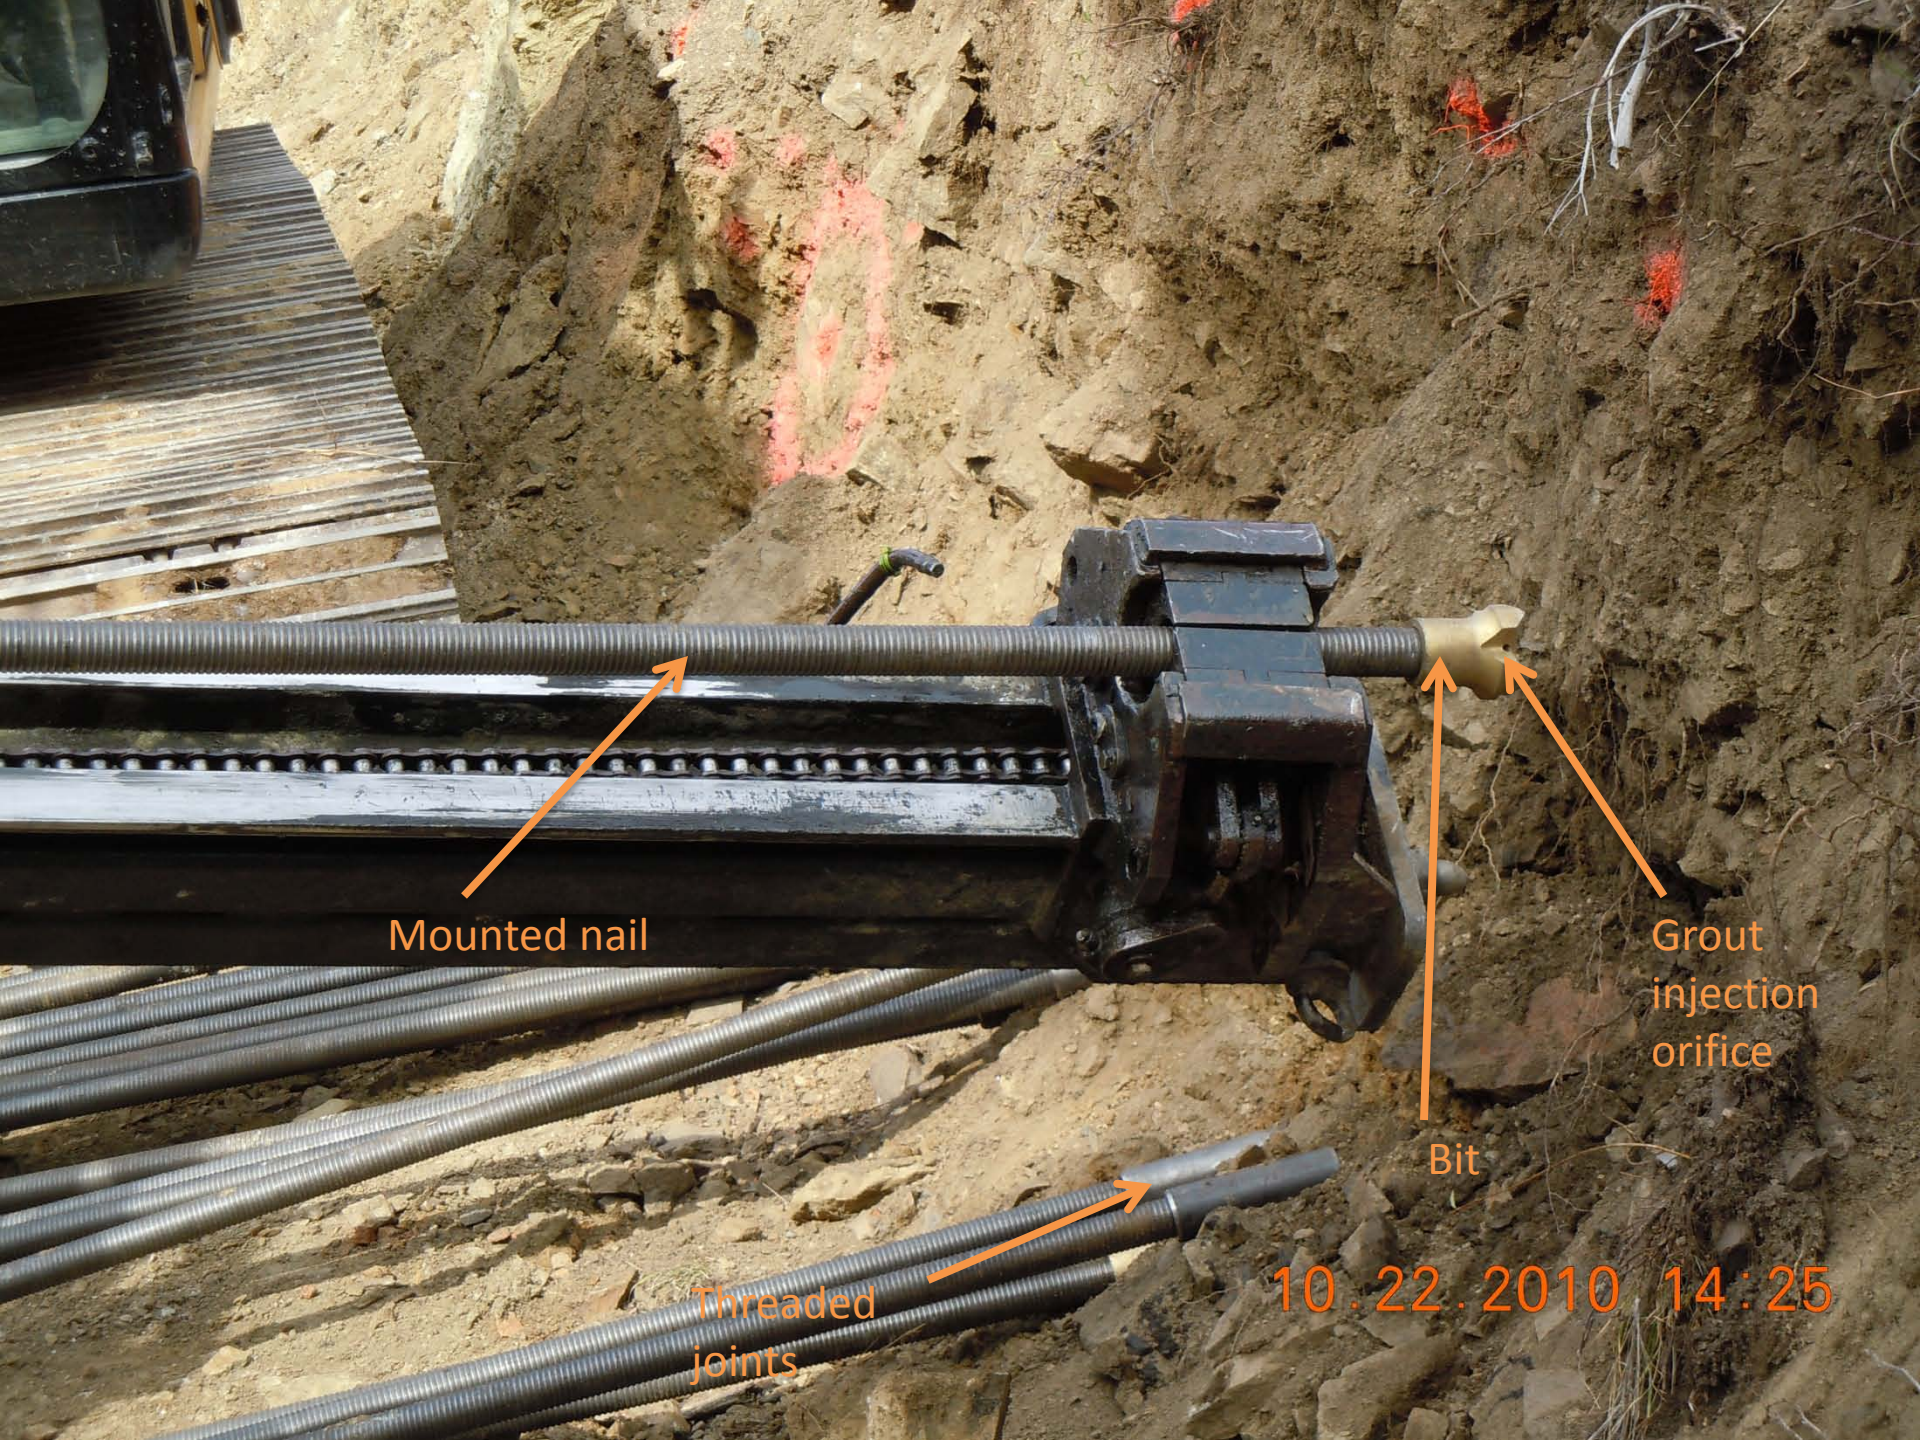
Mounted nail

Grout injection orifice

Bit

Threaded joints

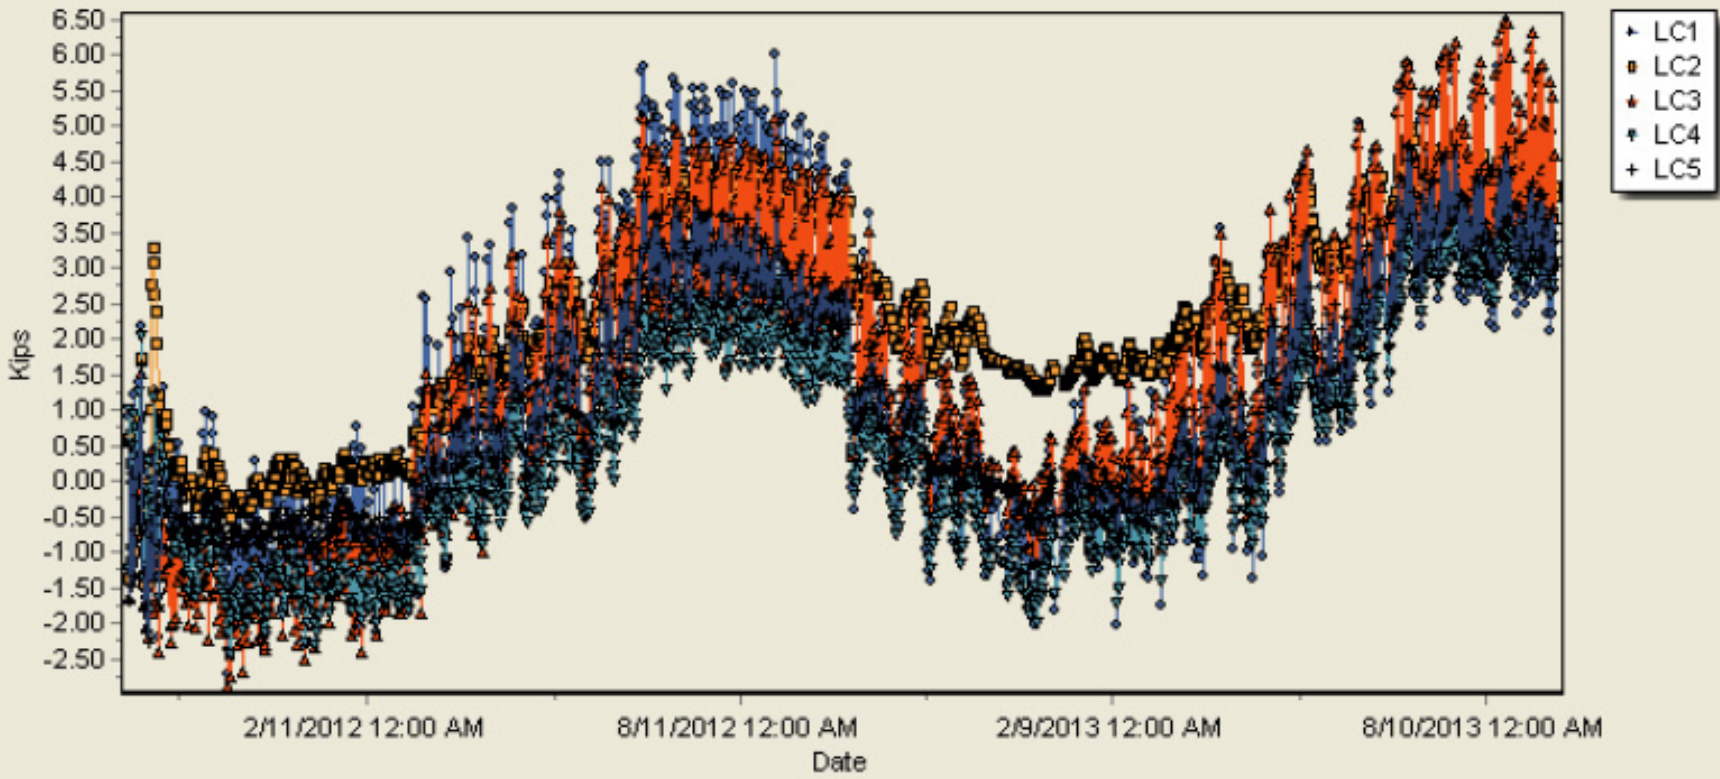
All Load Cells

Load Cell Data

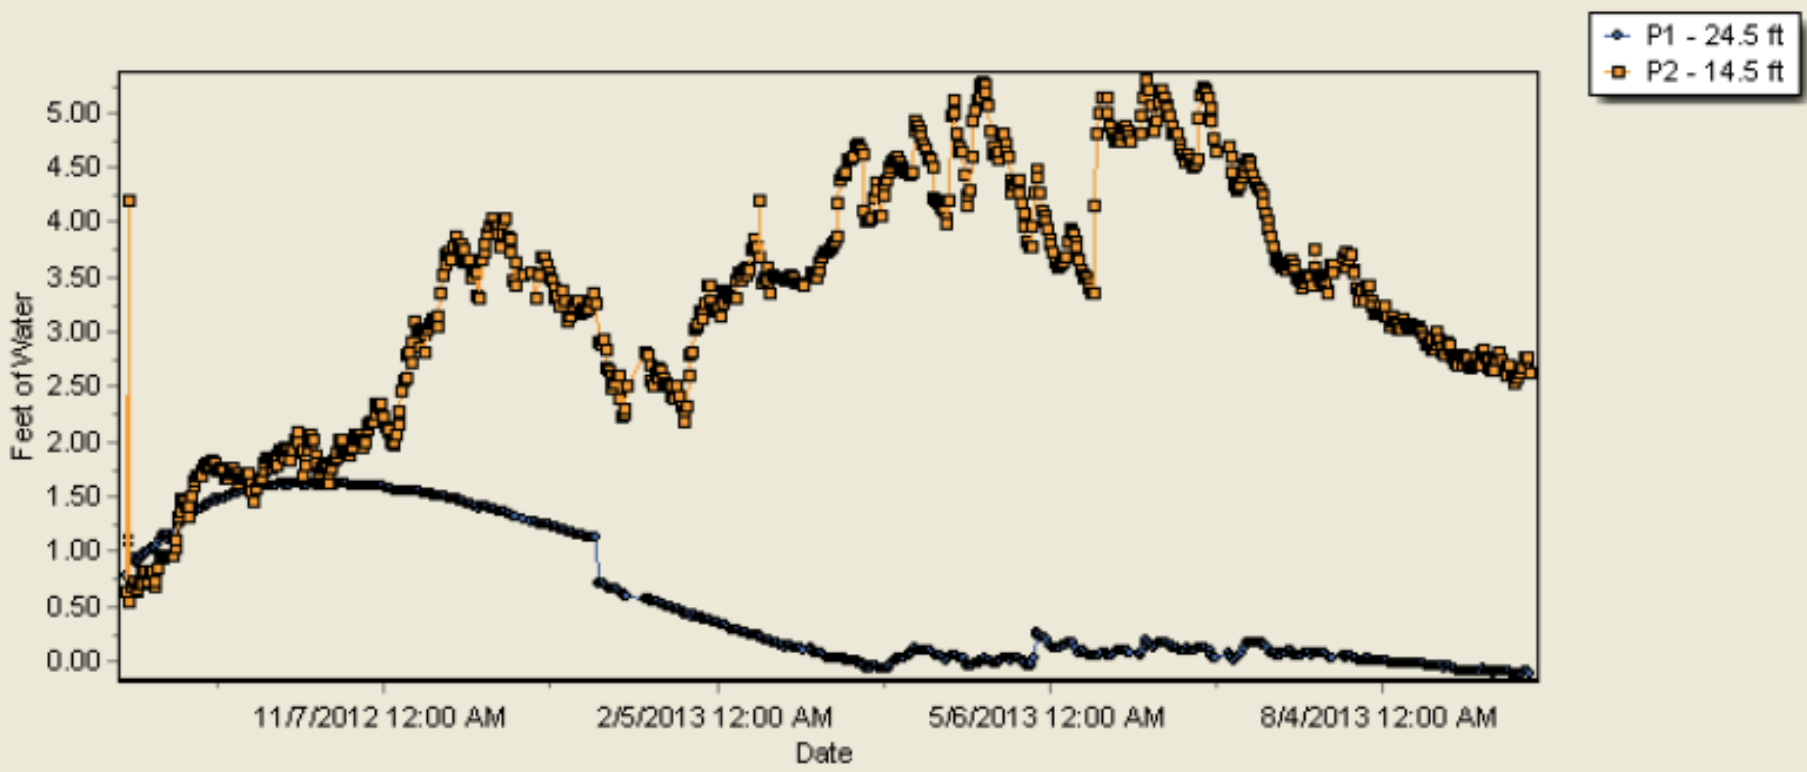
All Piezometers

Piezometer Data

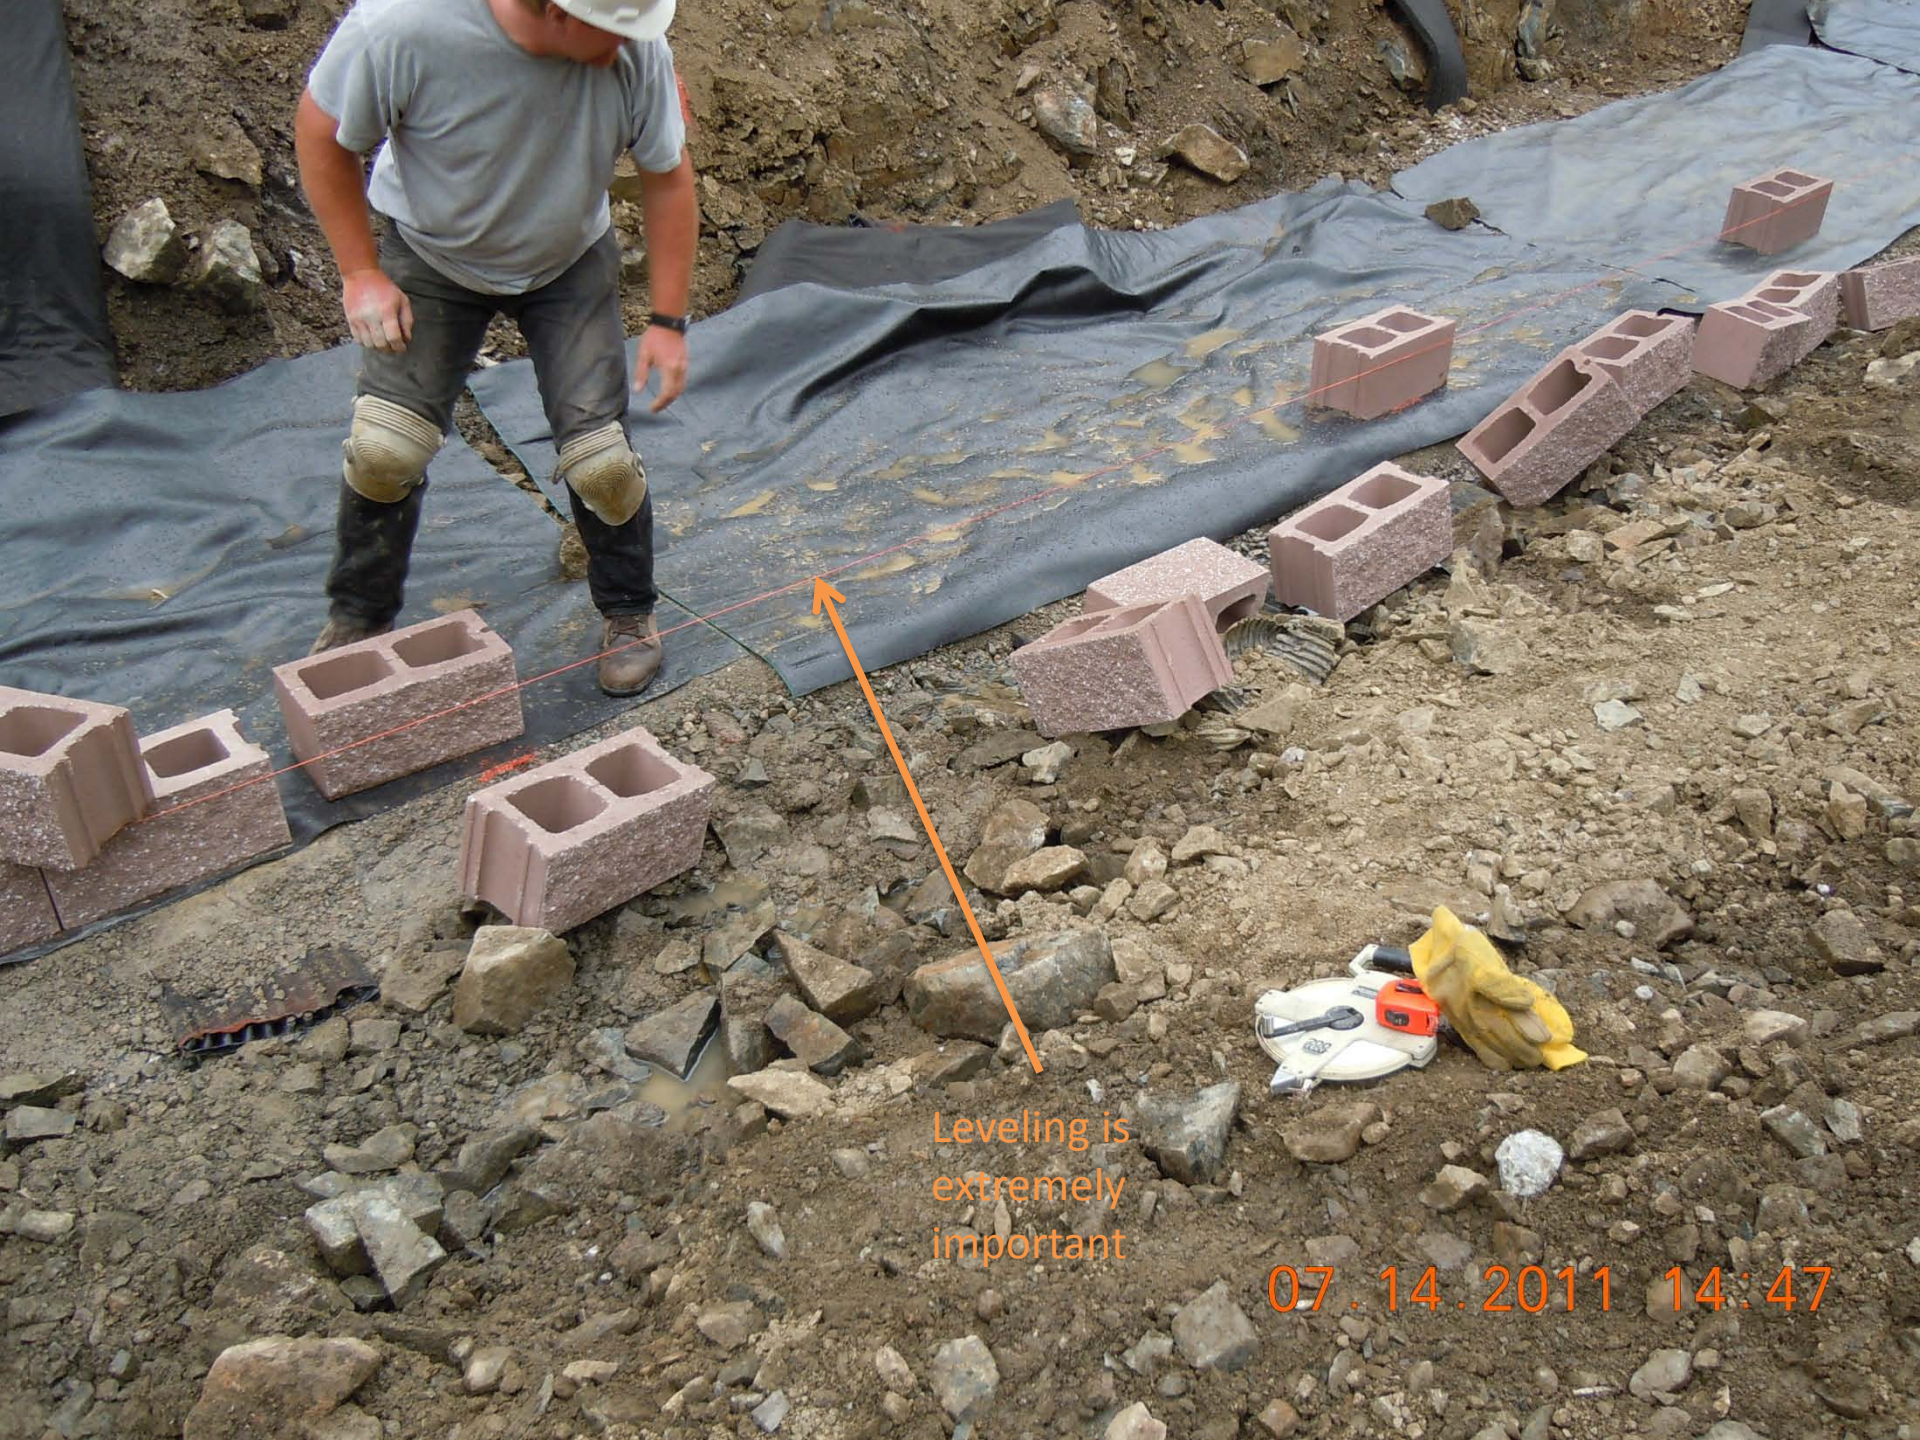
Leveling is extremely important
