# AGFC Lake Poinsett Renovation

# Phase I Construction - Water Control Tower and Spillway Renovations

# Phase 2 - Bank Stabilization

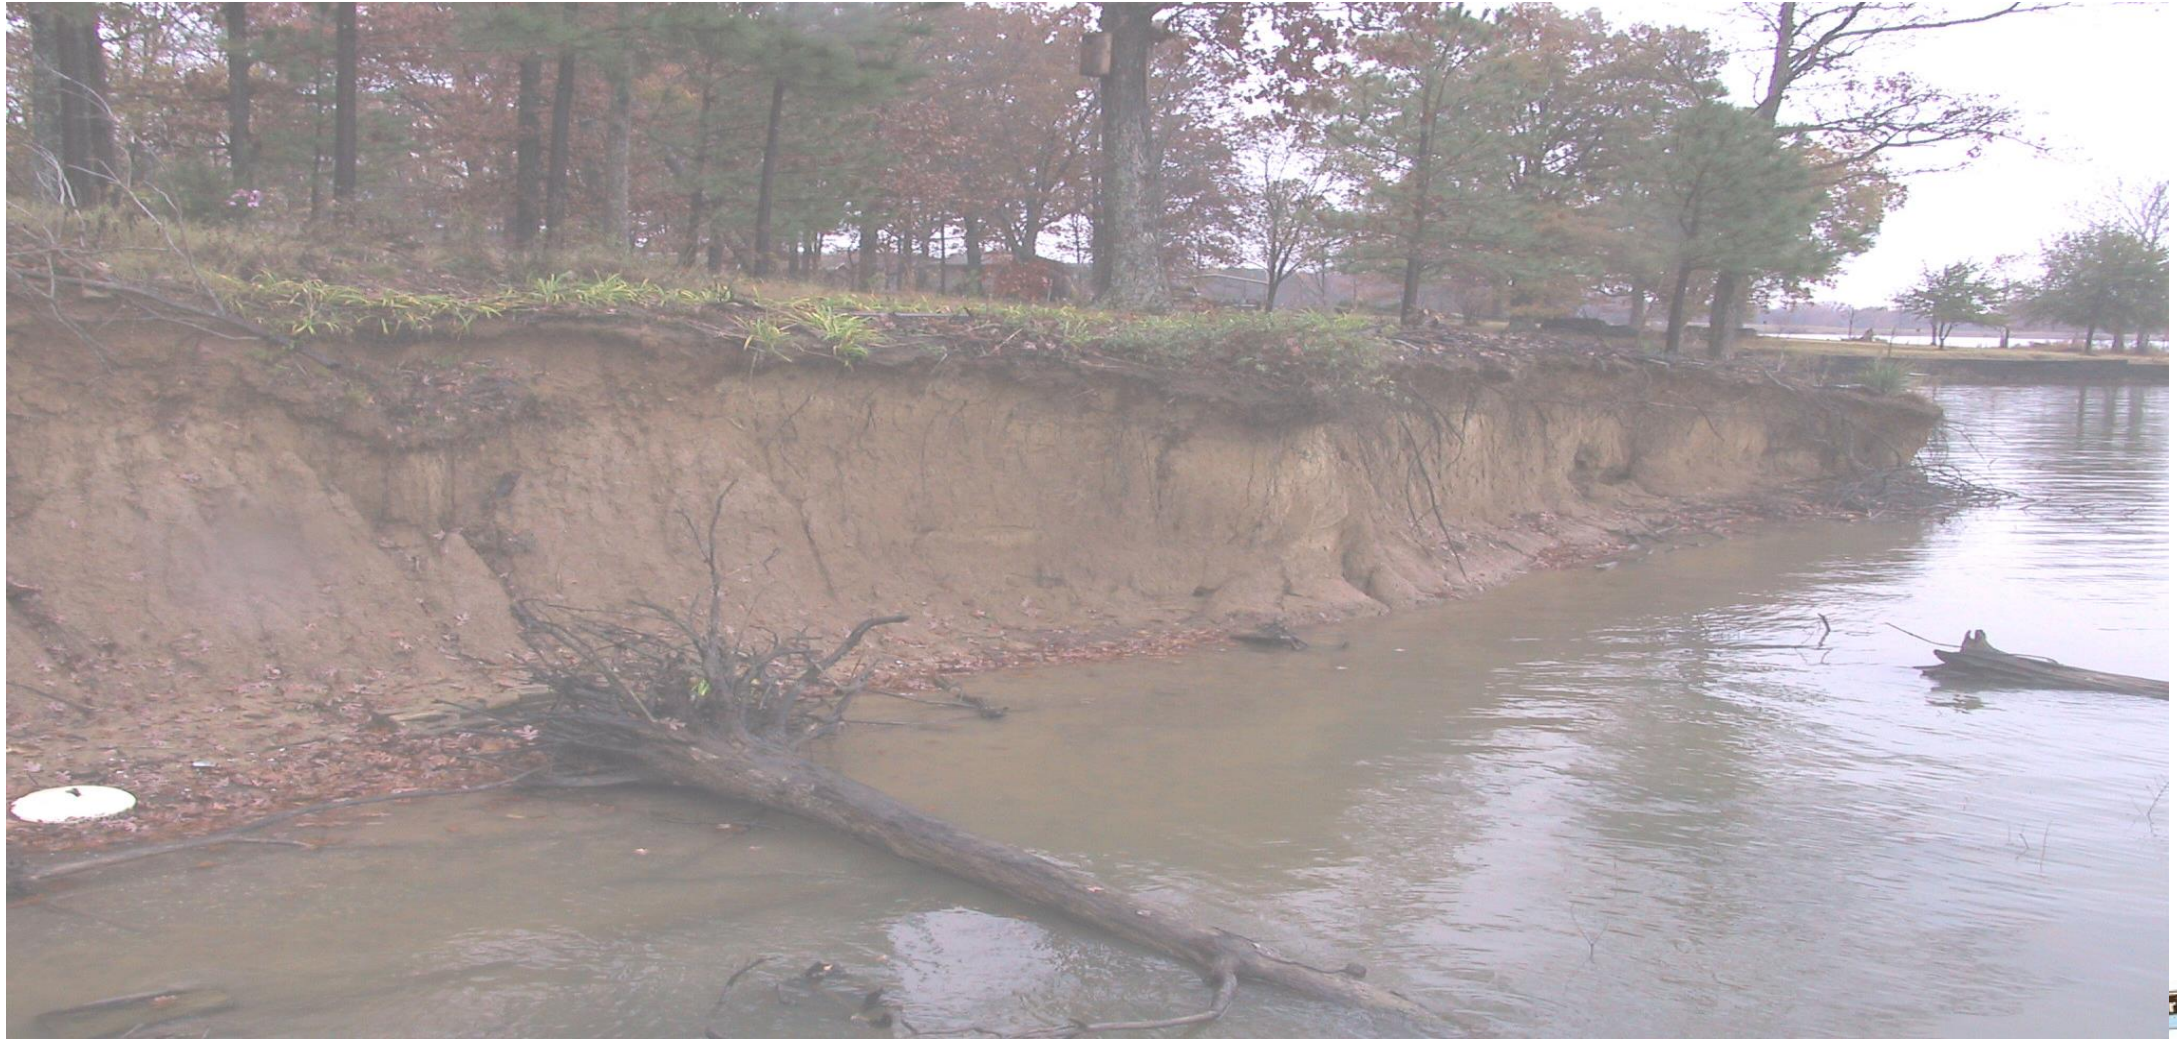
# Erosion

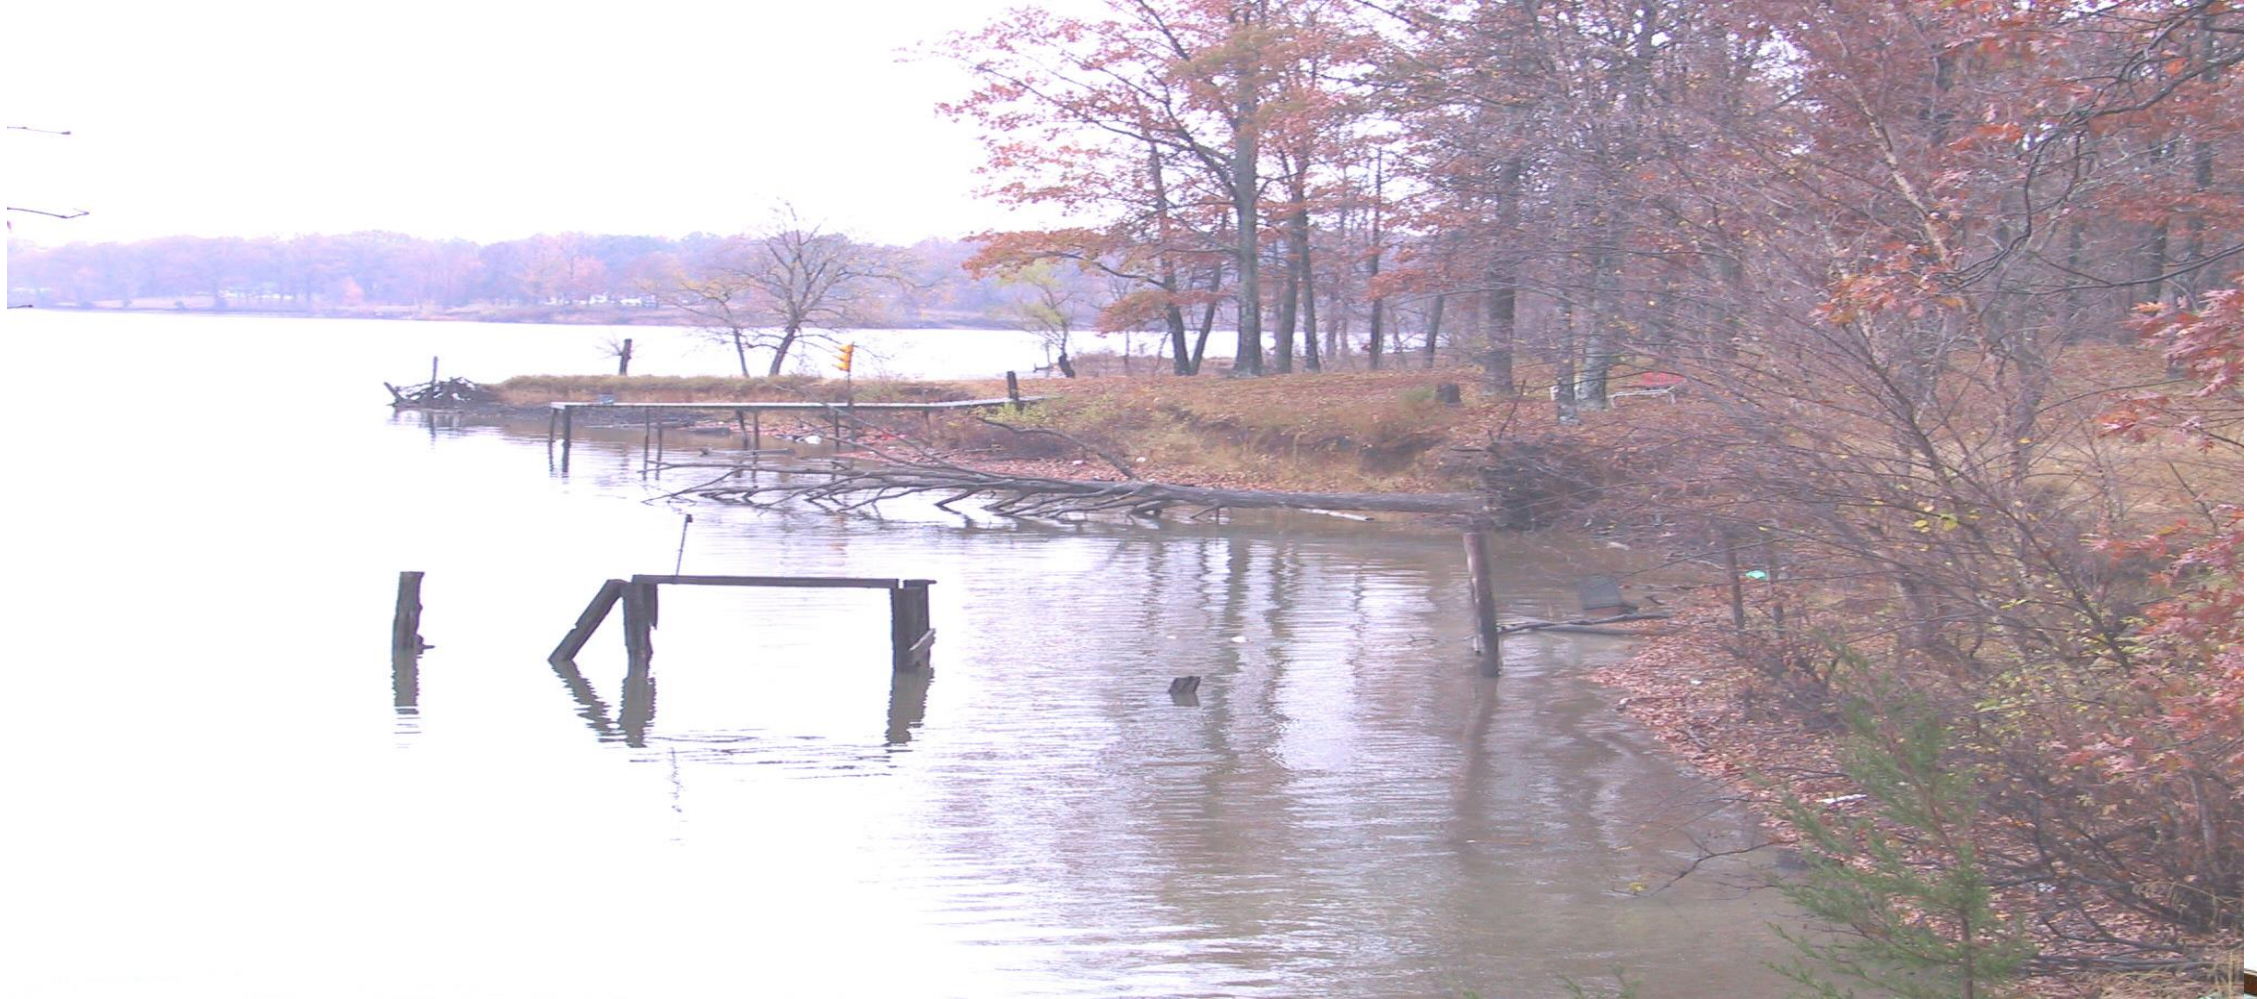
# Erosion onto property owner

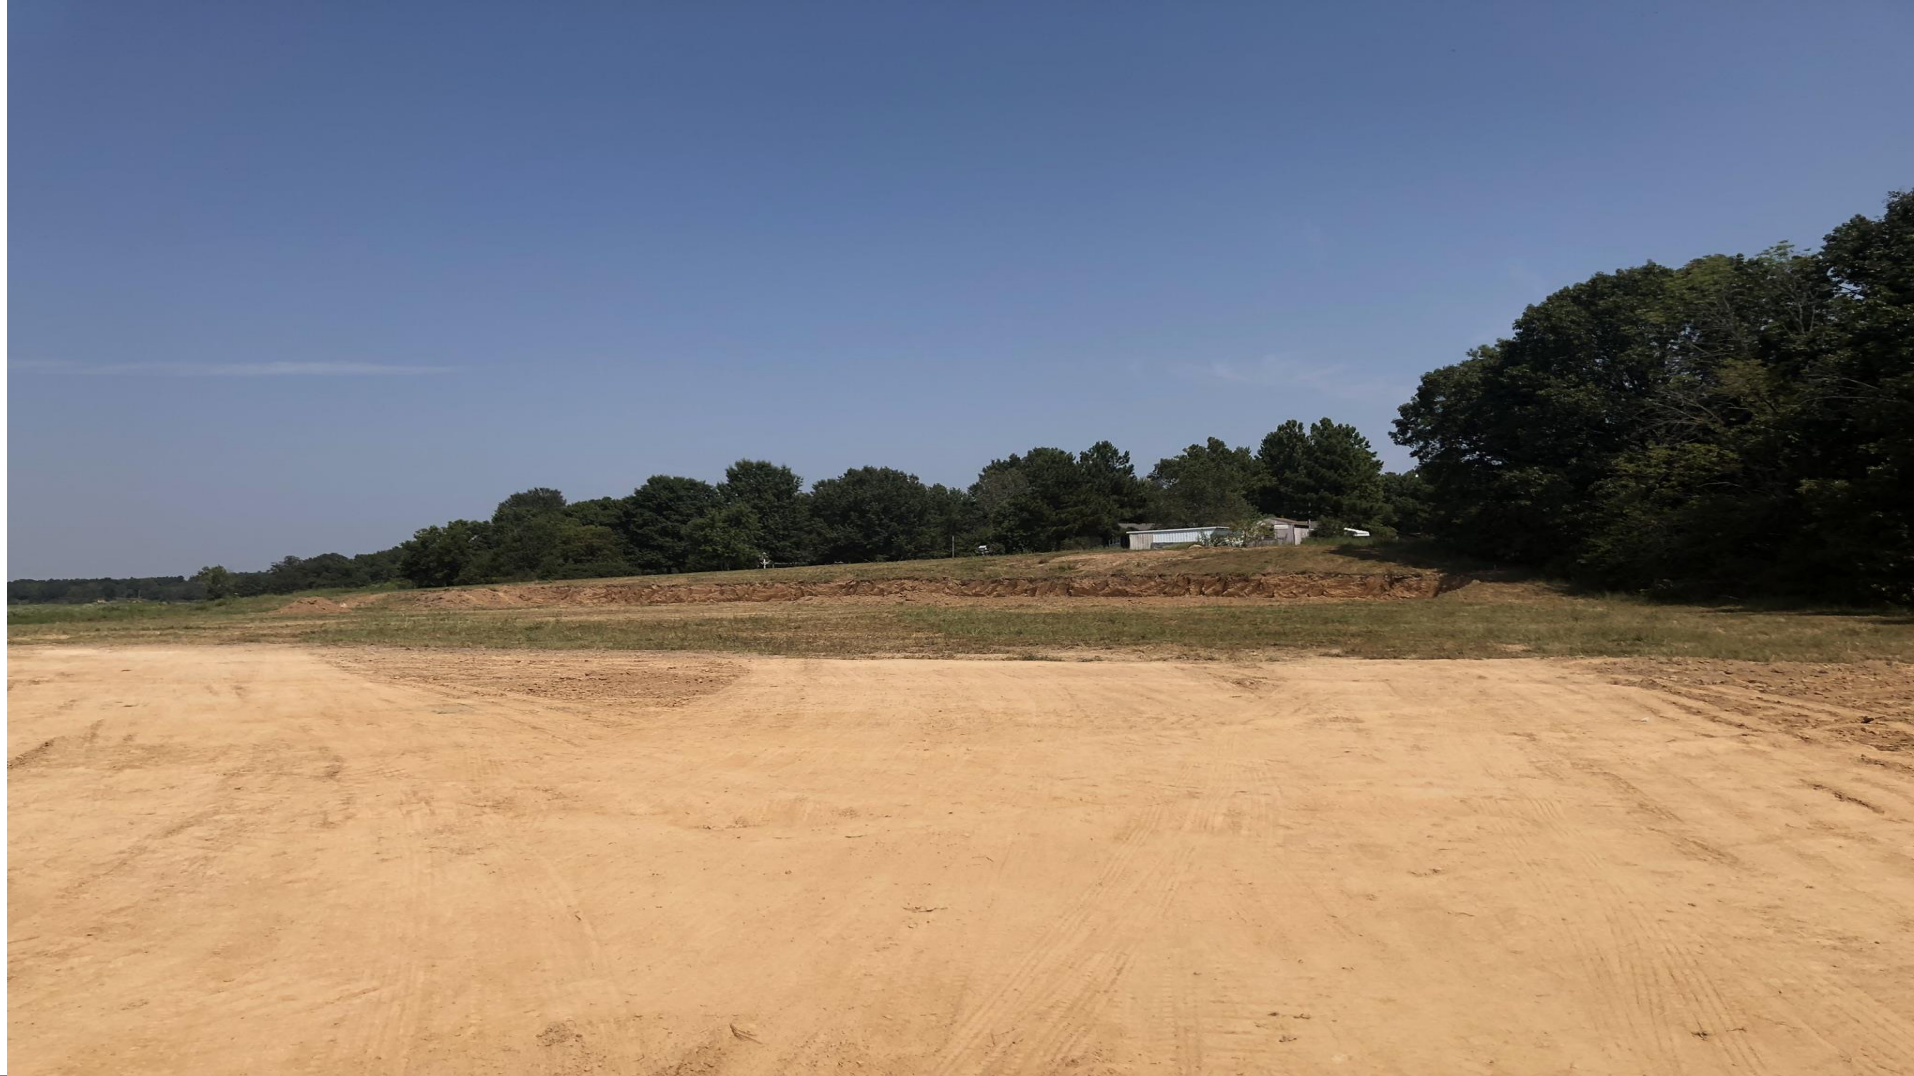
# Spillway expansion

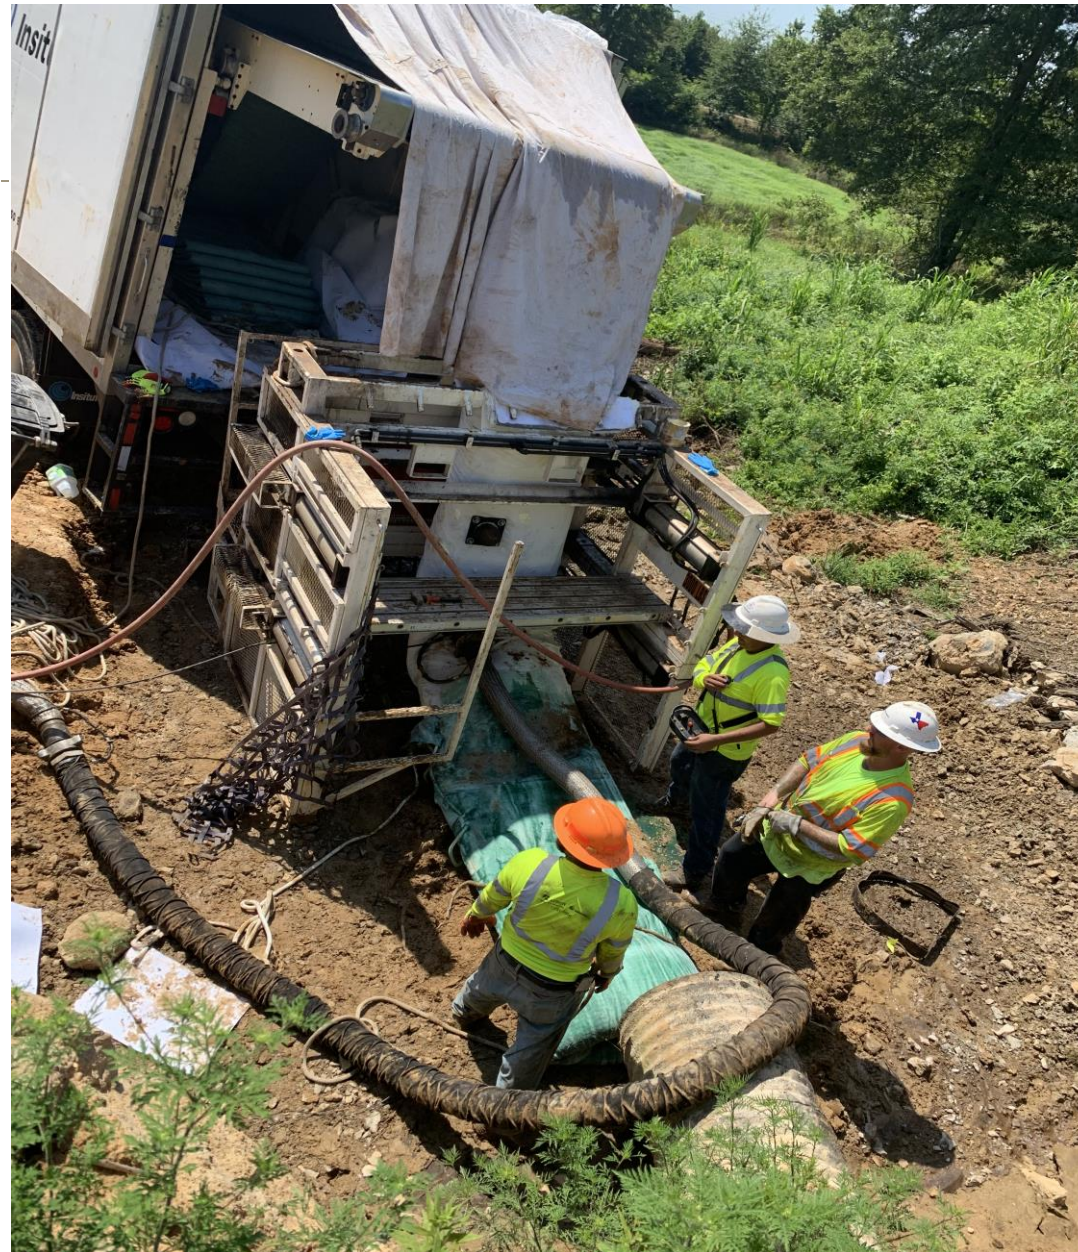
# Pipe Sleeve

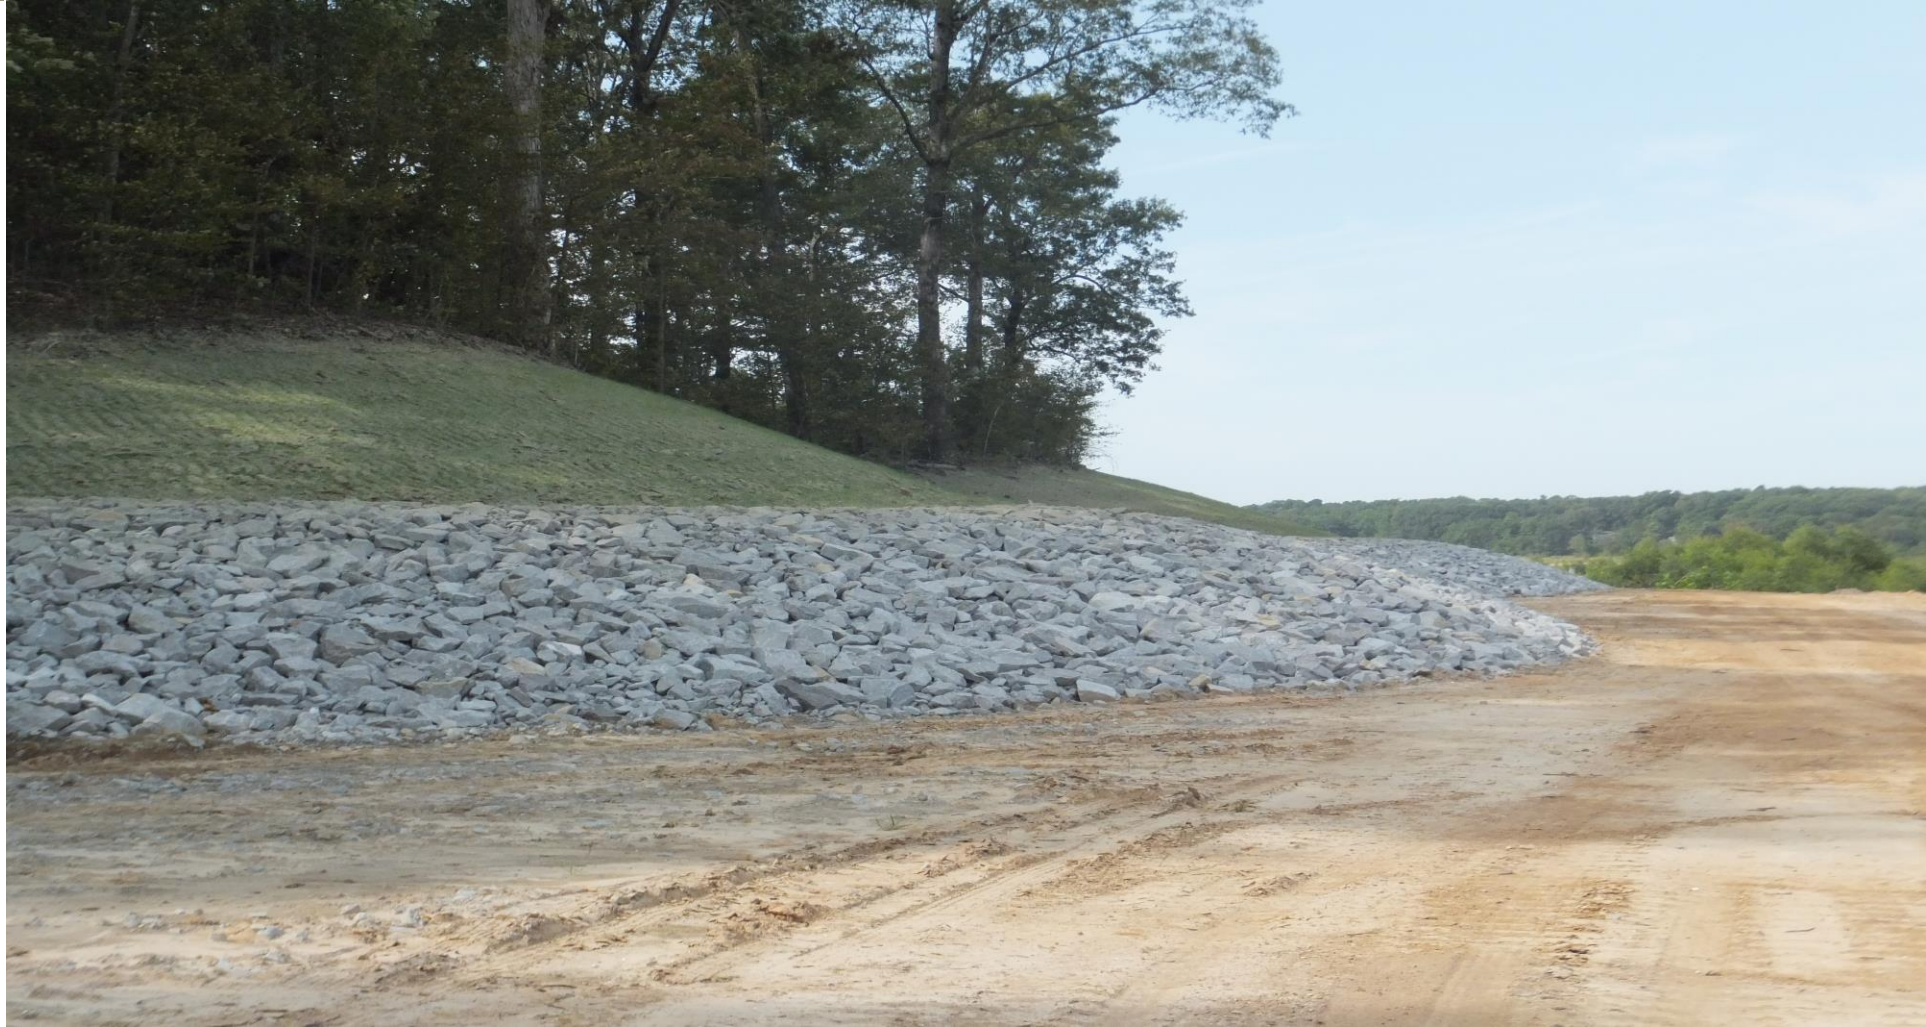
# Rip Rap

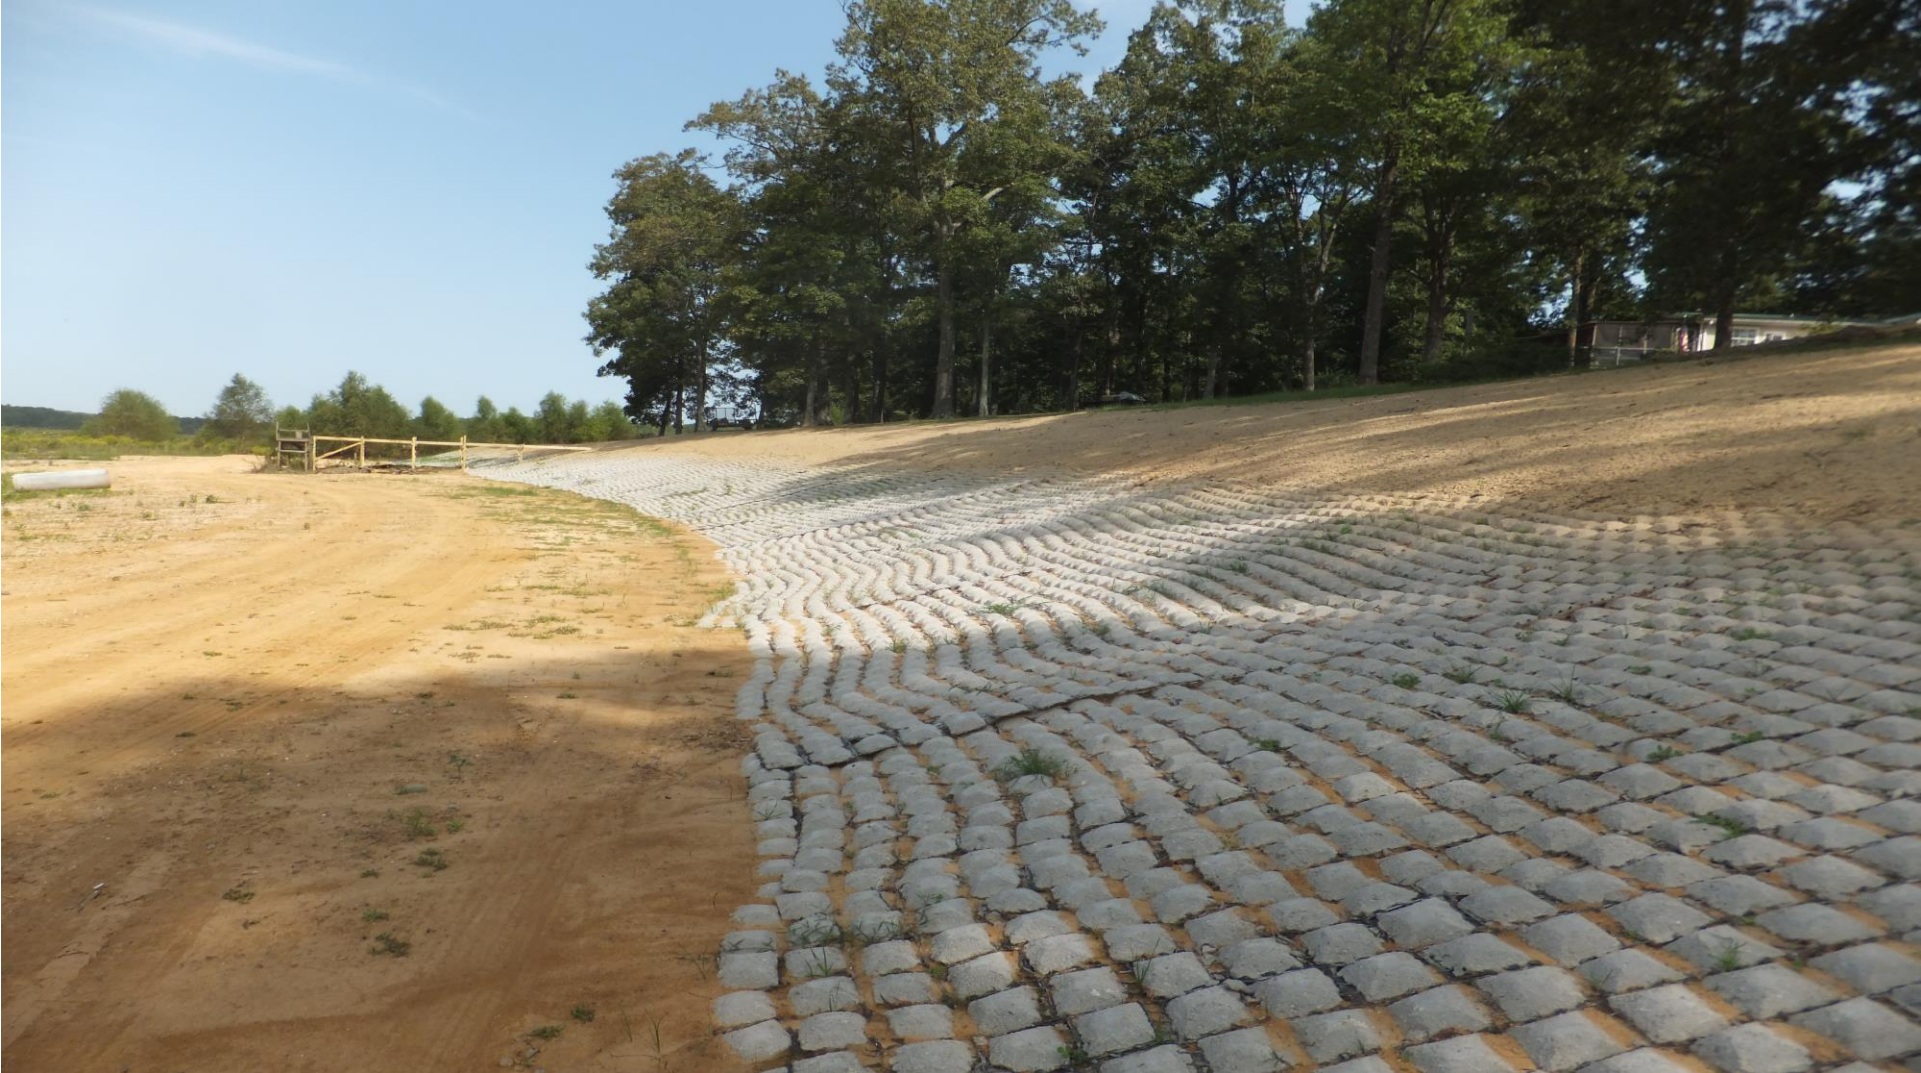
# Flexamat

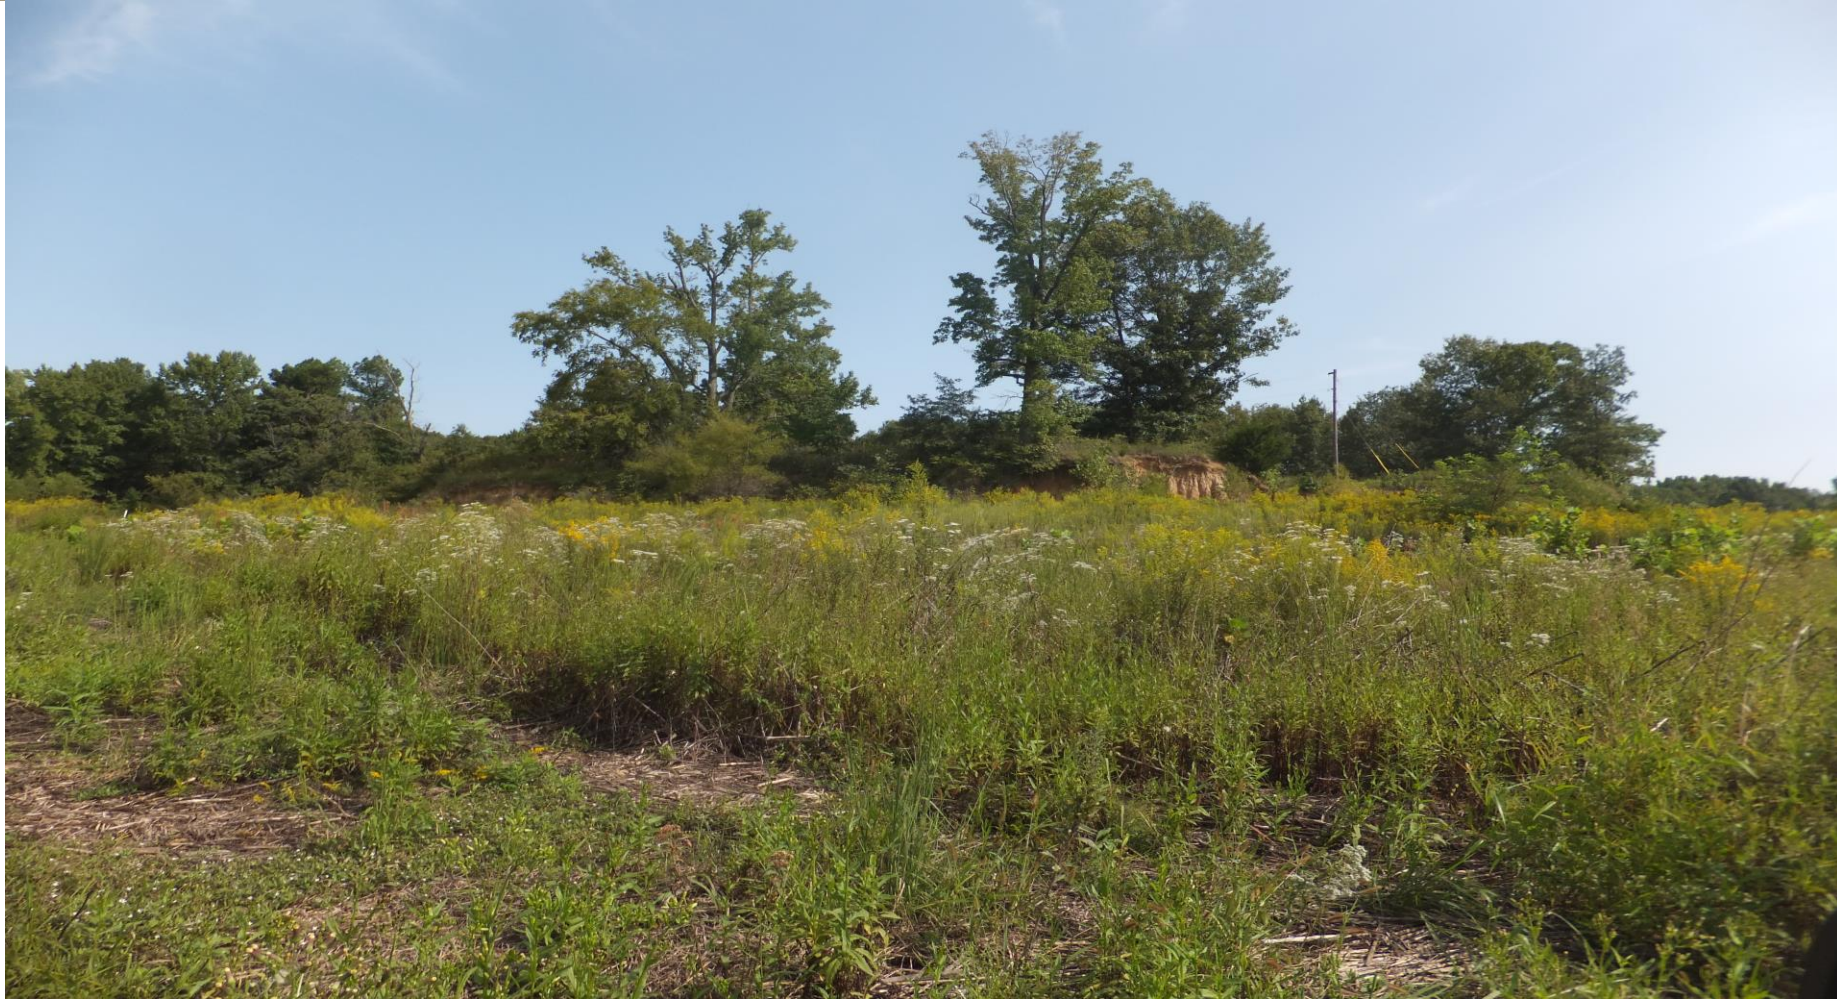
# Point 21-22 Before

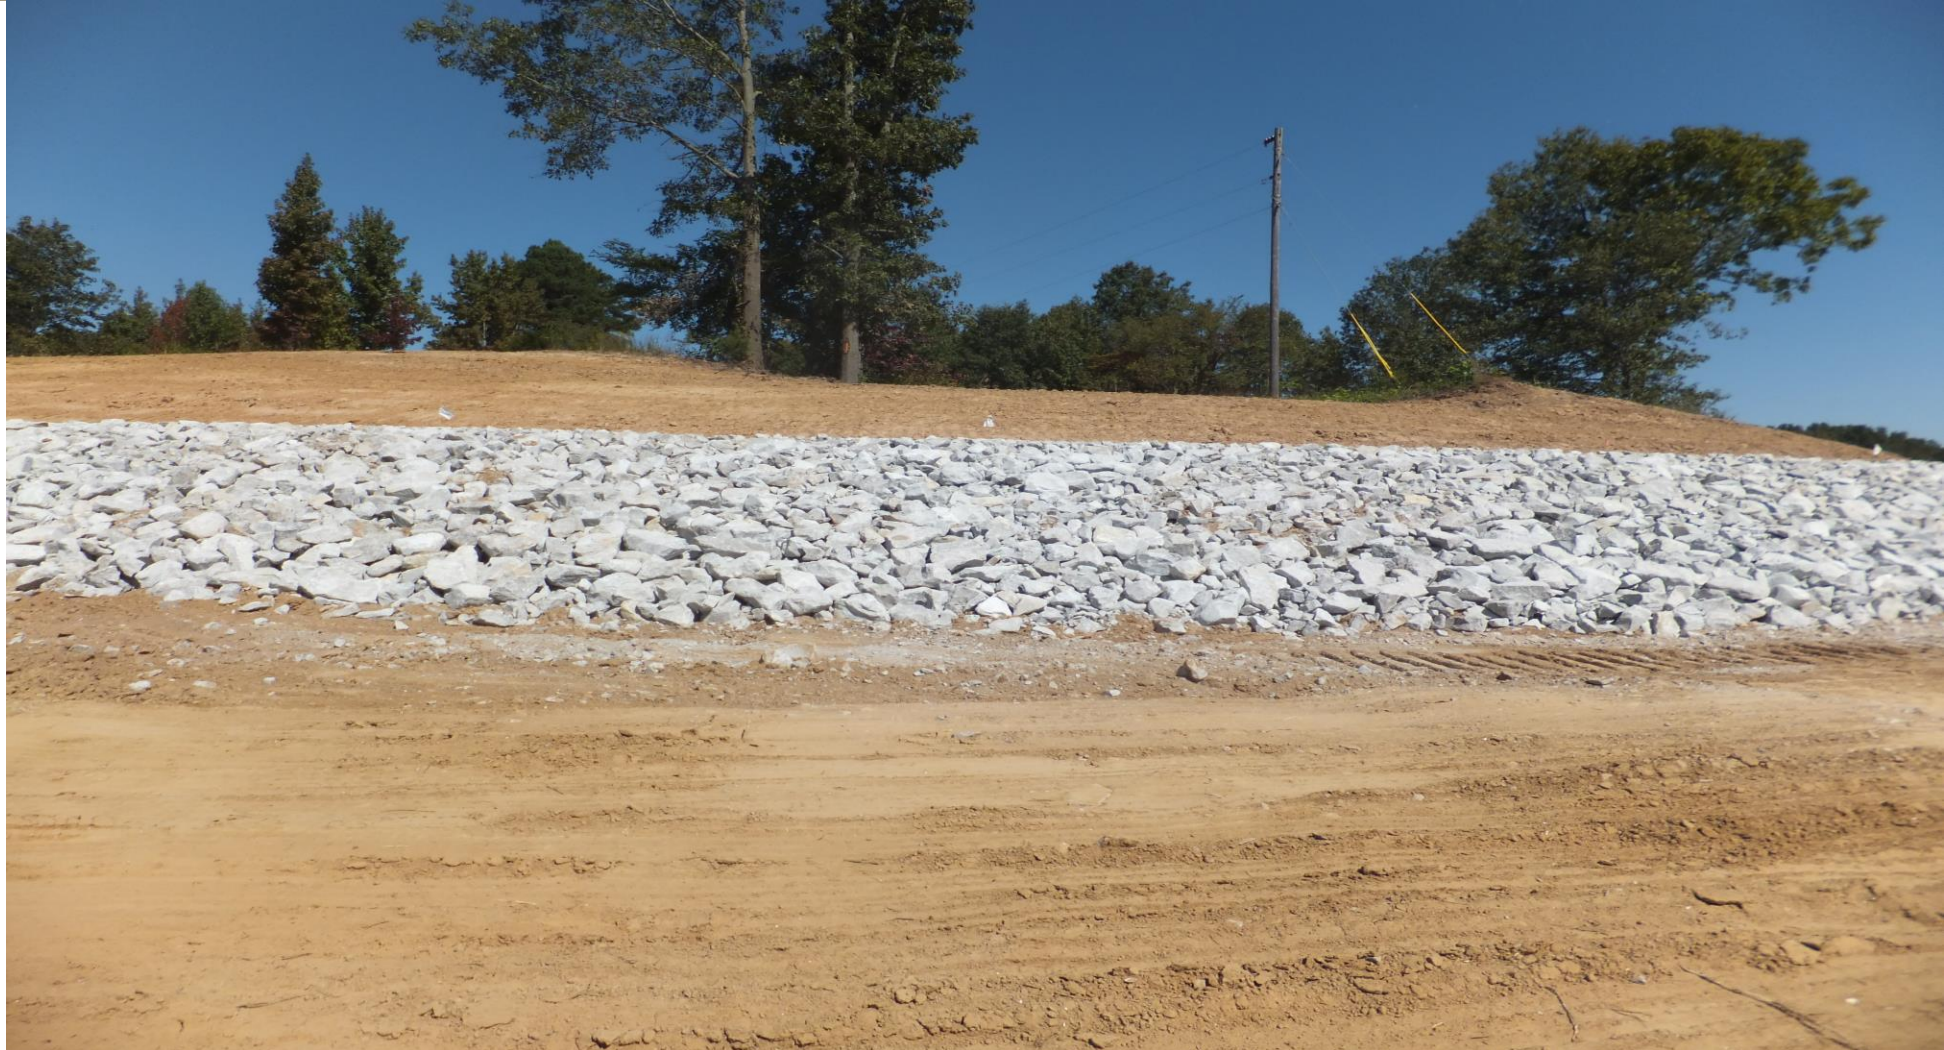
# Point 21-22 After
