The Revitalization of the Sioux Ranger District Compound

Bruce Crockett – U.S. Forest Service,
Northern Region Engineering

Chris Martison – A&E Architects,
Missoula and Billings Montana

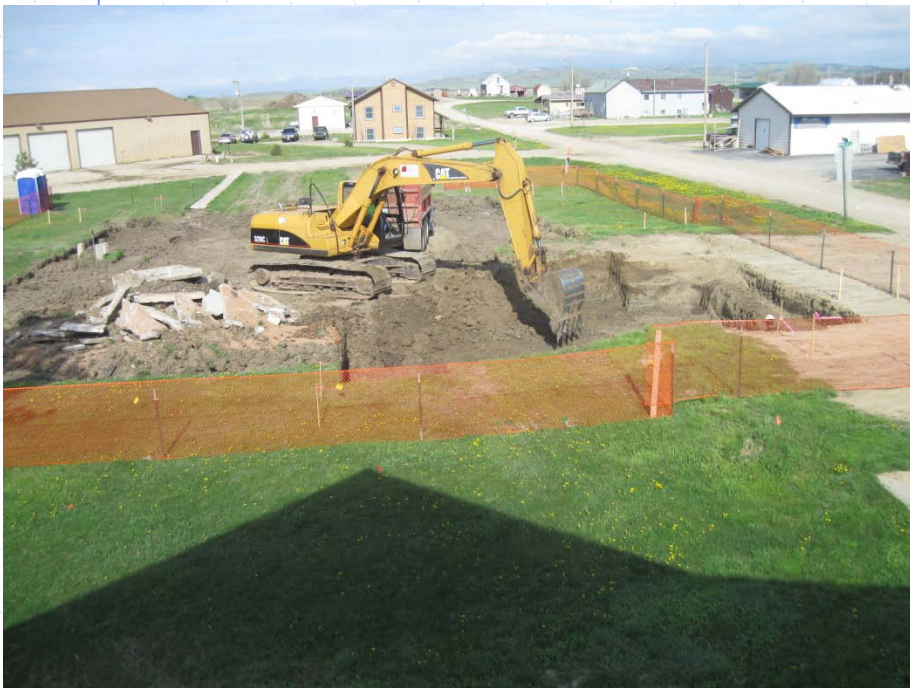
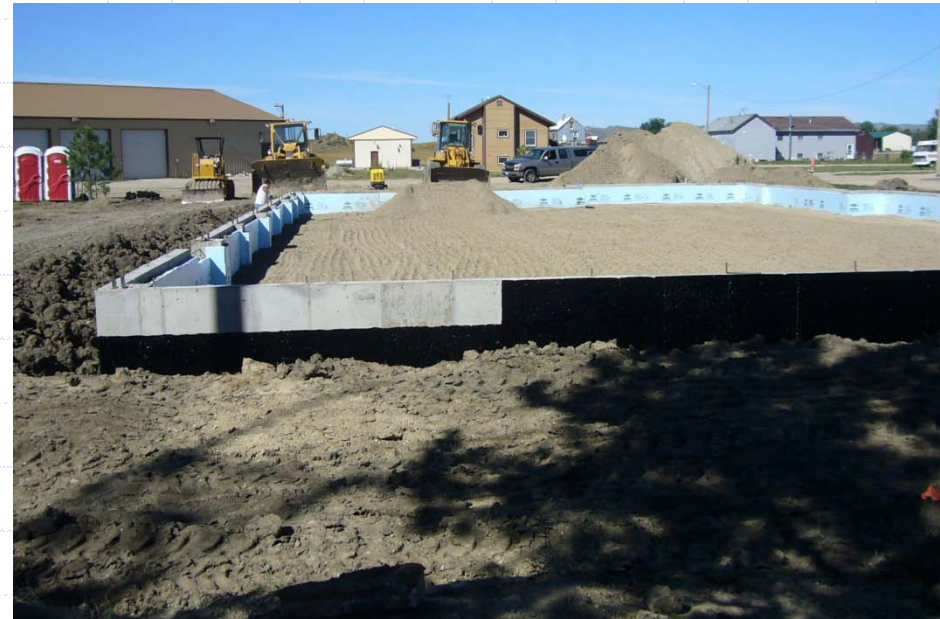
Water Issues ~ Who ordered this ~ we did not have swimming pools in the contract.

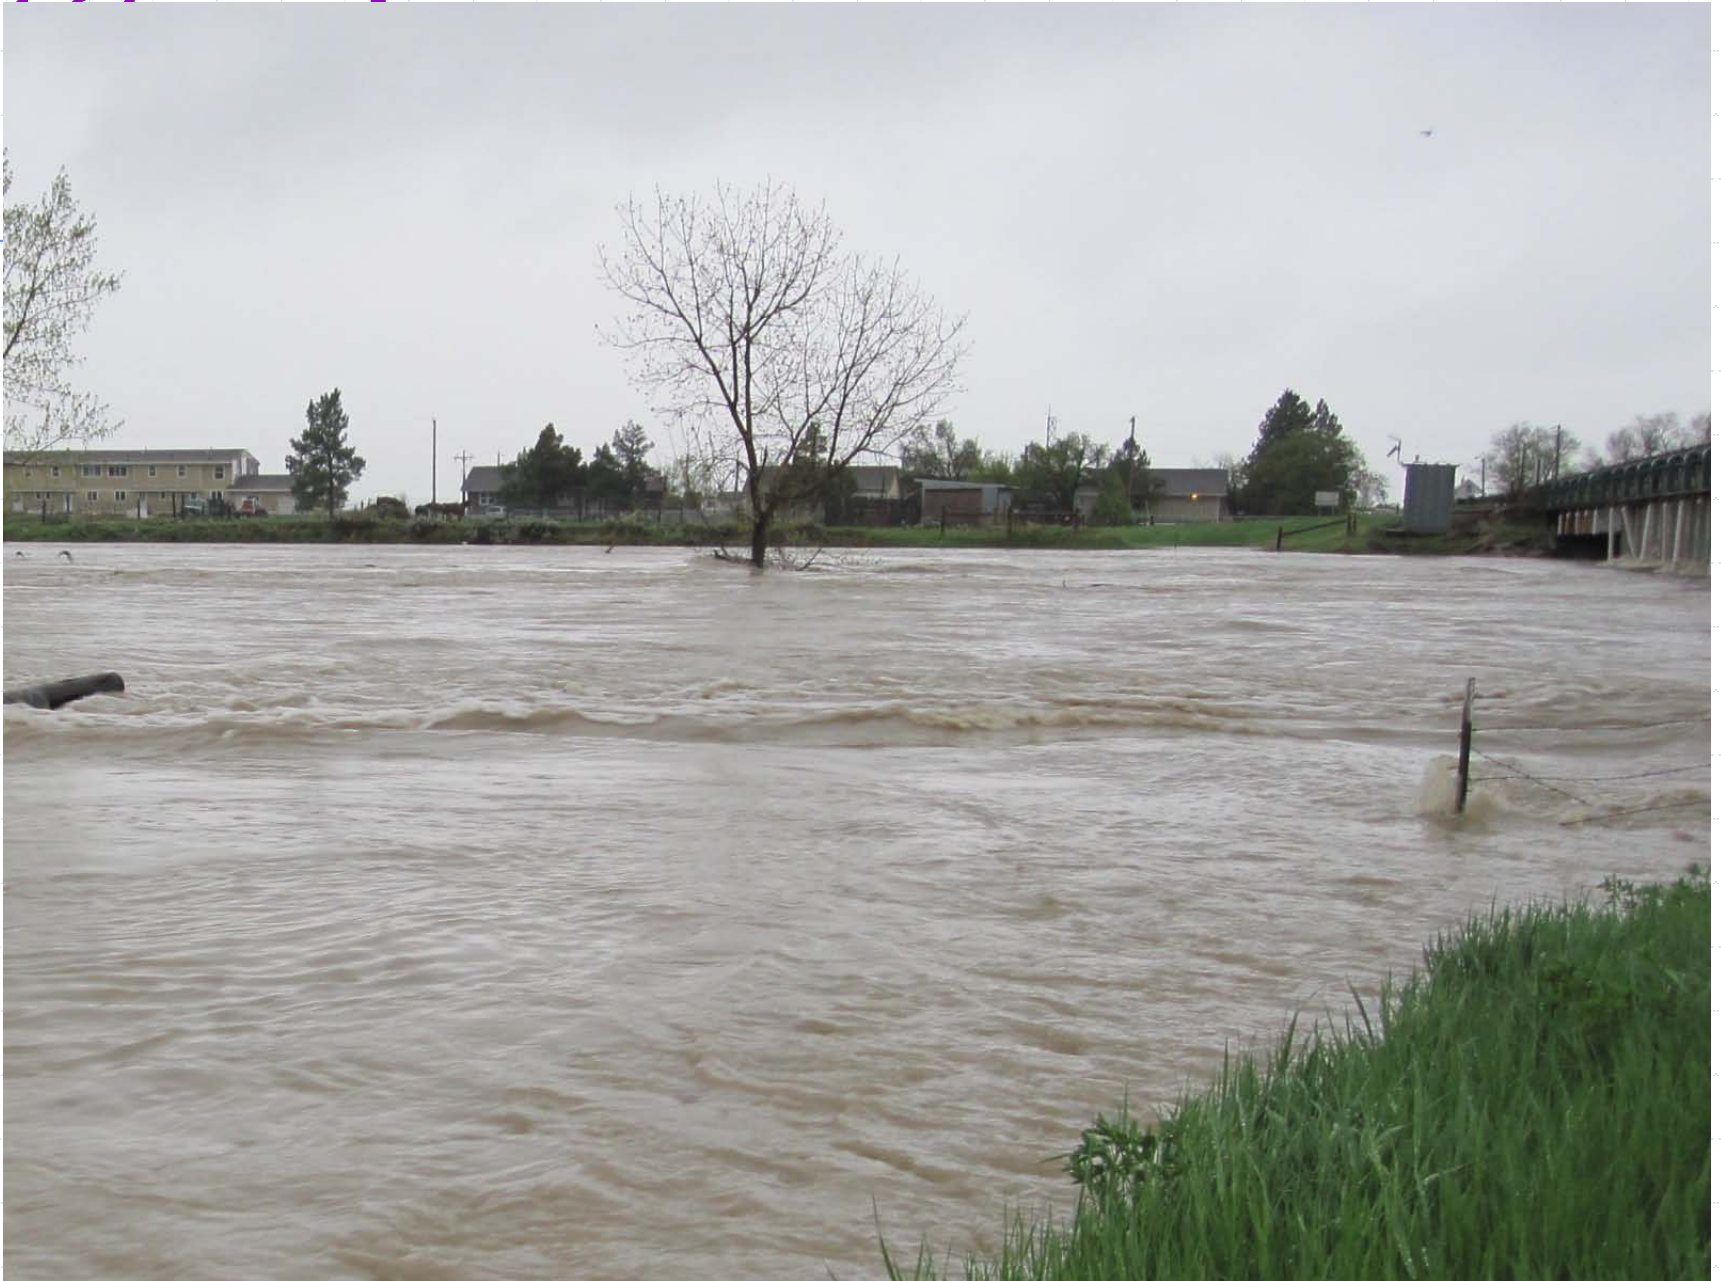
Day after the rains. Am I still in SD or did I get transported to Africa?
