MALONEY CREEK RESTORATION AND INTERPRETIVE TRAIL PROJECTS

ACE 2014 Conference

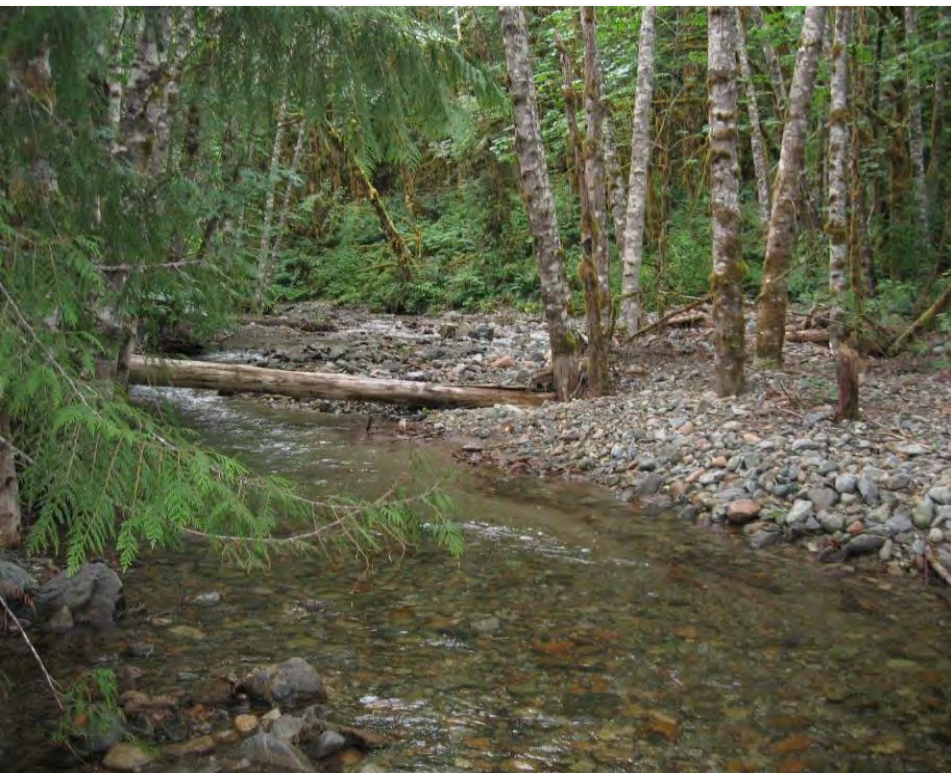
Lower Maloney Creek
“typical flow”

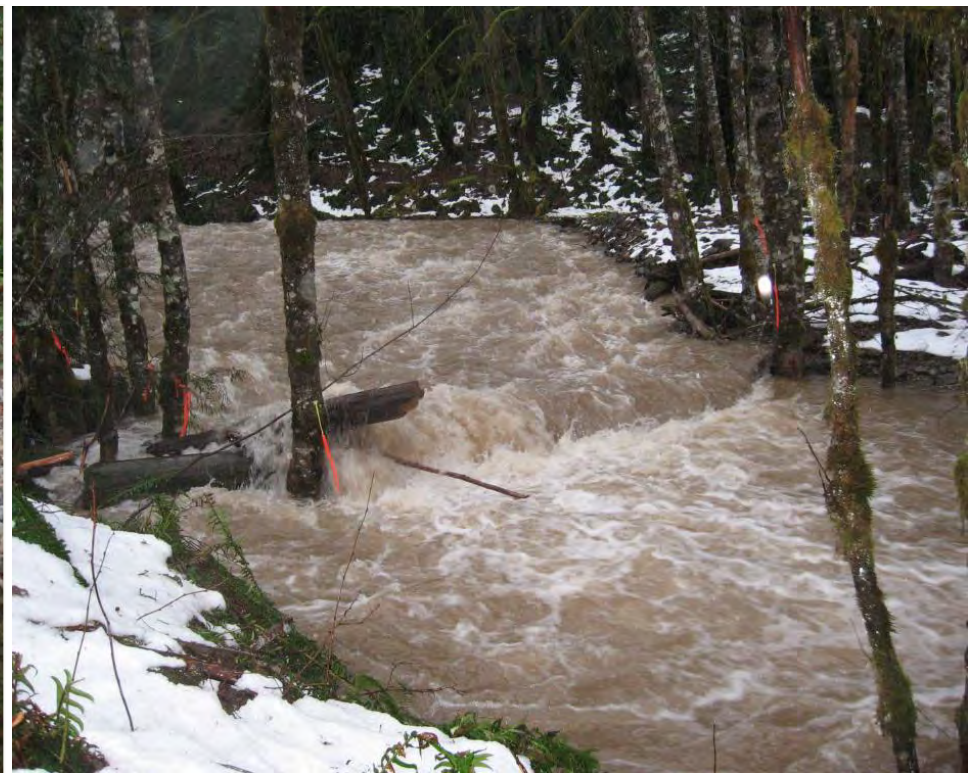
Lower Maloney Creek
near bankfull flow

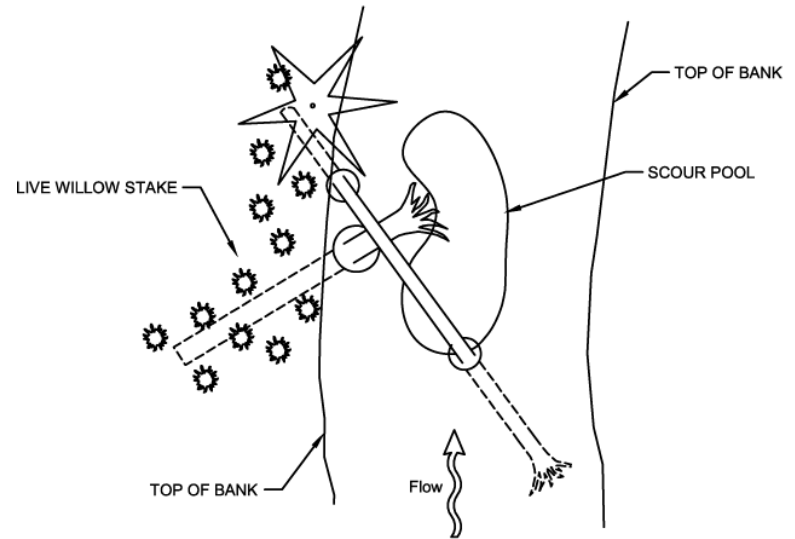
PLAN VIEW

TYPICAL MID-CHANNEL LOG STRUCTURE

- Limit impacts to flow conveyance
- No mechanical anchors (per USFS)
- Stability calculations - Buoyancy, drag, and moment forces (NRCS)

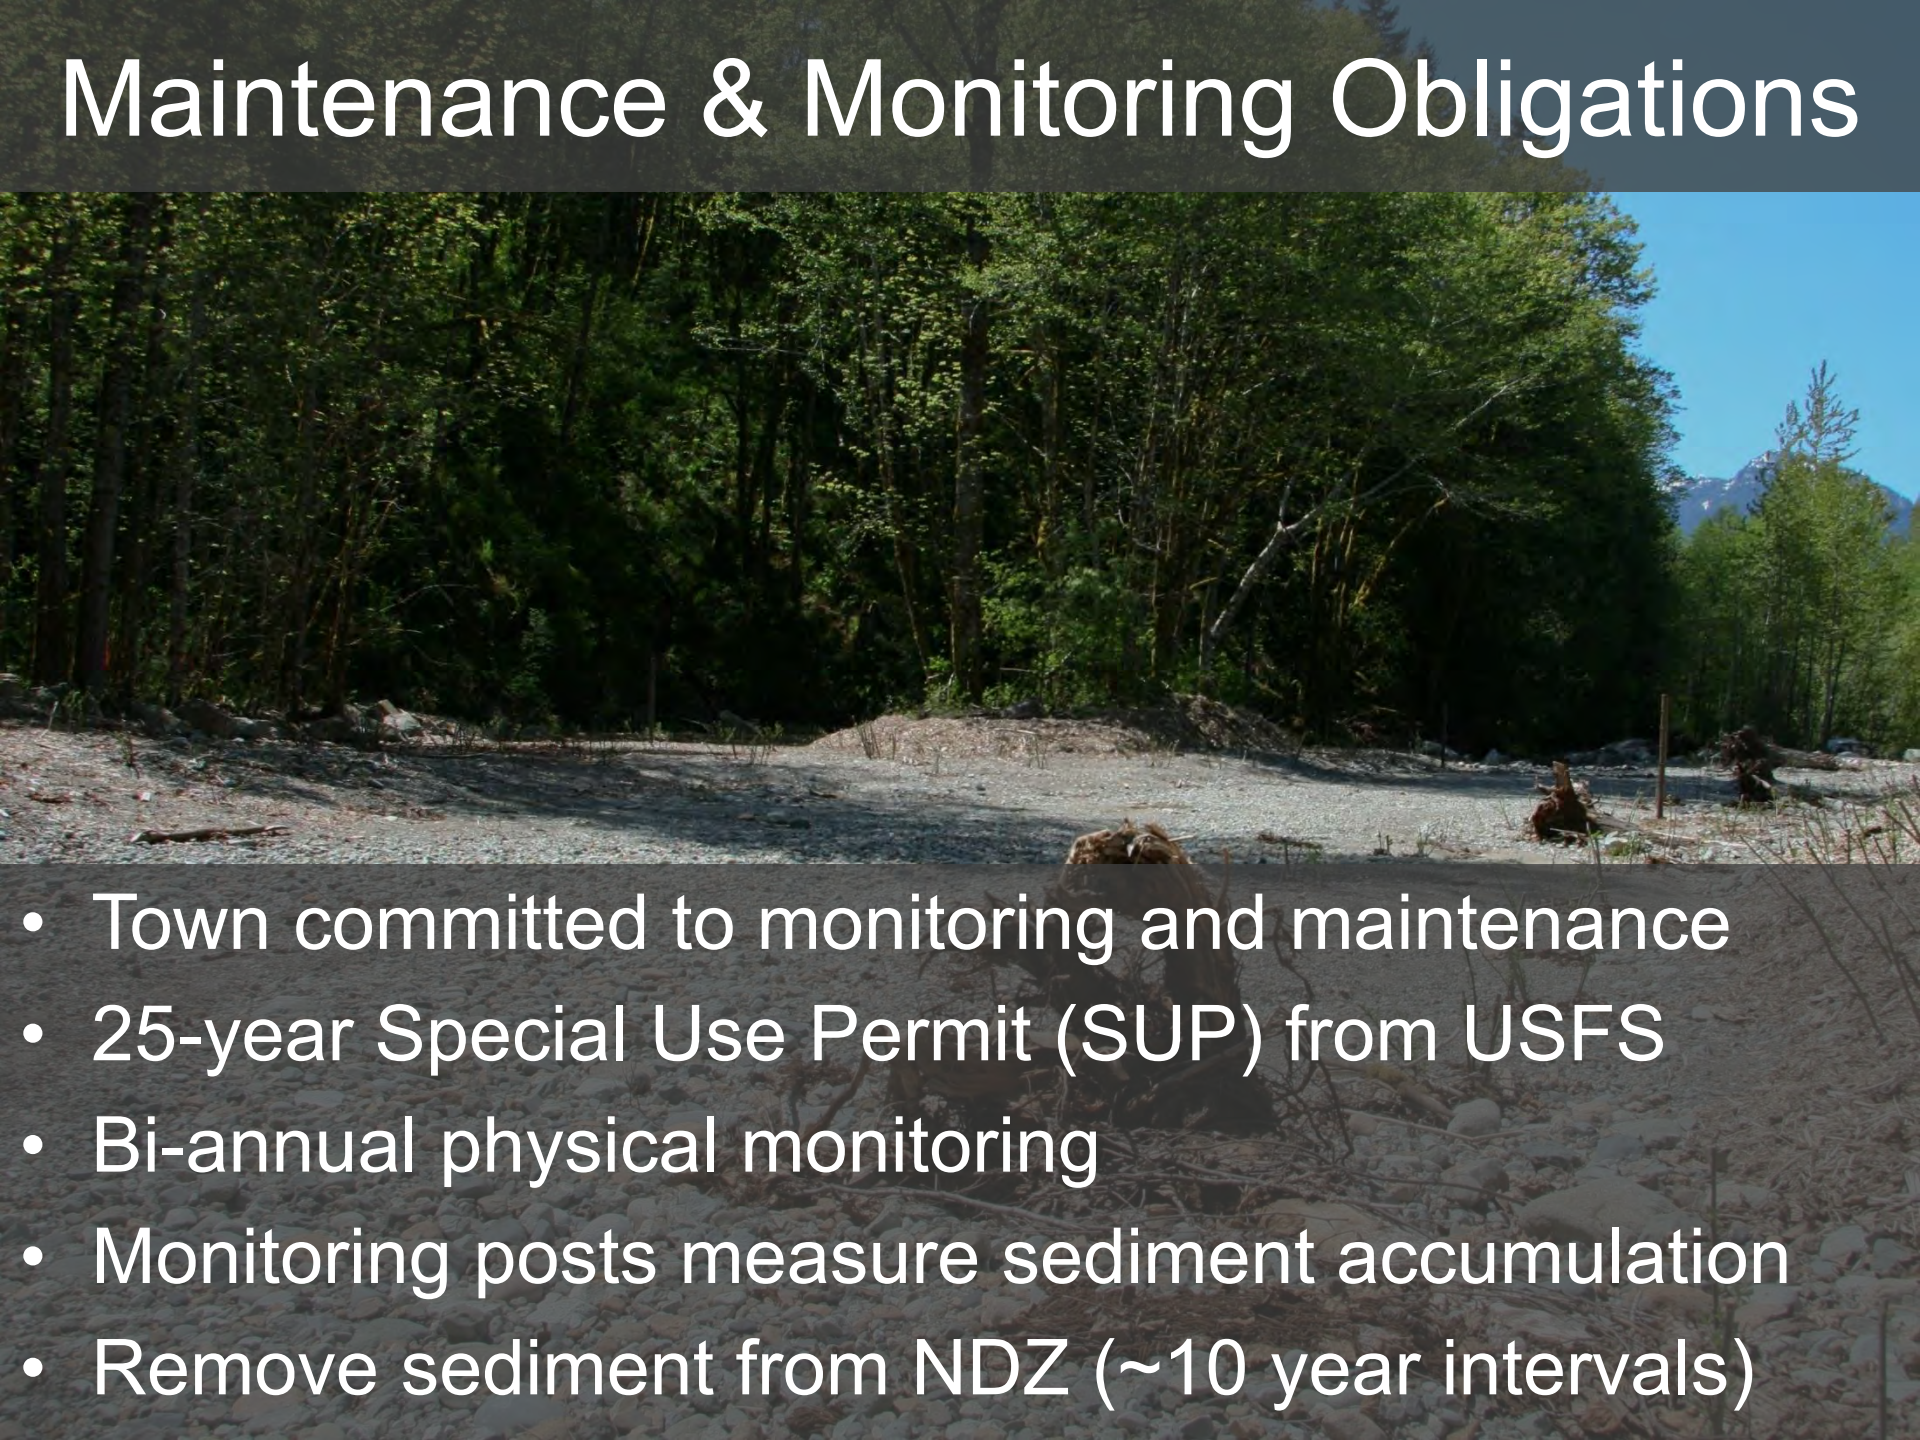
- Town committed to monitoring and maintenance
 - 25-year Special Use Permit (SUP) from USFS
 - Bi-annual physical monitoring
 - Monitoring posts measure sediment accumulation
 - Remove sediment from NDZ (~10 year intervals)

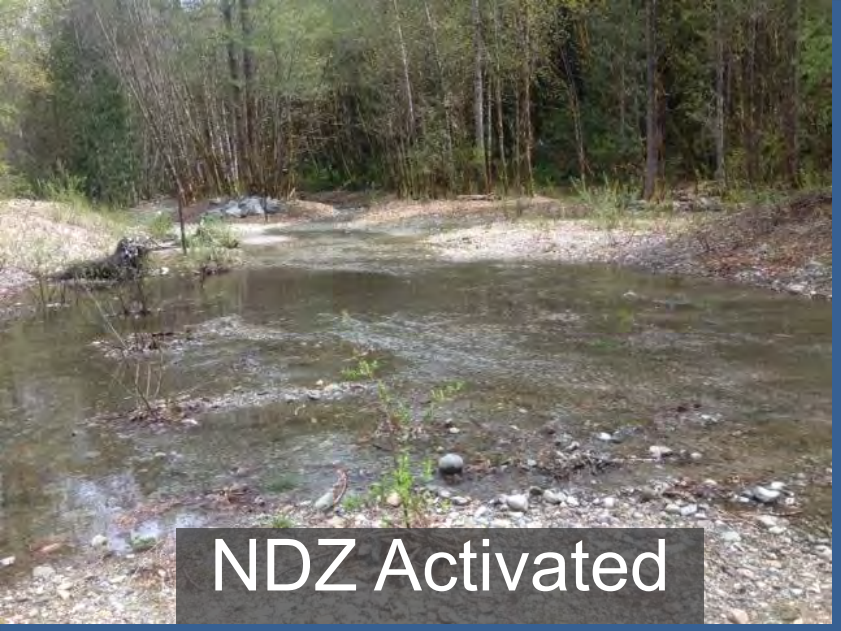
NDZ Activated

- Design channel would have improved sediment transport capacity but still would be overwhelmed by large (episodic) sediment inflows
- Therefore, a Natural Deposition Zone (NDZ) was created to sustain downstream improvements
 - NDZ located at upstream end of project where the stream corridor flattens and widens
 - Overflow channels convey peak flows into NDZ
 - Designed to capture coarse sediment
 - Storage capacity ~4,000 CY; expected annual deposition of ~450 to 600 CY per year in NDZ
 - Periodic maintenance required (~10-year intervals)

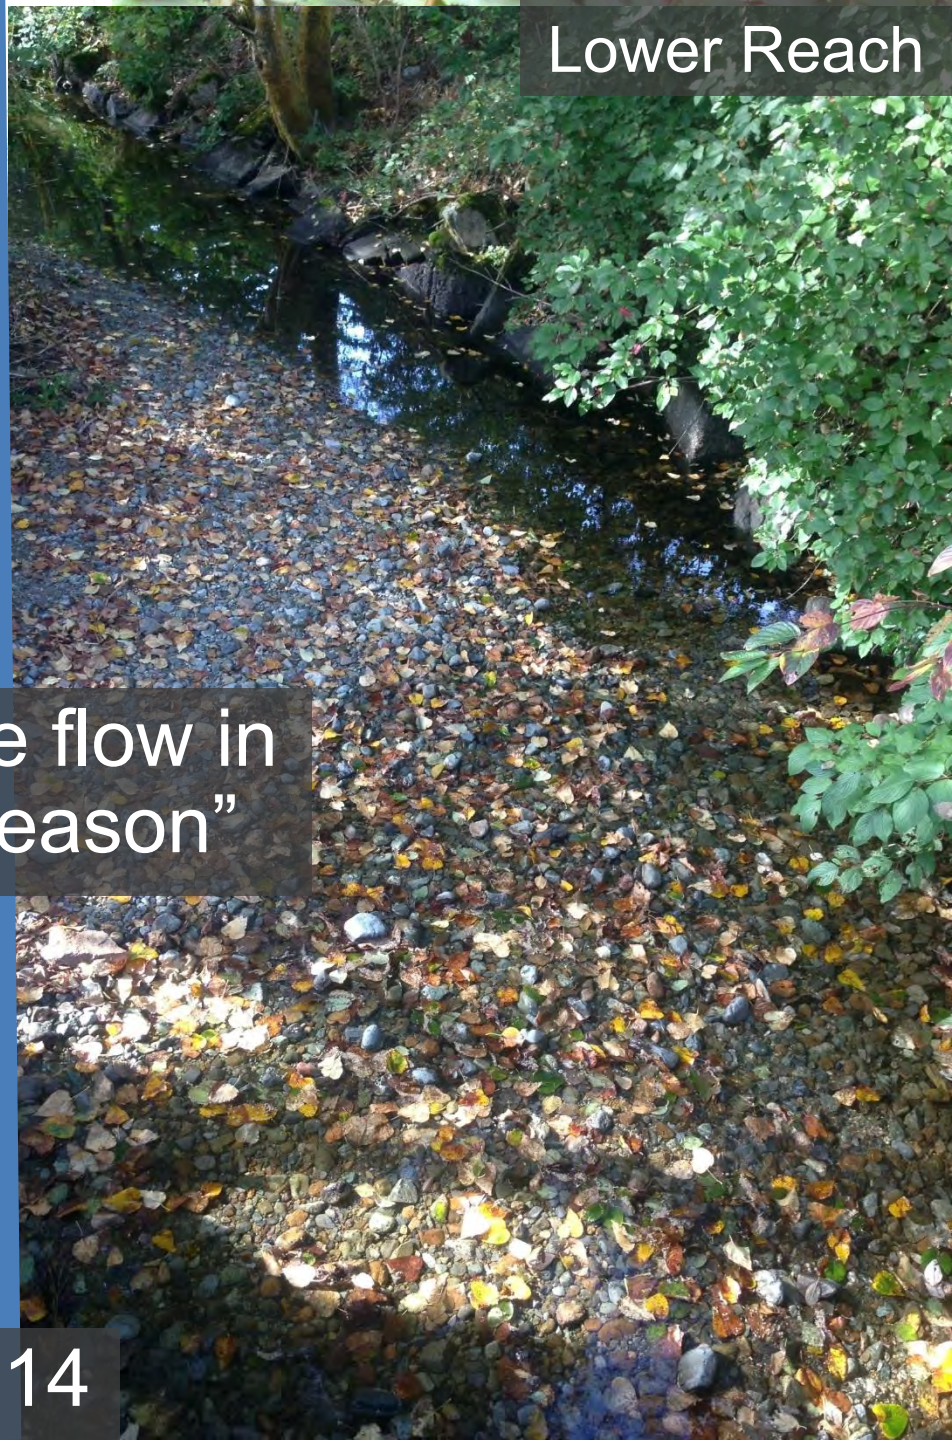
Surface flow in
“dry season”

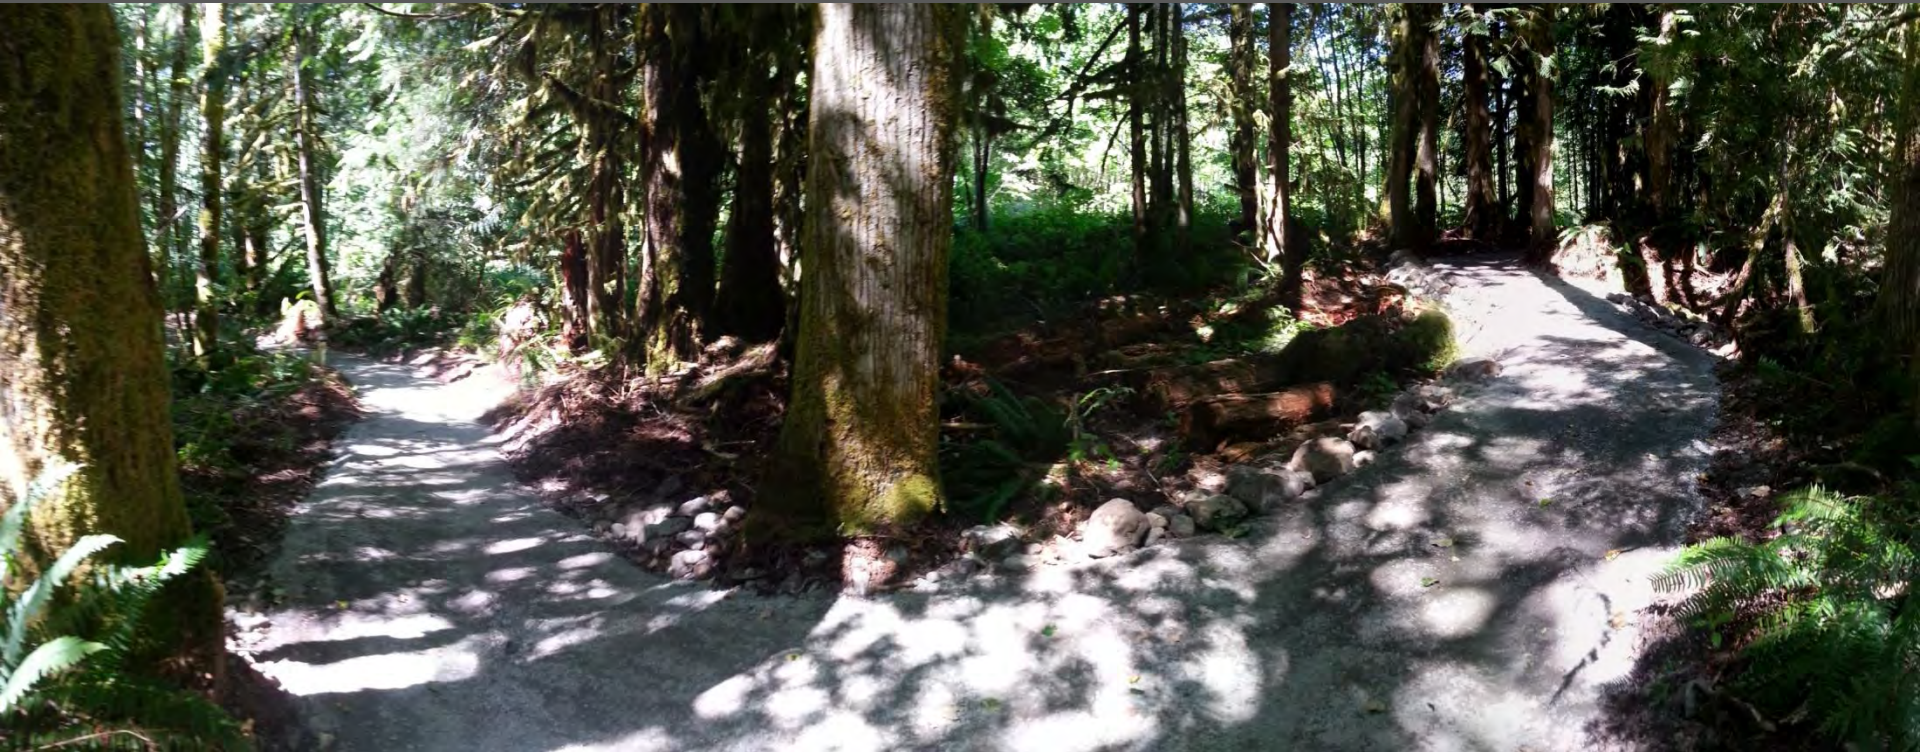
Special “trail mix” from fully crushed 1/2- minus with the addition of 25% finer crushed screening reject material to add additional binder
