# Suttle Lake Dam Fish Passage Project

Nate Dachtler  
Alan Buehrig  
Deschutes National Forest  
ndachtler@fs.fed.us

*A tale of two dams and a lost sockeye population*

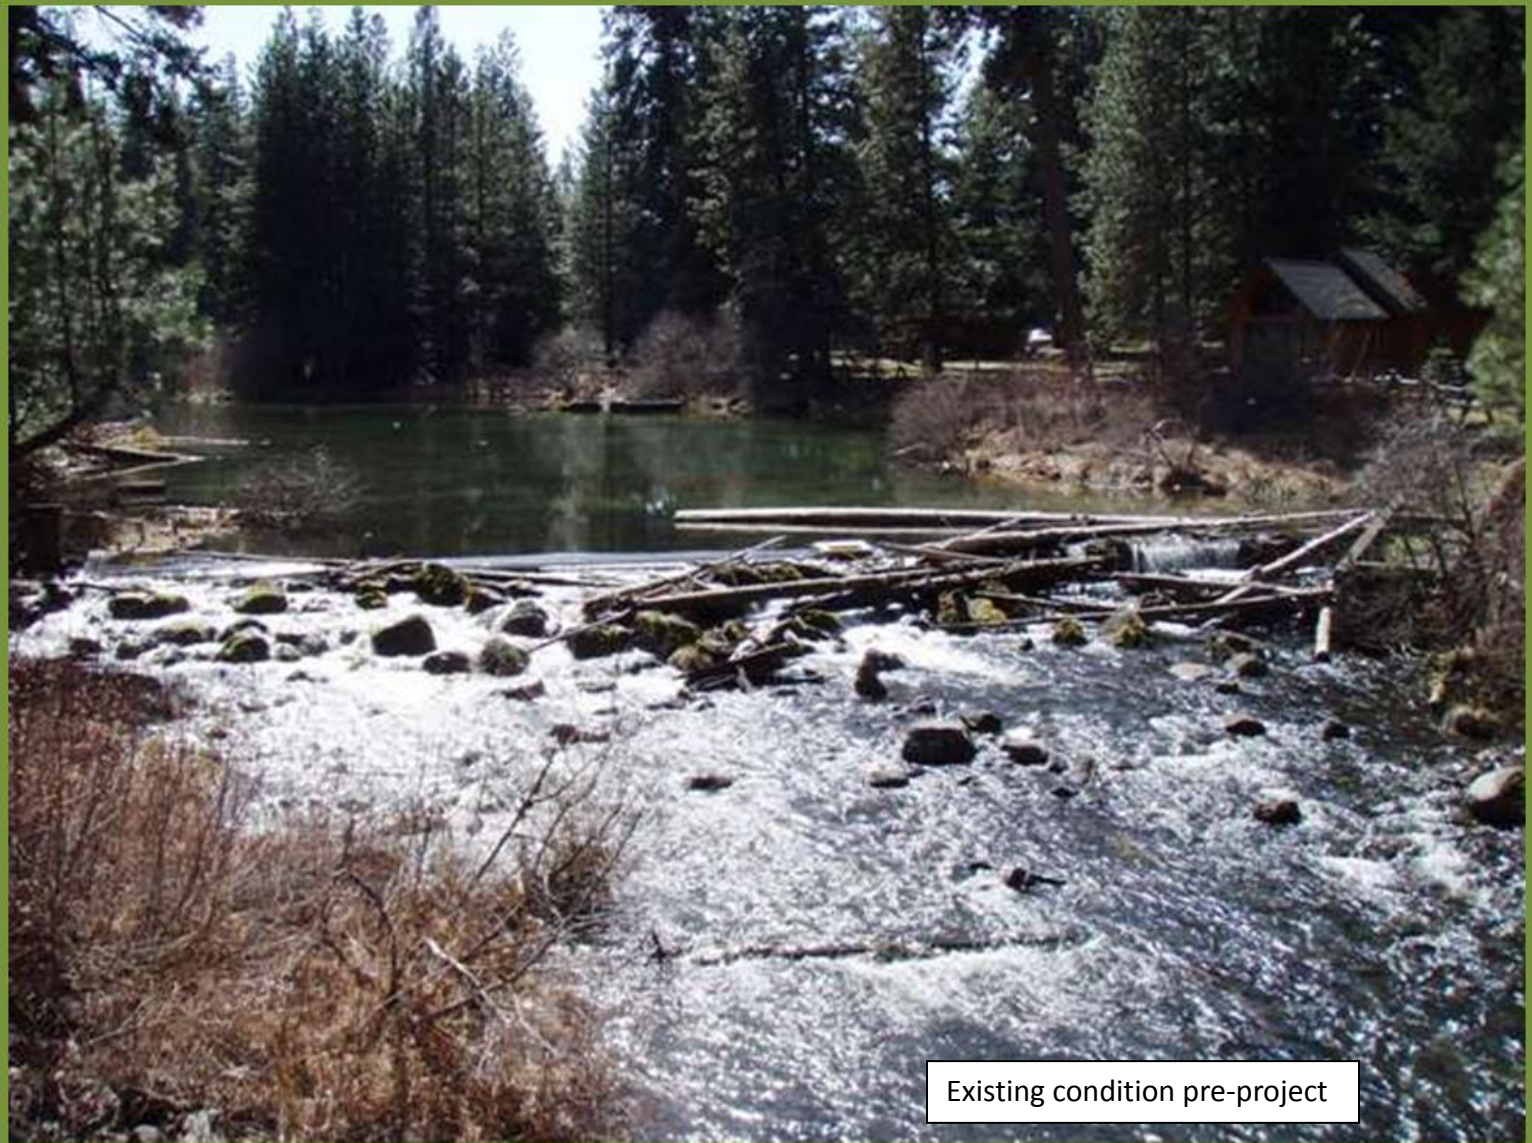
Existing condition pre-project

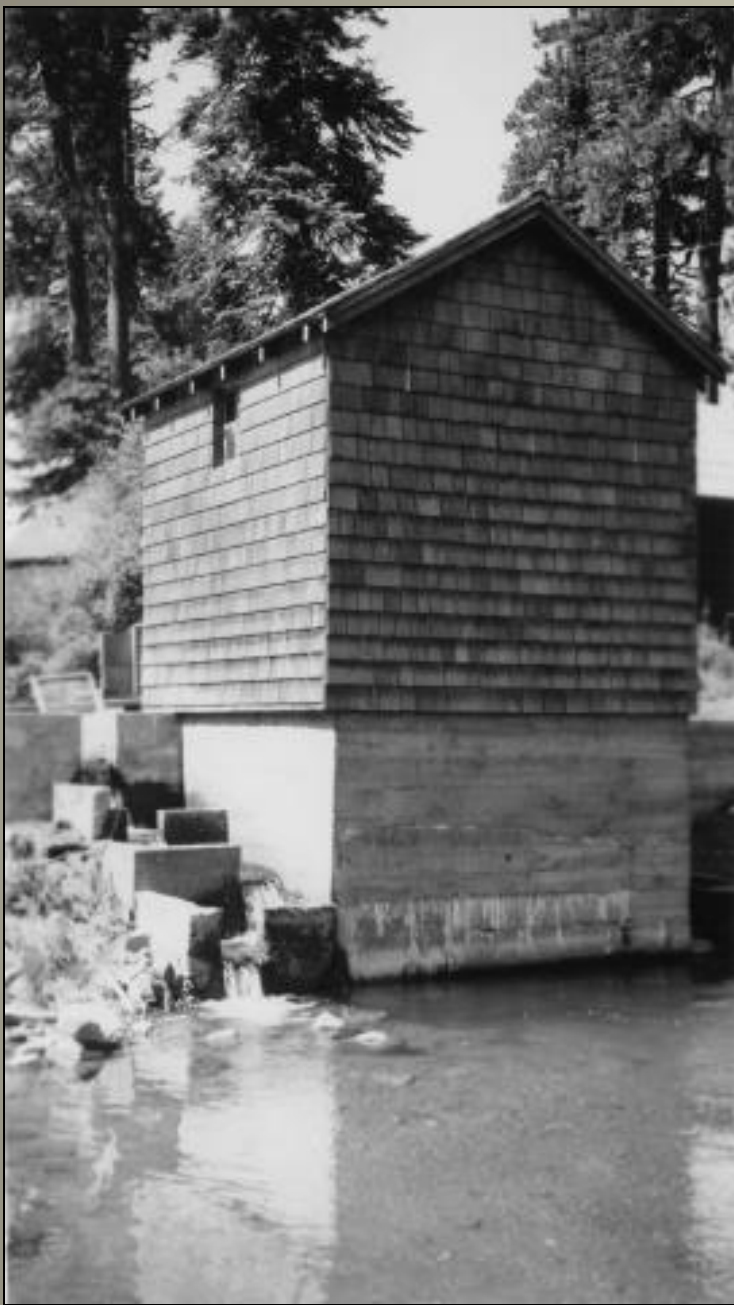
*Powerhouse and fish ladder below dam at Suttle Lake outlet, 22 June 1942. Source: Pacific Northwest Stream Survey Photographic Collection, Oregon State University Archives, Corvallis, Oregon.*

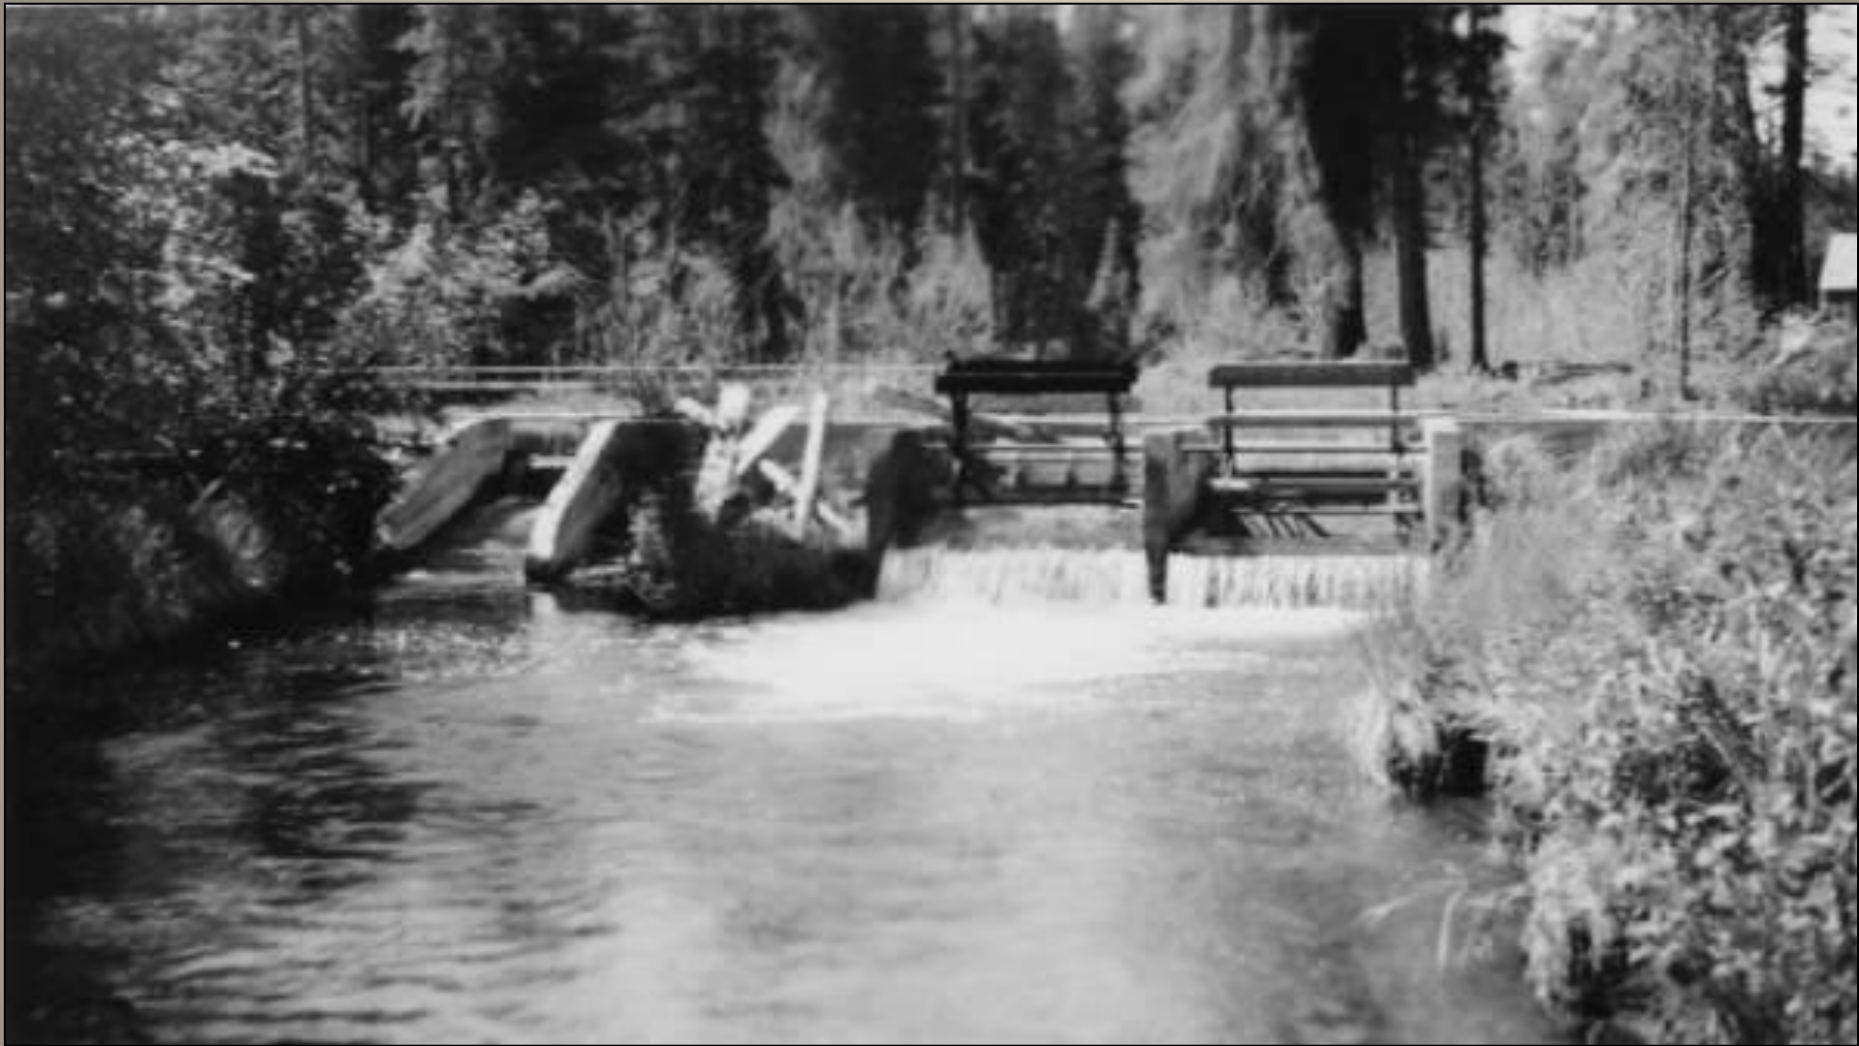
**Rotating screens and spillway in power dam at the Suttle Lake outlet, 22 June 1942.**

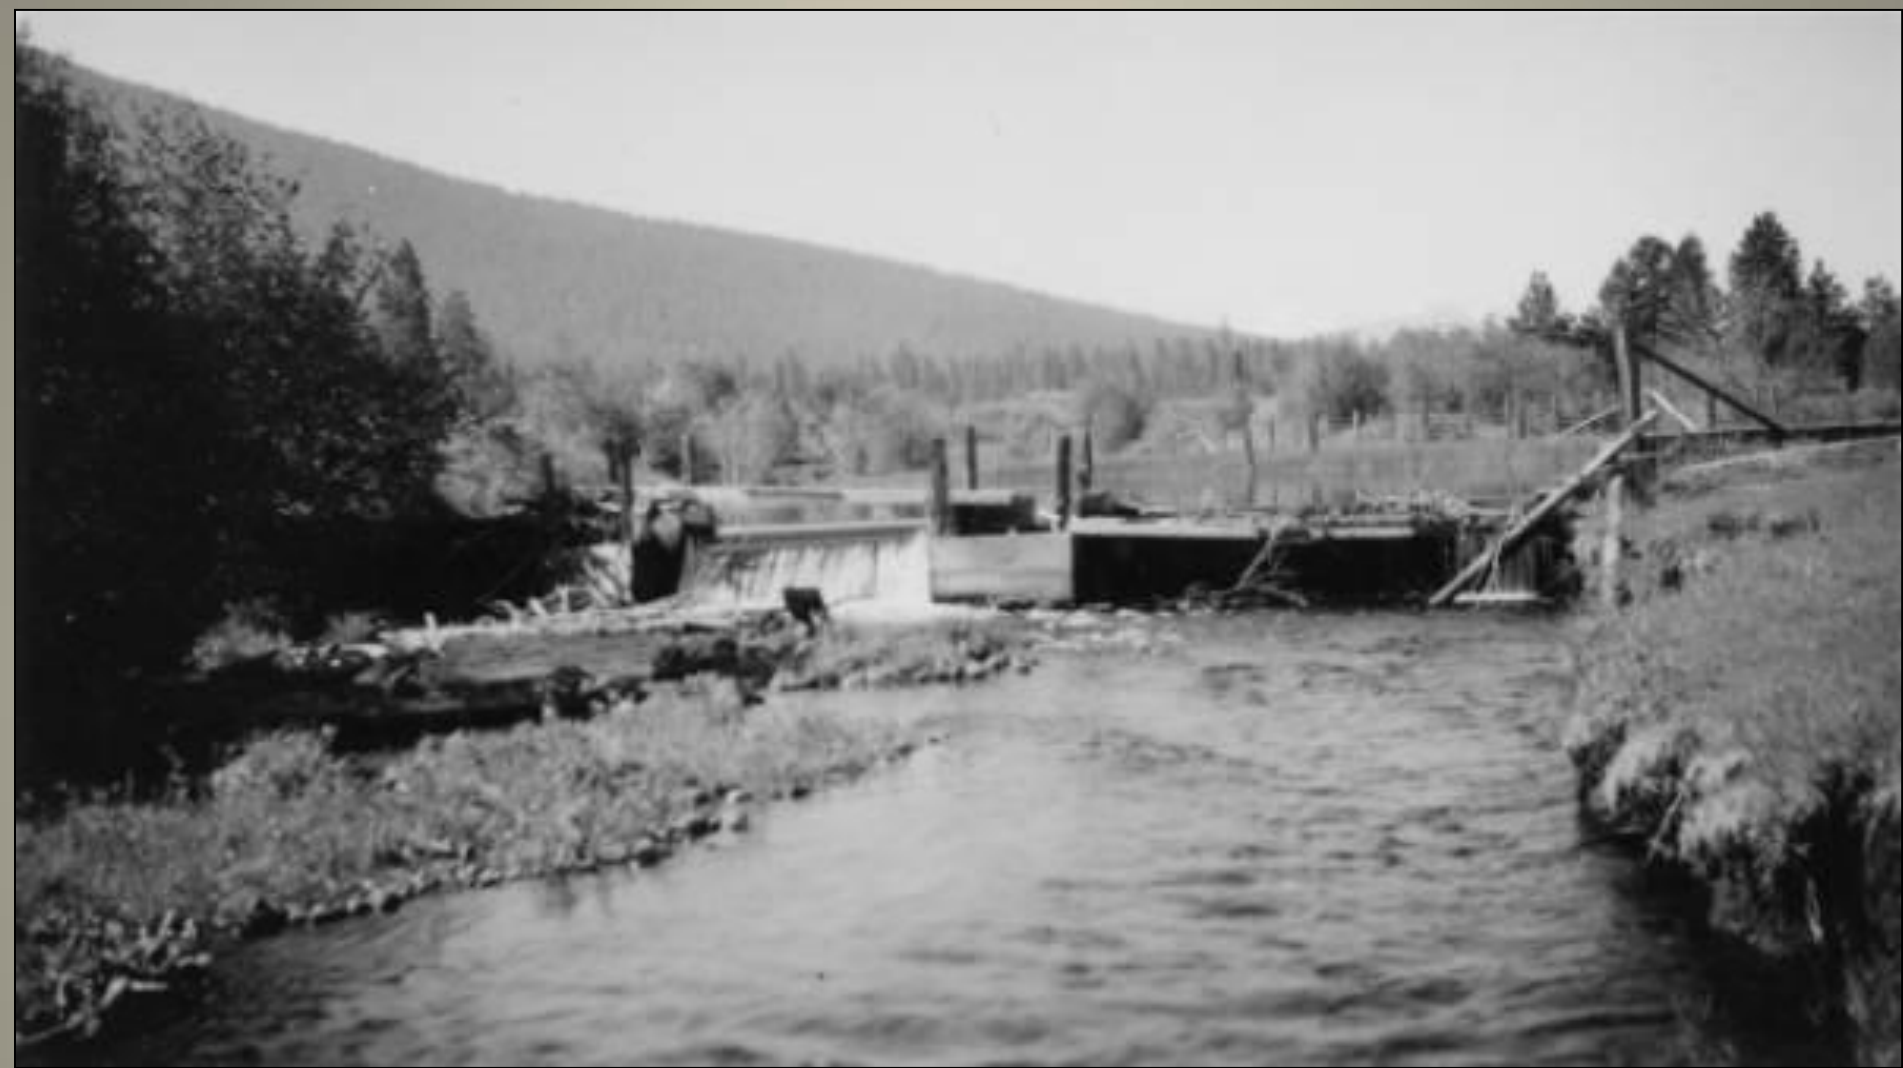
**Upper dam on Lake Creek at Lake Creek Lodge, 22 June 1942.**

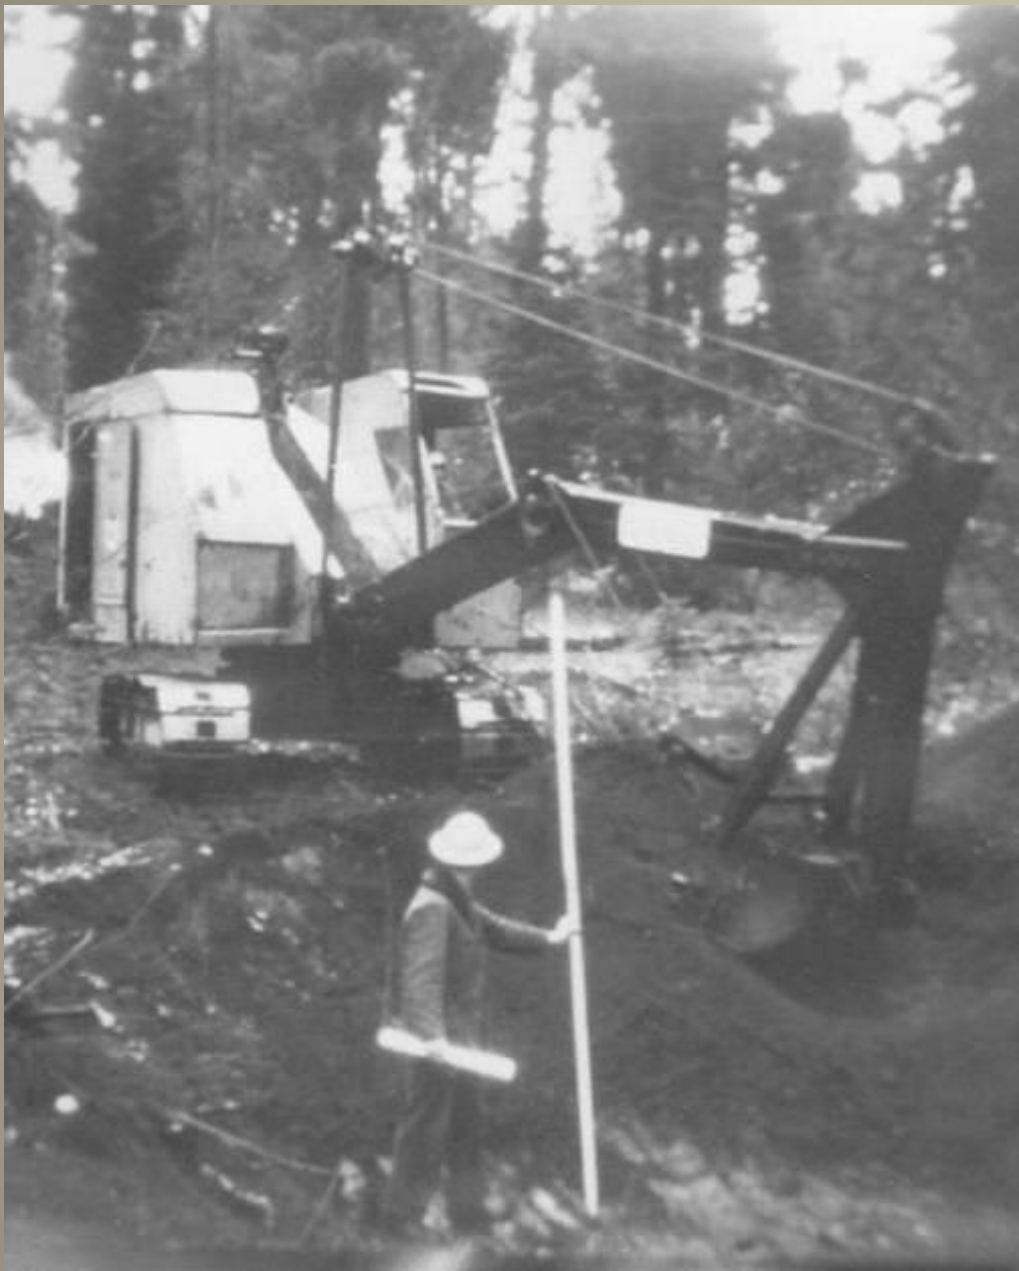
**Start of excavation for the 1961 dam.**

- Second dam constructed to maintain lake level for recreation.
- The 1961 dam cost \$ 18,507 to construct and took eight months to complete.
- Excavation was accomplished with a TD-9 Drott 4 in 1 and a ½ yard backhoe.
- Heavy rains in November and February delayed construction.

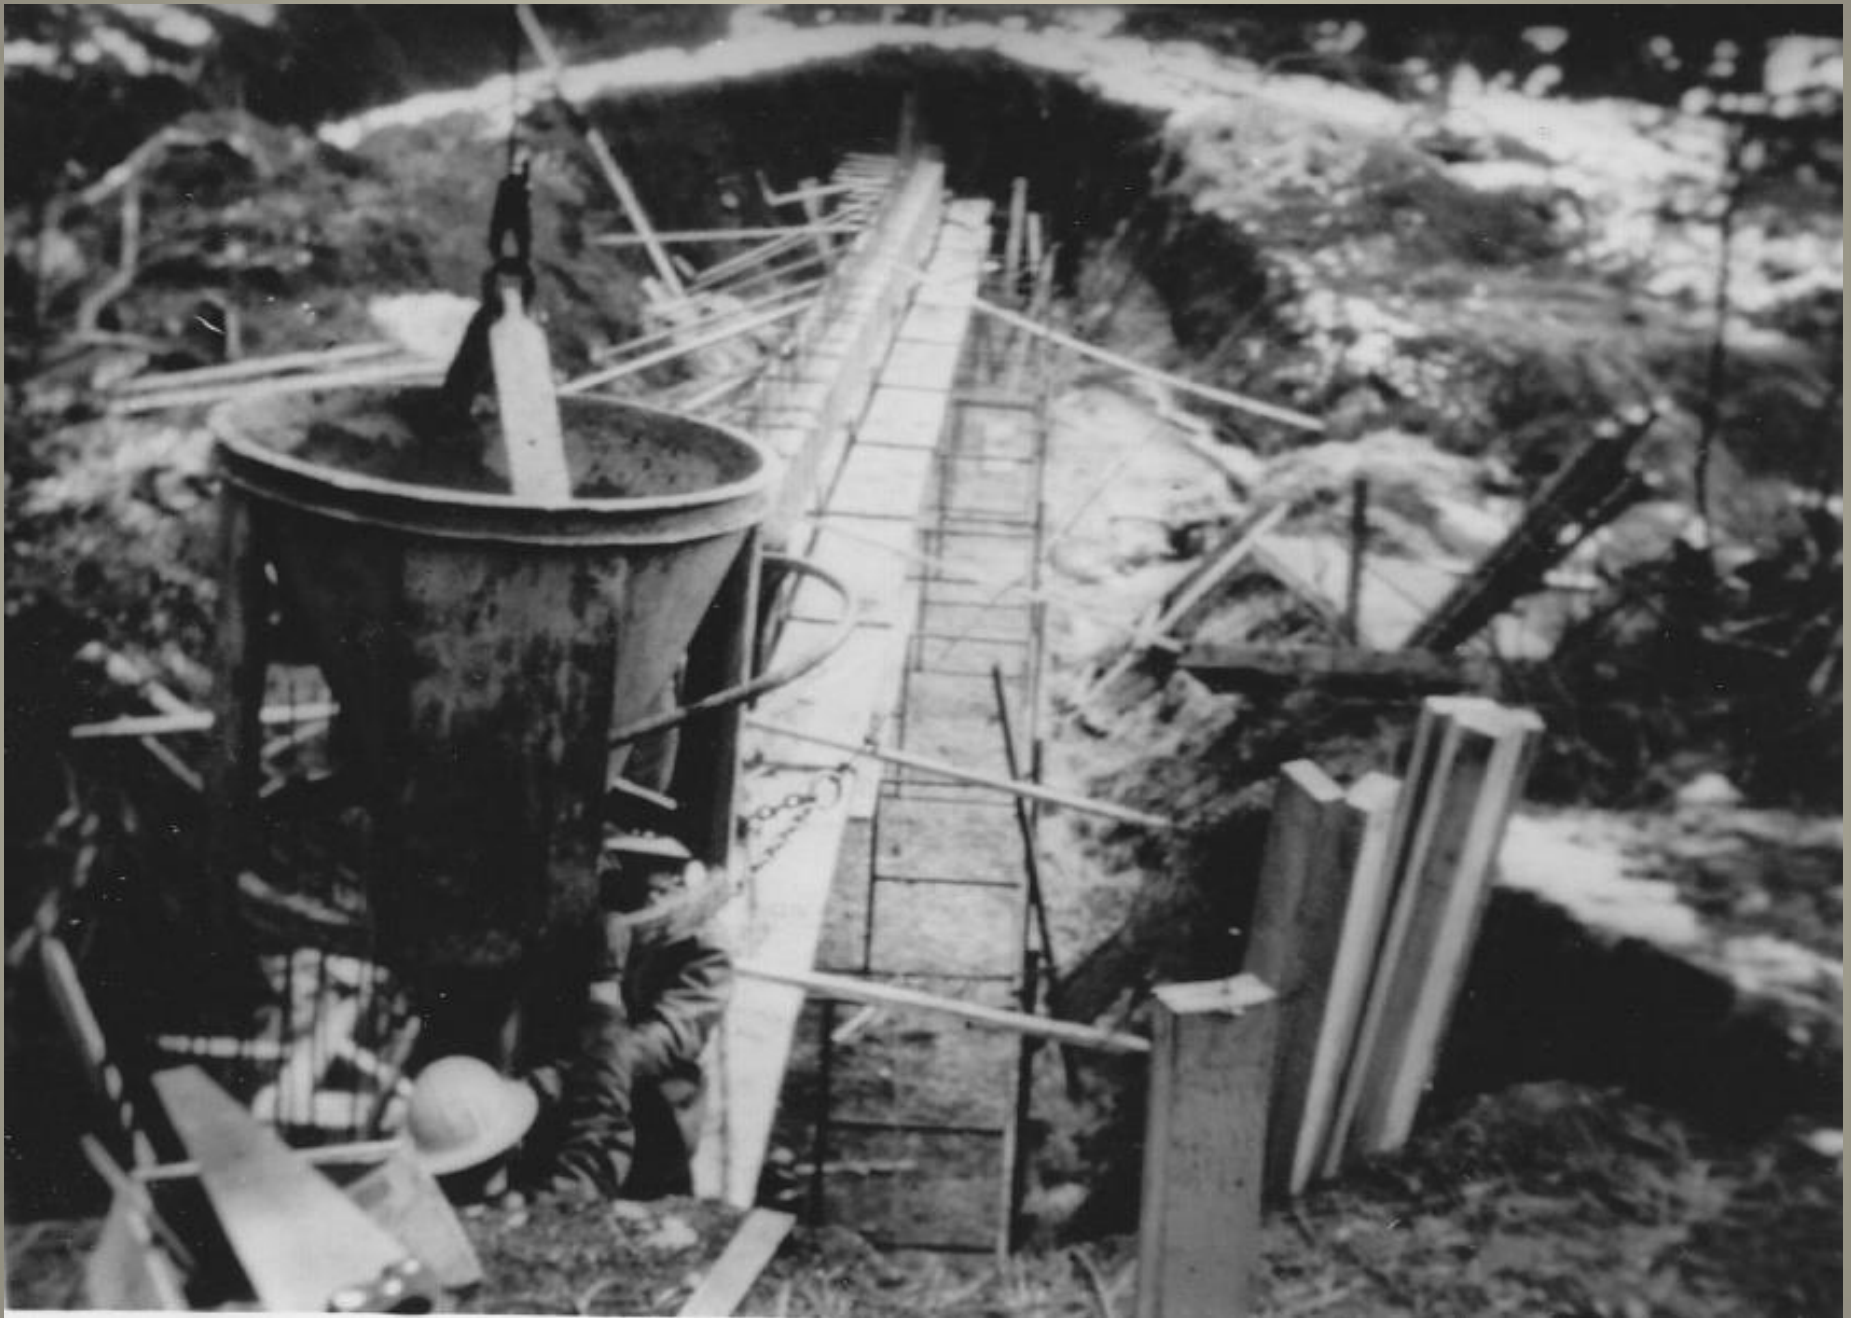
Pouring core wall for the 1961 dam.

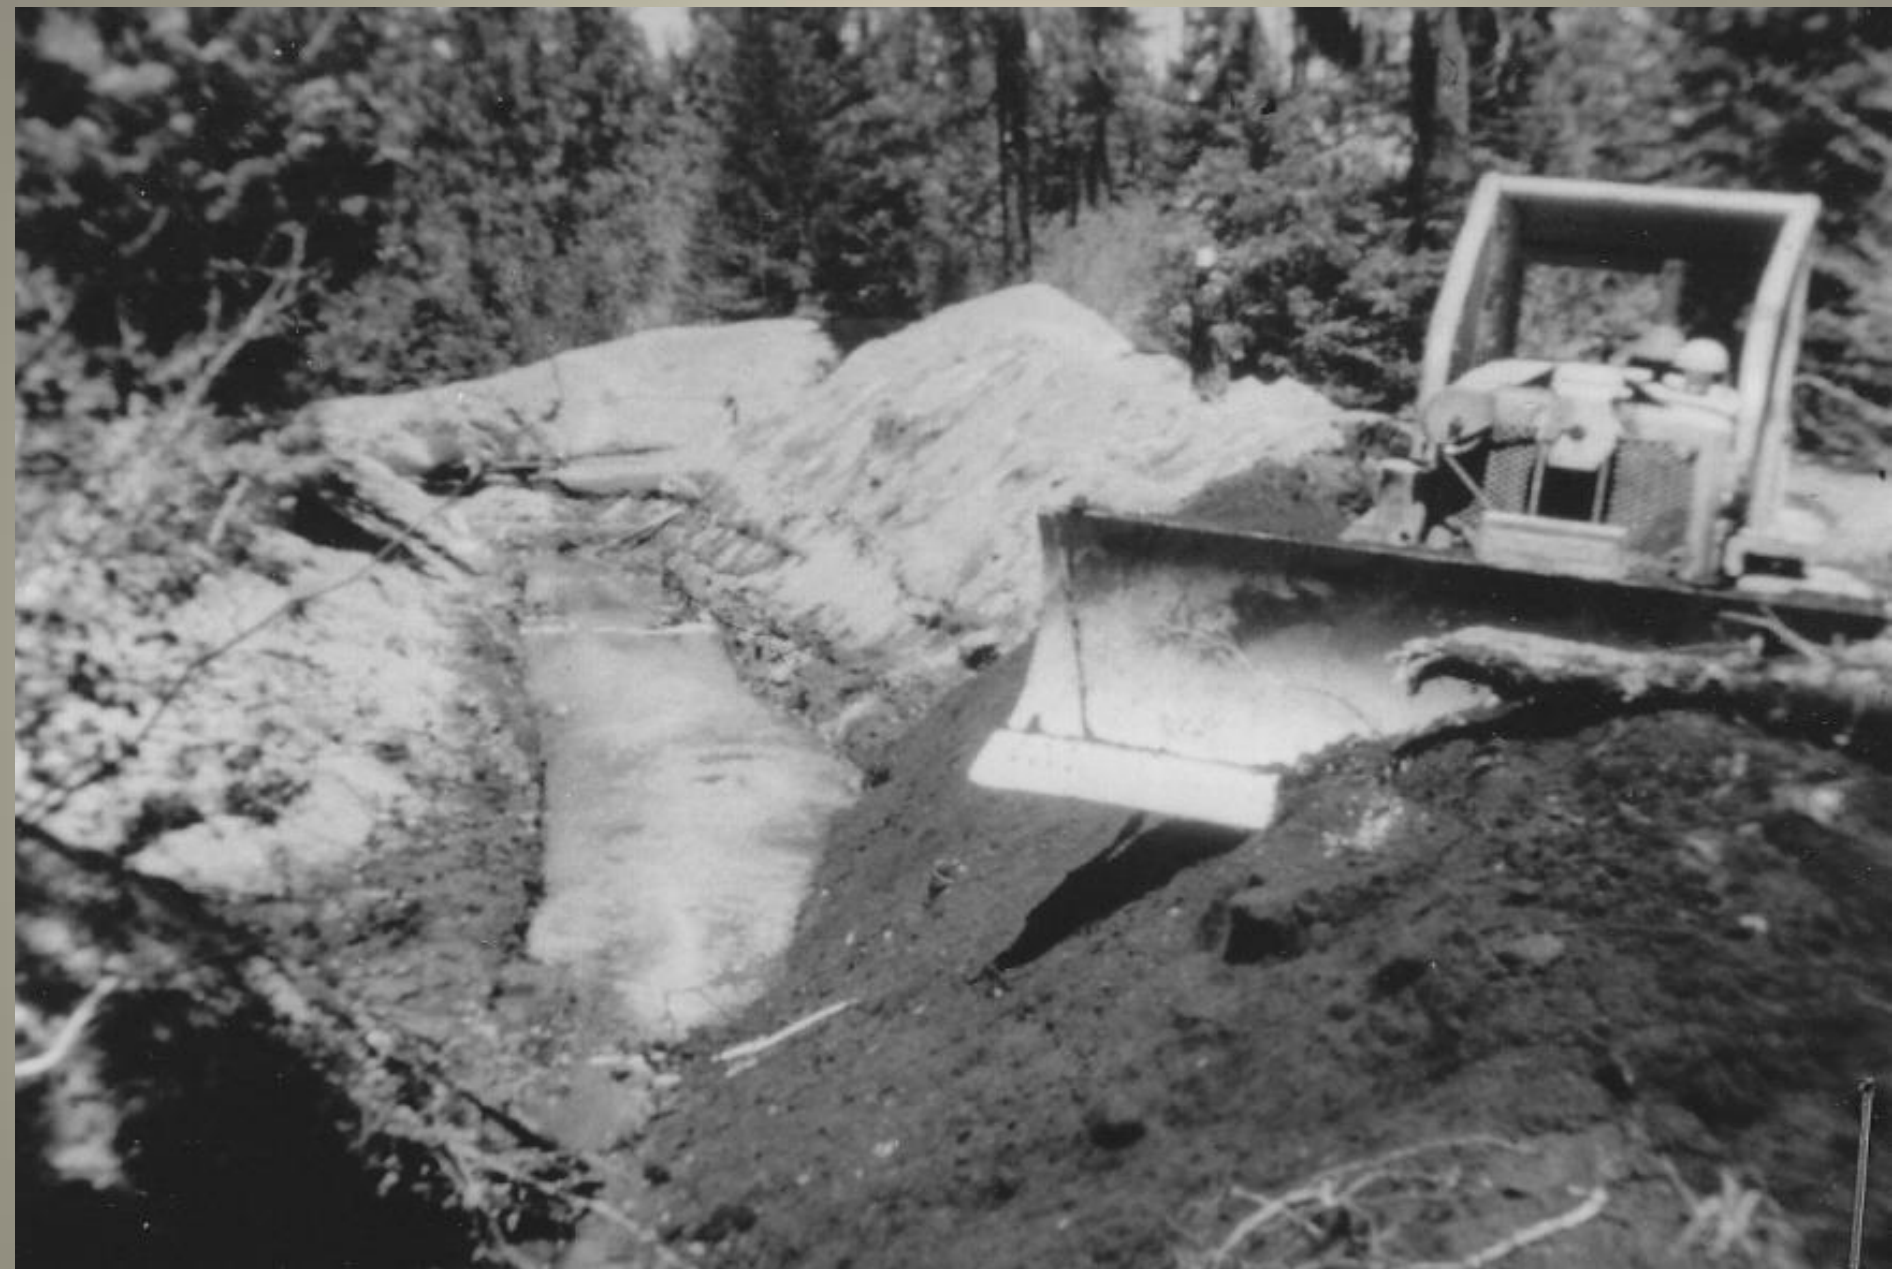
Filling in bypass channel for 1961 dam.

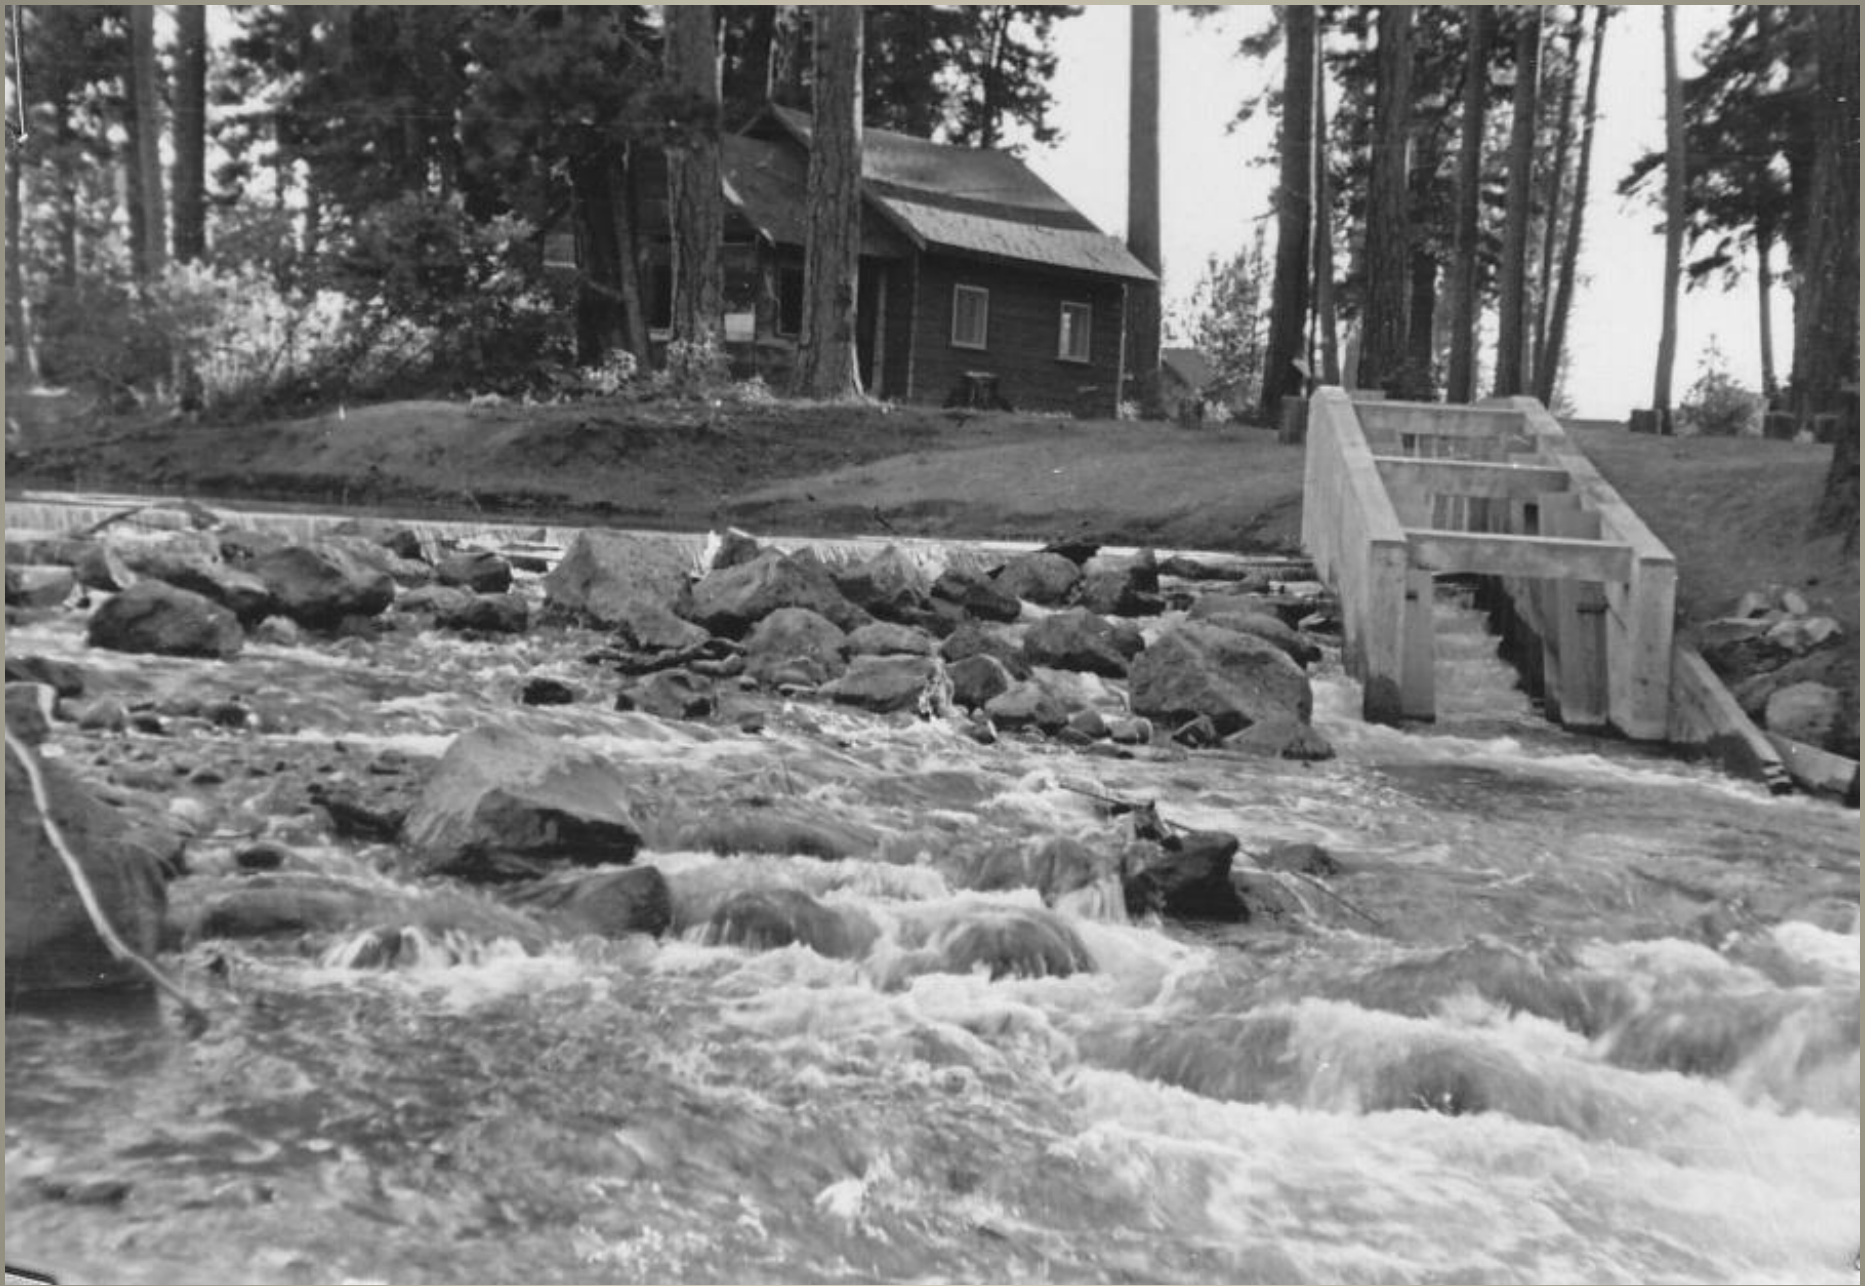
Completed 1961 dam with fish ladder.

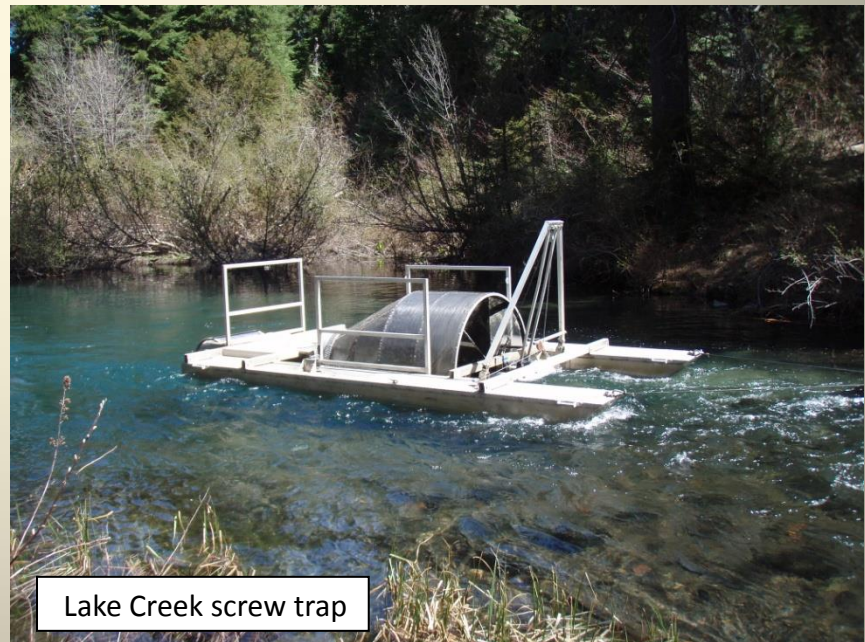
Lake Creek screw trap

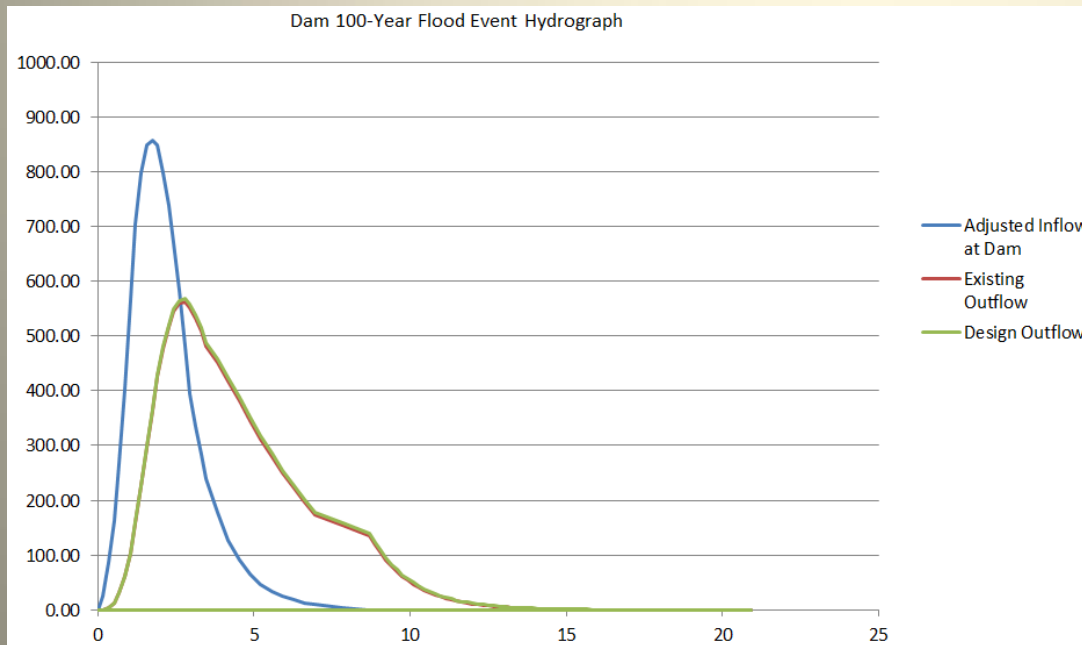
**Reservoir Fills Up  
At Known Relationship**

**Water Exits Dam At Calculated Rate**

**Time Step Analysis Completed at 10 minute Intervals.**

**Conclusion – Based on Reduced Dam Surface Area but Increase Earthwork & Logss Attenuation Effect of Dam on Watershed Is Not Expected to Change From Existing**

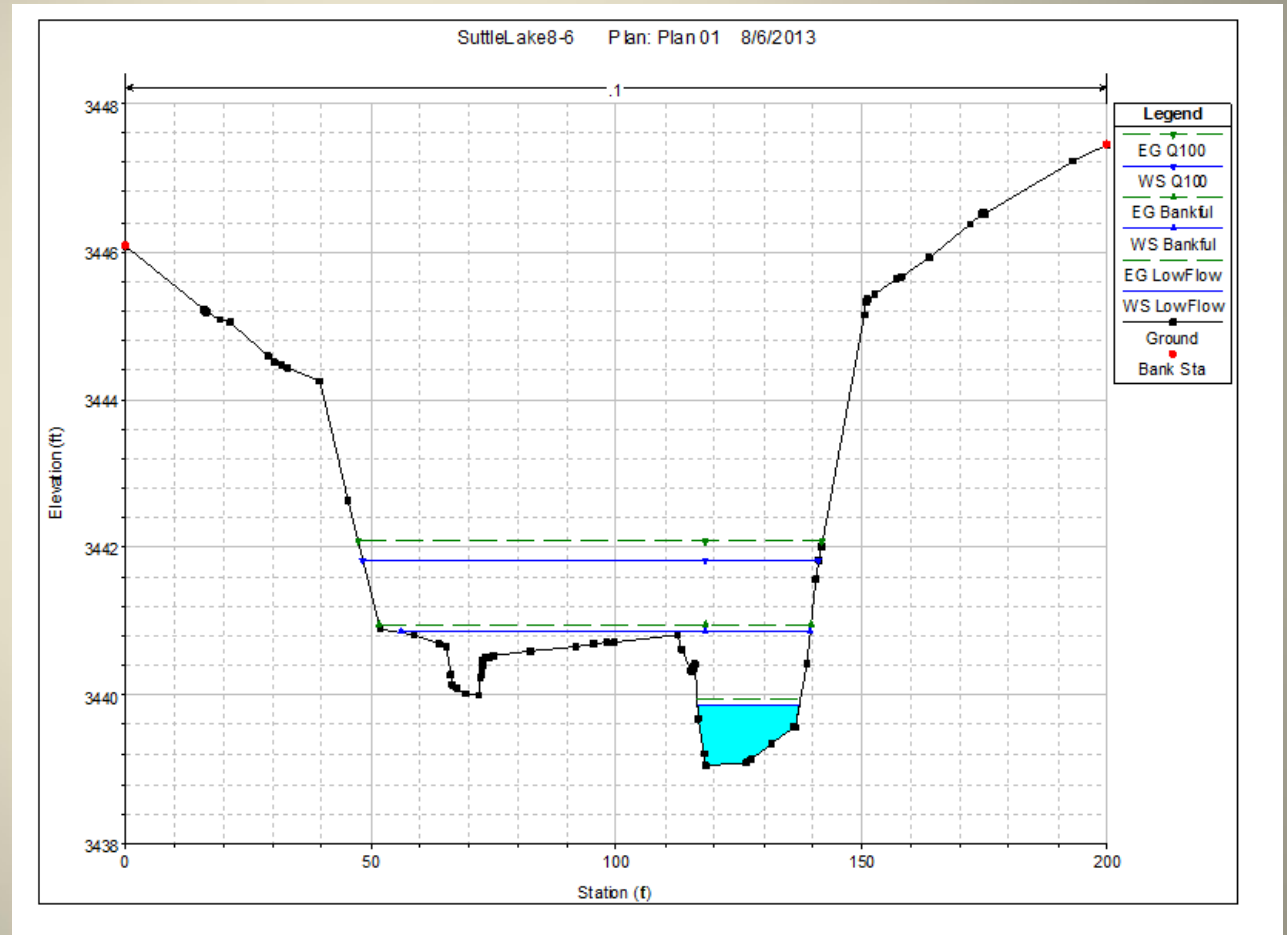
- **Hydraulic Analysis**

**Hec-Ras utilized  
to evaluate hydraulics  
Of stream Downstream**

**-Check 100 year flood  
elevations**

**-Evaluate to see if any  
hydraulic jumps occur –  
global scour concerns**

**-Check bed mobility  
Of particles that will not  
move in a 100 year  
flood event**
