# Hume Lake Dam Preservation and Rehabilitation Project

Designed by John Eastwood and constructed in 1908 Hume Lake Dam is the first multi-arch reinforced concrete dam in the world. The dam is located in the Sierra Mountains east of Fresno, California. Its original purpose was as a log pond and water source for a 17 mile flume used to transport timber downstream.

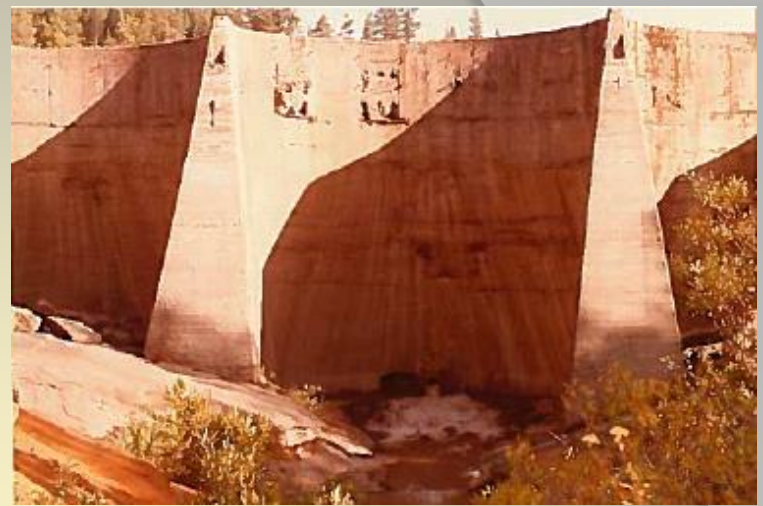
USFS infilled the 12 original 5x8' spillway gates (also known windows) in arches 5, 6, & 7. Primary spillway is now the outlet works. Auxiliary spillway is the dam crest.

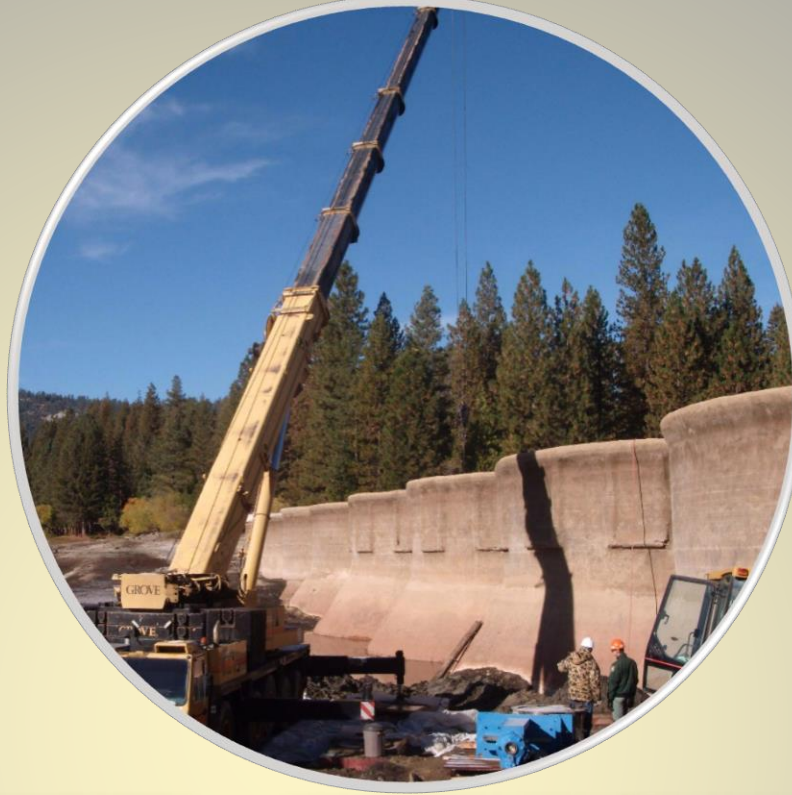
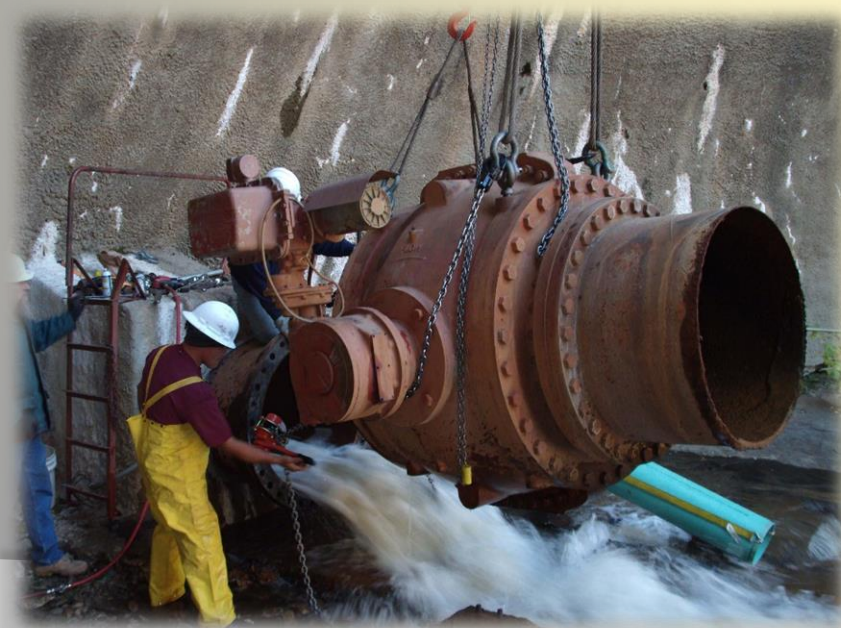
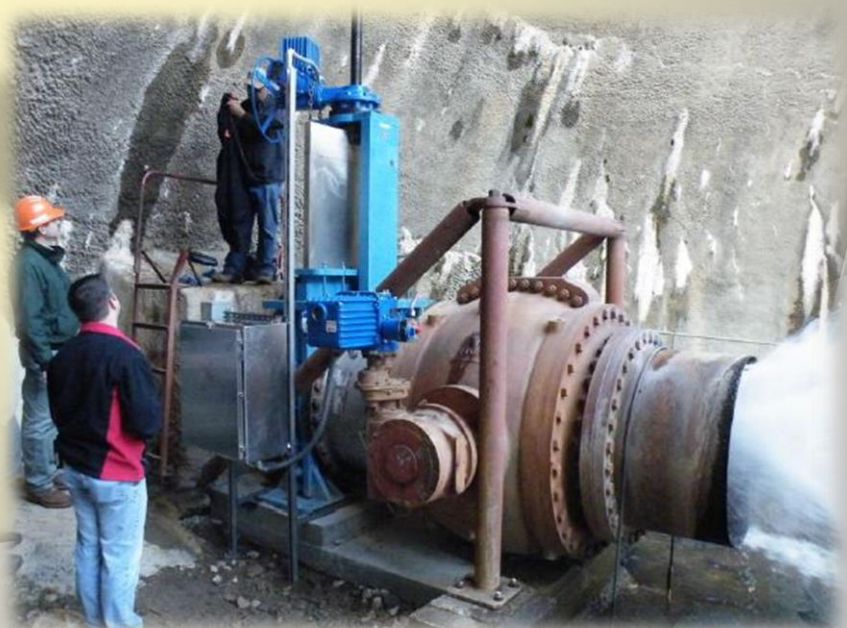
Outlet works was upgraded with new controls and the installation of an isolation valve upstream of the existing 36 inch ball valve.

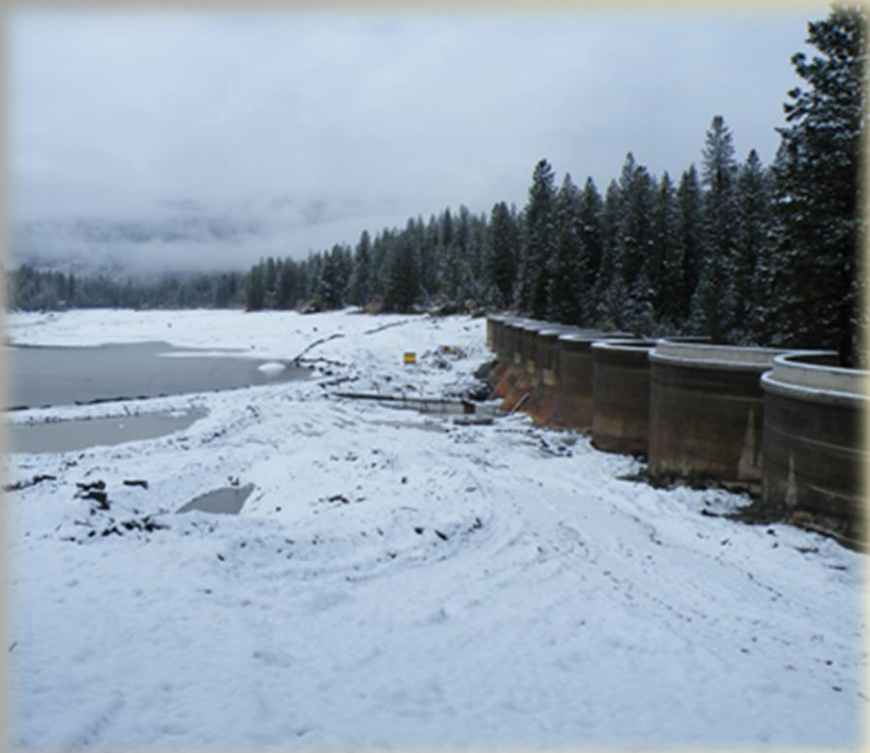
After 4+ years of drought more than 20 inches of precipitation fell on the project during construction significantly complicating construction.

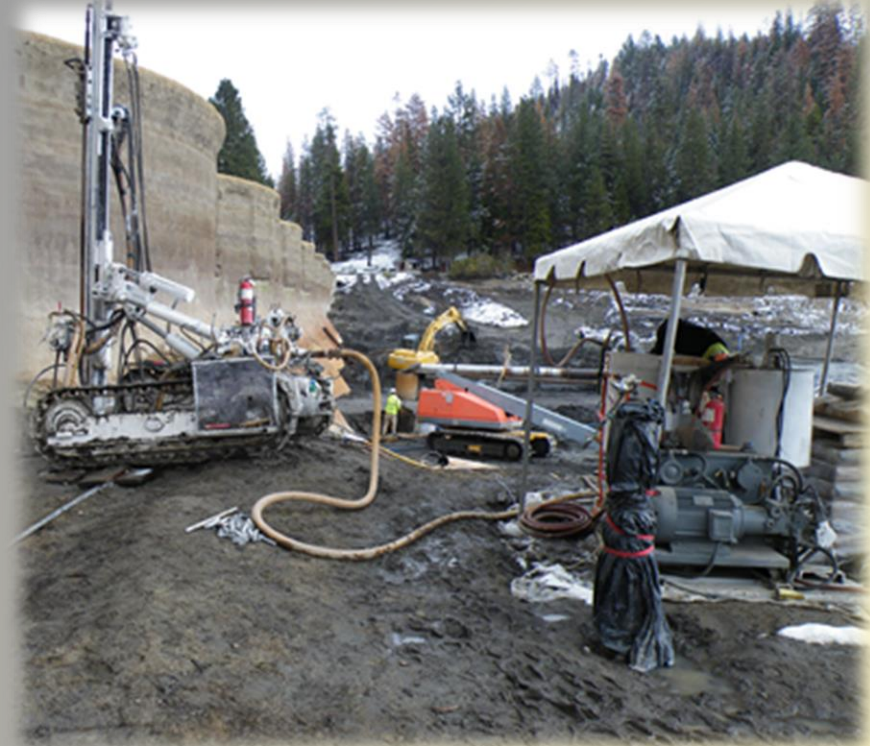
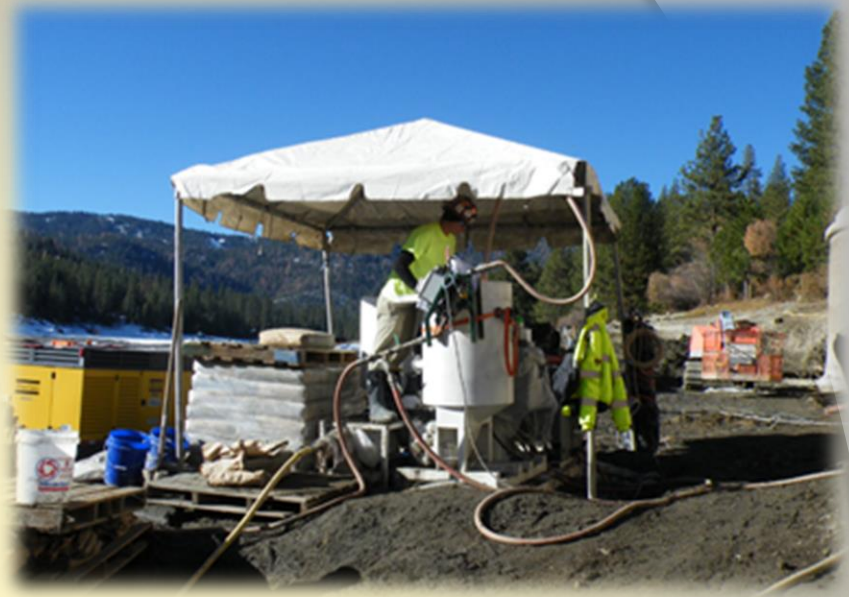
Depth	3p3	3p2	3p1	3s1	4p3	4p2	4t2	4s1	4t1	4p1	5s2	5p2	5s1	5p1
5-Feb	Blue	Green	Red	Green	Red	Green	Green	Green	Green	Red	Blue	Blue	Blue	Green
10-May		Green	Red			Red	Red			Green				
15-Oct		Green	Green		Red	Green	Green	Red		Green				
15-18					Green	Green

Foundation grouting program grout take analysis from December 2015

Cementitious grouting with some sodium silicate on occasion. Rotary drilling – no percussion.

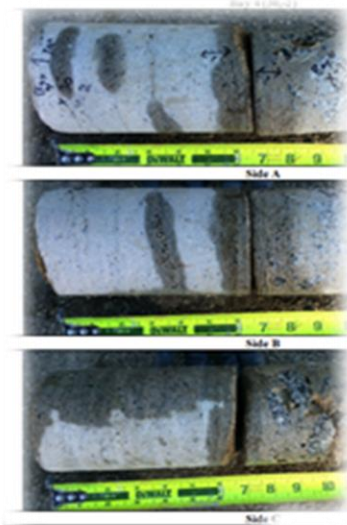
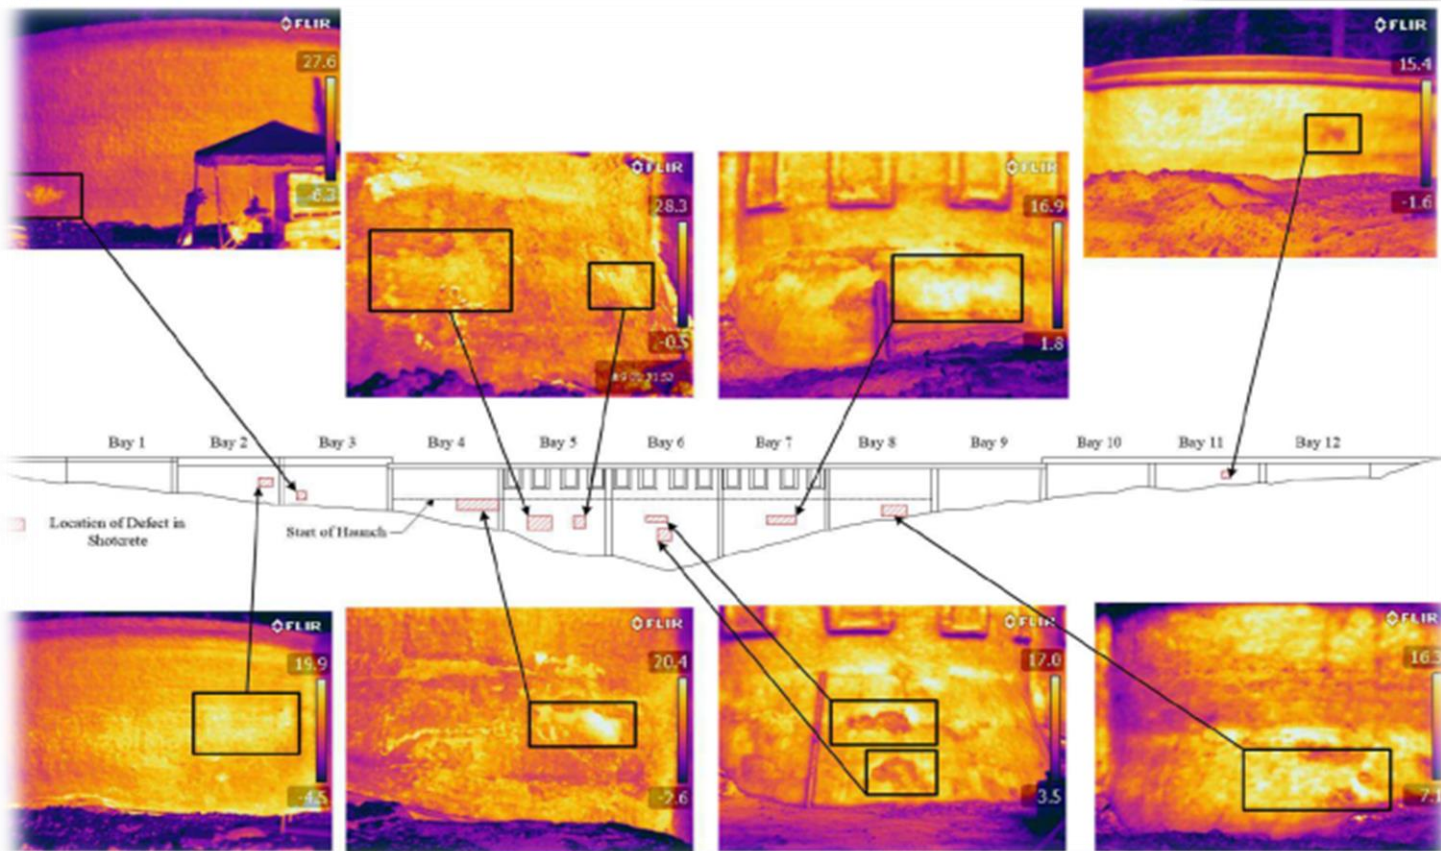
Infrared imaging to detect areas of shotcrete delamination for liner installation.

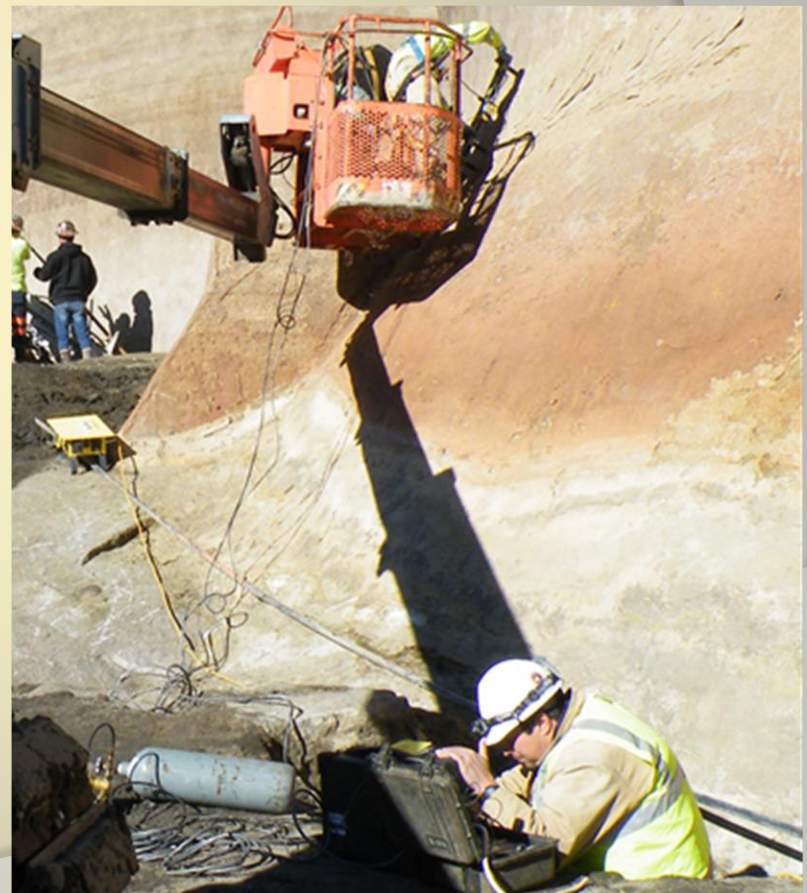
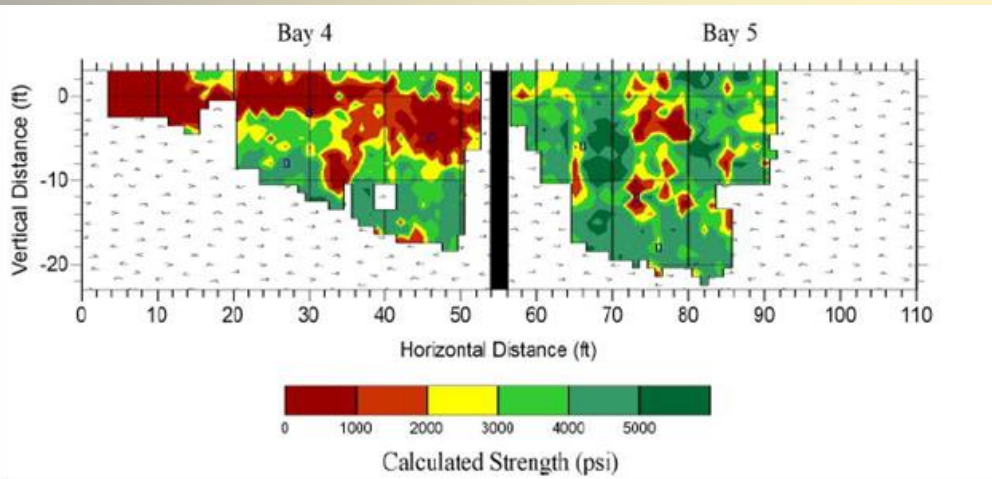
Echo impact/pulse velocity results Bay 4 and 5. The loading response and coring suggest results were skewed by shotcrete overlay. However, future investigations and/or treatments could use results as a guide. Targeted structural grouting may benefit from such non-destructive techniques.

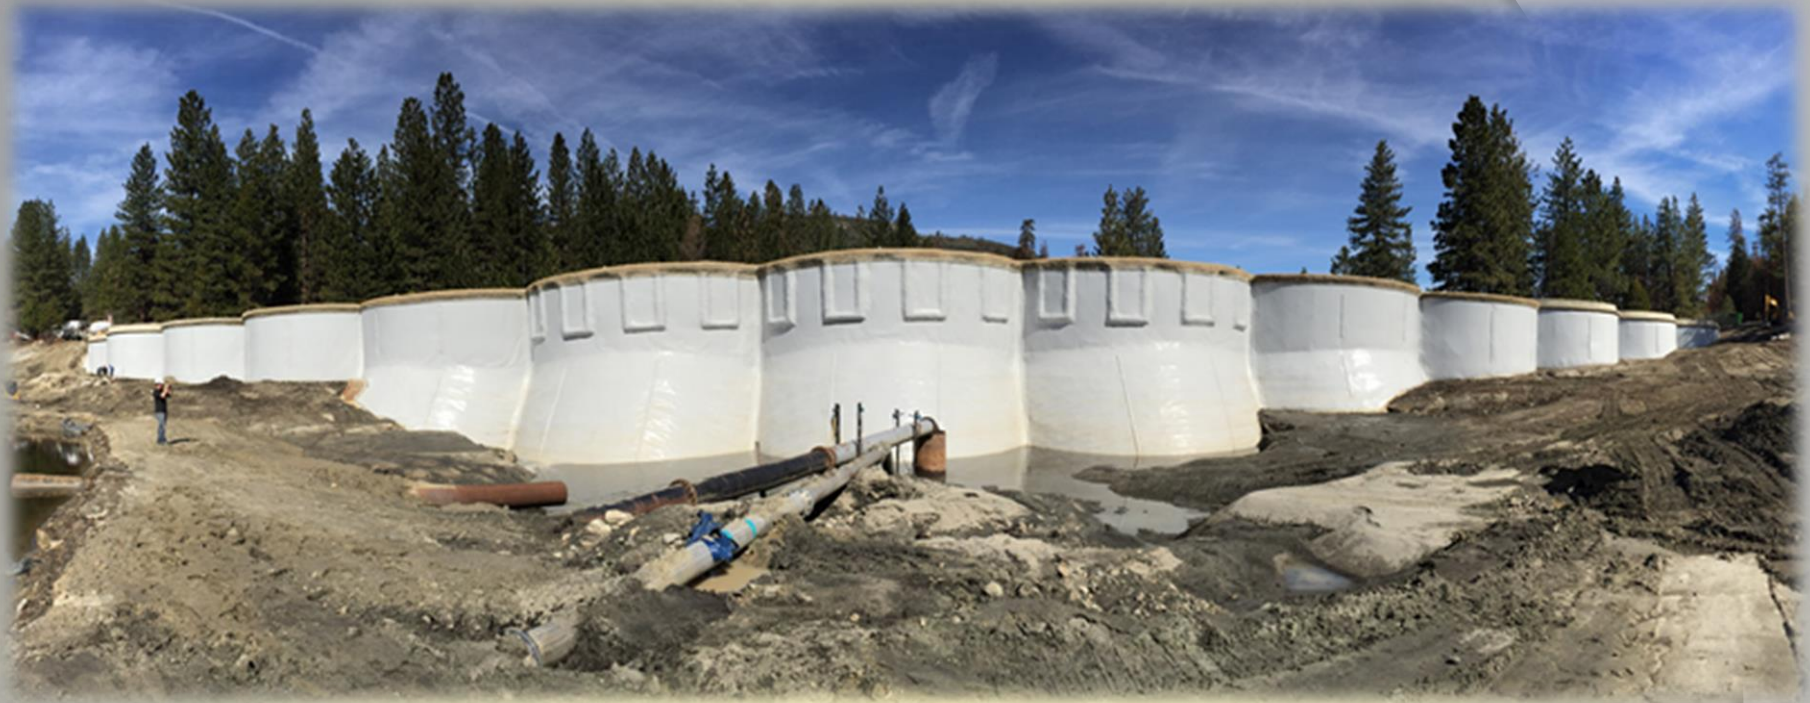
Panoramic view of Hume Lake Dam after the completion of foundation grouting and membrane installation – March 2016
