# AGFC Lake Poinsett Renovation

# Phase I Construction - Water Control Tower and Spillway Renovations

# Phase 2 - Bank Stabilization

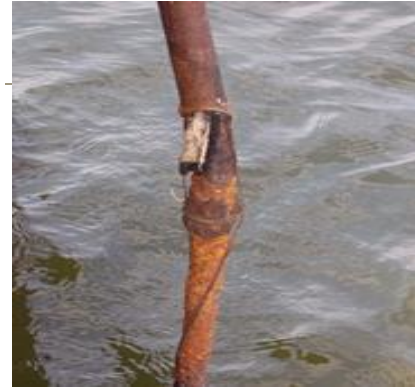
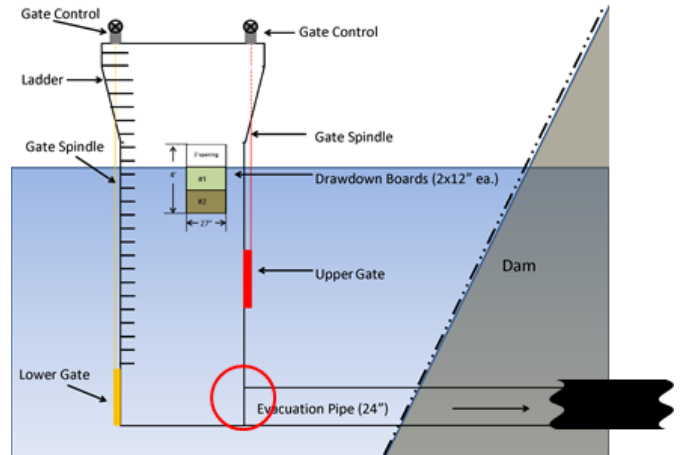
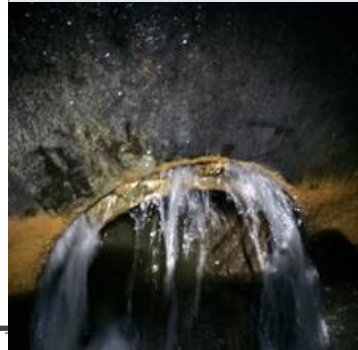
- ❑ Severe shoreline erosion
- ❑ High Risk Dam
- ❑ Outflow structure and apron compromised
- ❑ Water Control Structure was inoperable
  - ❑ Upper gate stem completely broken
  - ❑ Lower gate questionable
- ❑ Evacuation pipe compromised
- ❑ Emergency Spillway needed regrading, widening and repair
