Stabilization of an Infinite Slope Failure Utilizing Hollow Bar Soil Nails with Long-Term Monitoring Plan September 2013

Presented By: Christopher "Chud" Lundgreen, EIT
Regional Geotechnical/Pavements Engineer
Northern Region, USDA Forest Service

Hyalite Canyon Slide, Gallatin NF

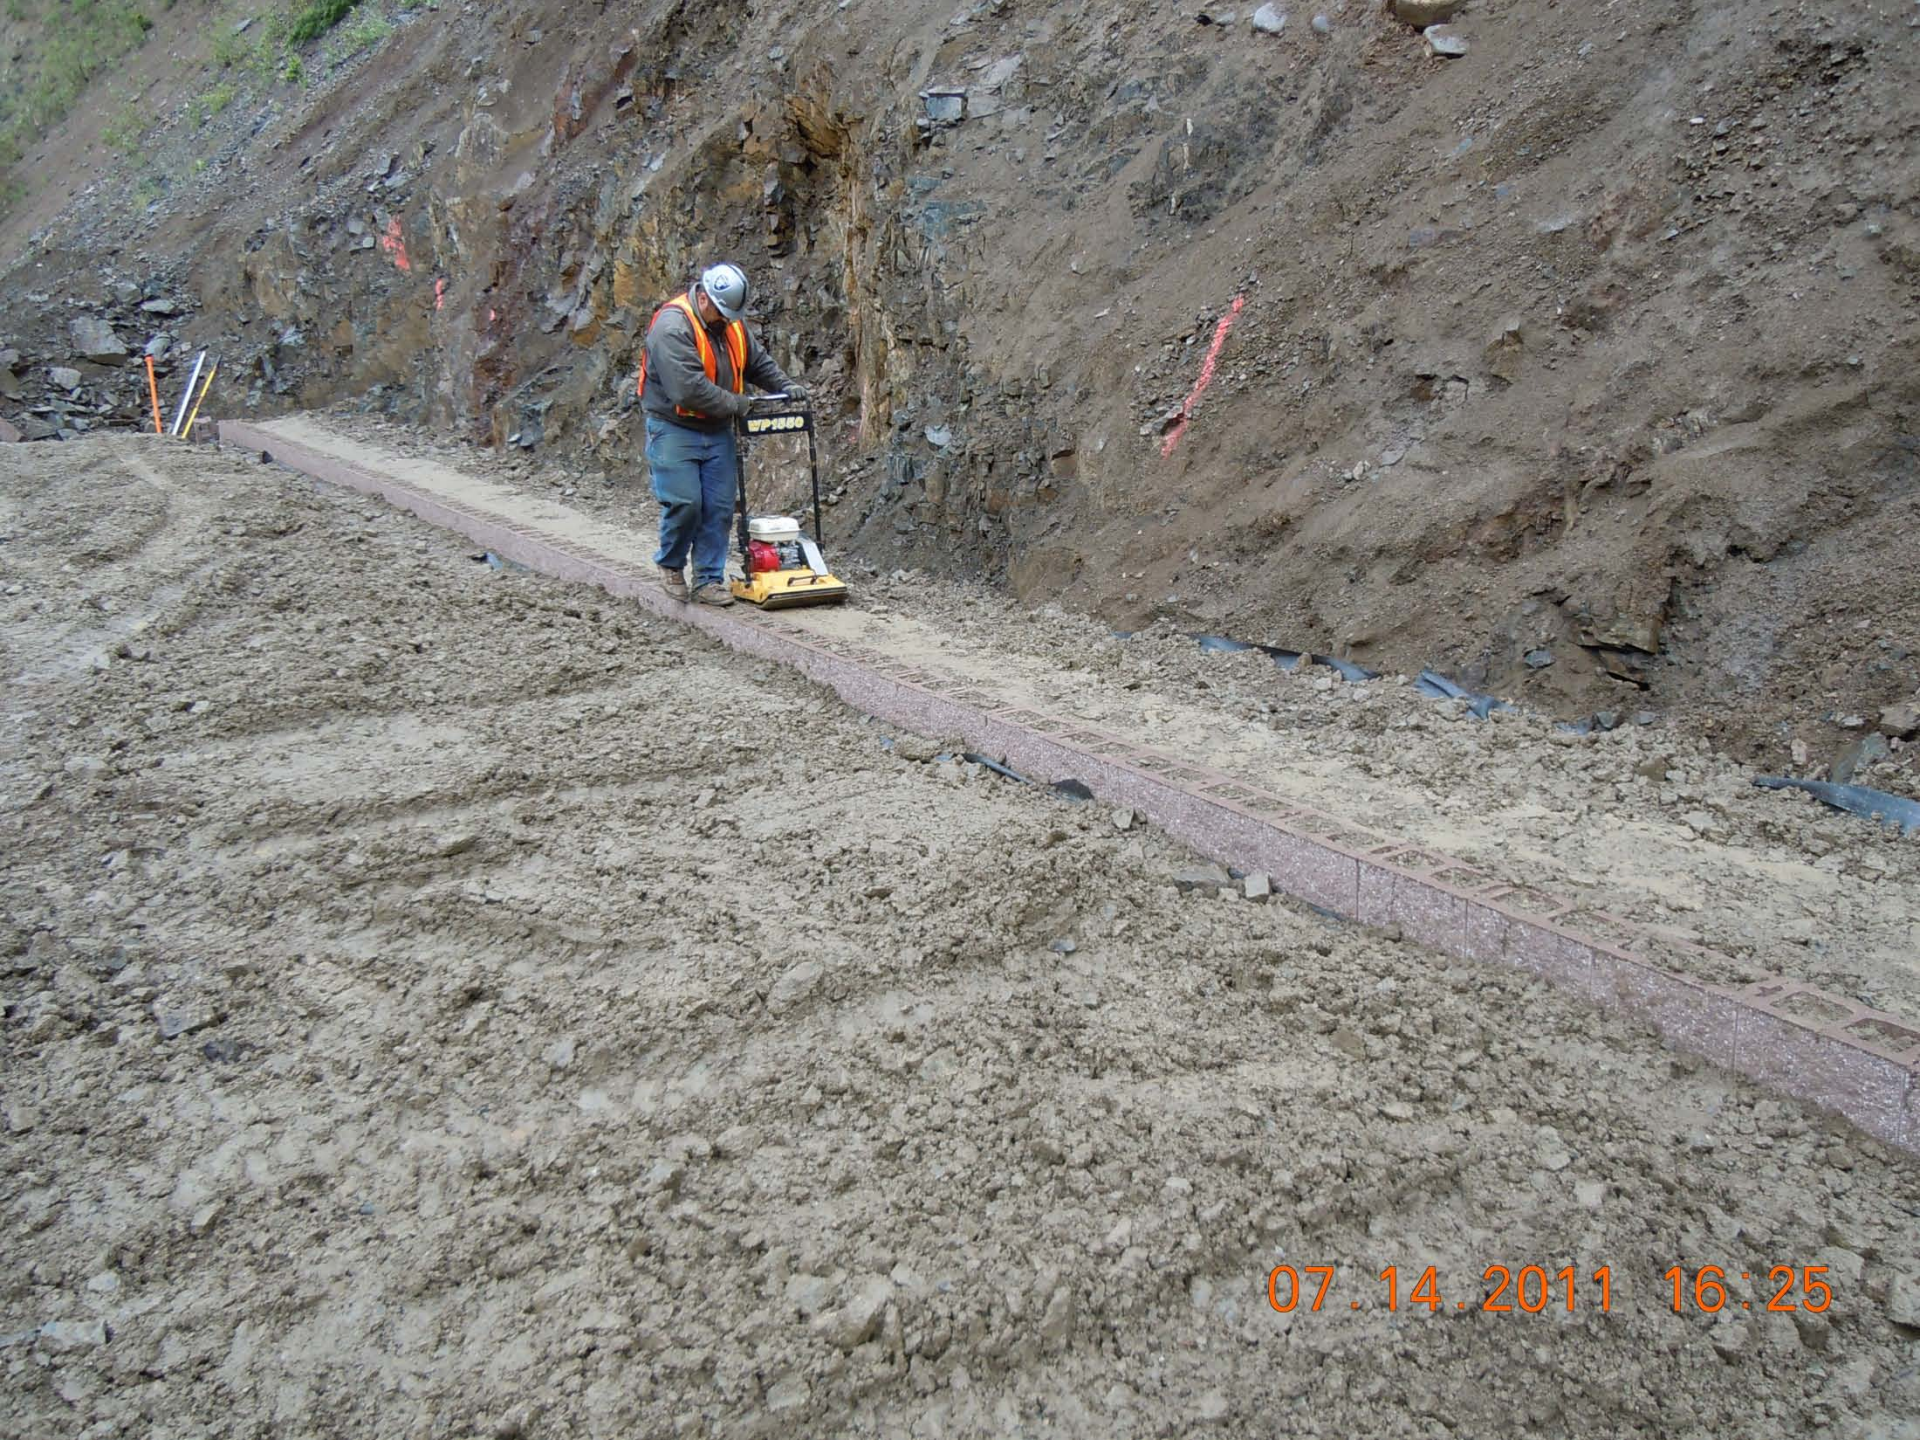
Leveling is extremely important
